GIPPSLAND PORTS

**PORT WELSHPOOL LONG JETTY –  
CONDITION ASSESSMENT VALIDATION  
ASSESSMENT REPORT**

F0001-AA004066-AAR-03

15 JULY 2011

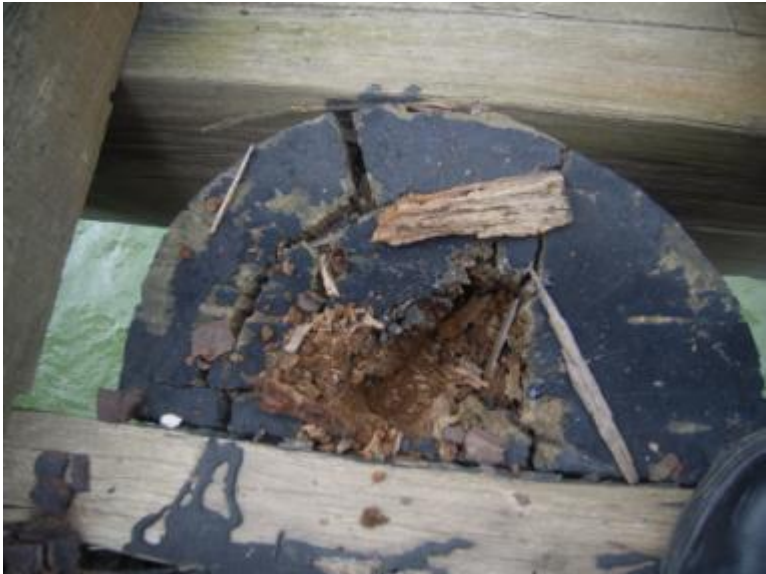
| Element | Defect | Example |
|---|--|---|
| Pile | Rot through inner heart wood at pile top | |

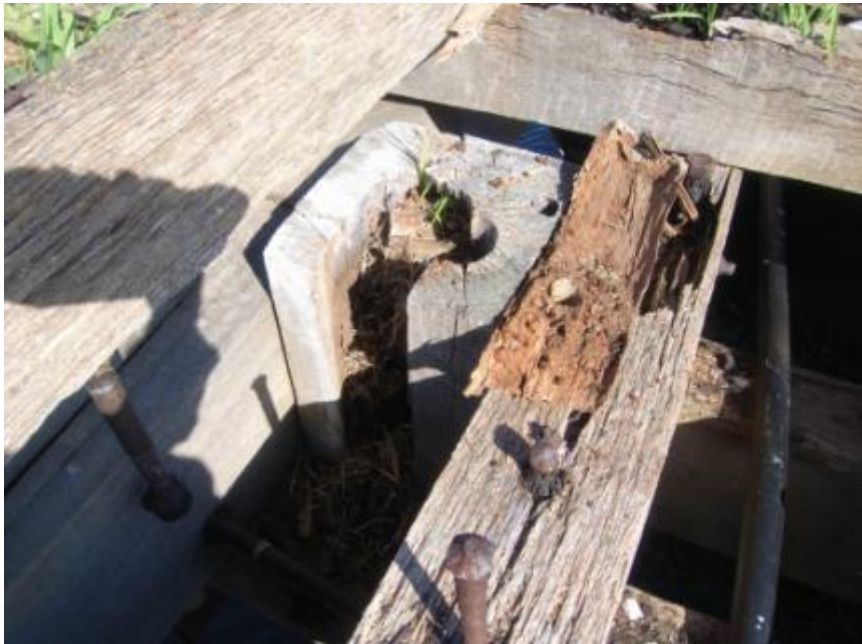
| Element | Defect | Example |
|---|--|---|
| Pile | Termite attack in pile top | |

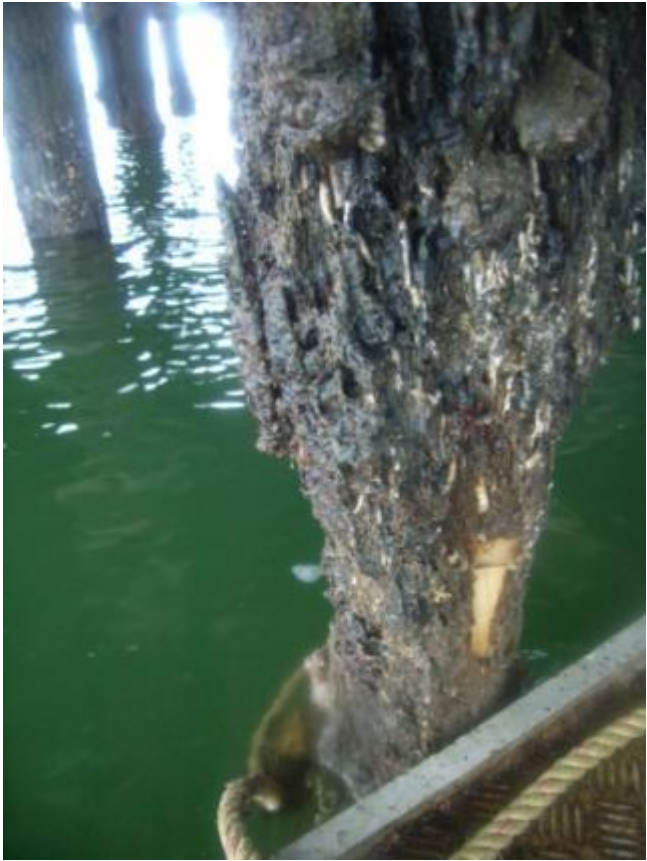
| Element | Defect | Example |
|---|--|--|
| Pile | Pile with heavy Teredo and Limnoria attack. | |

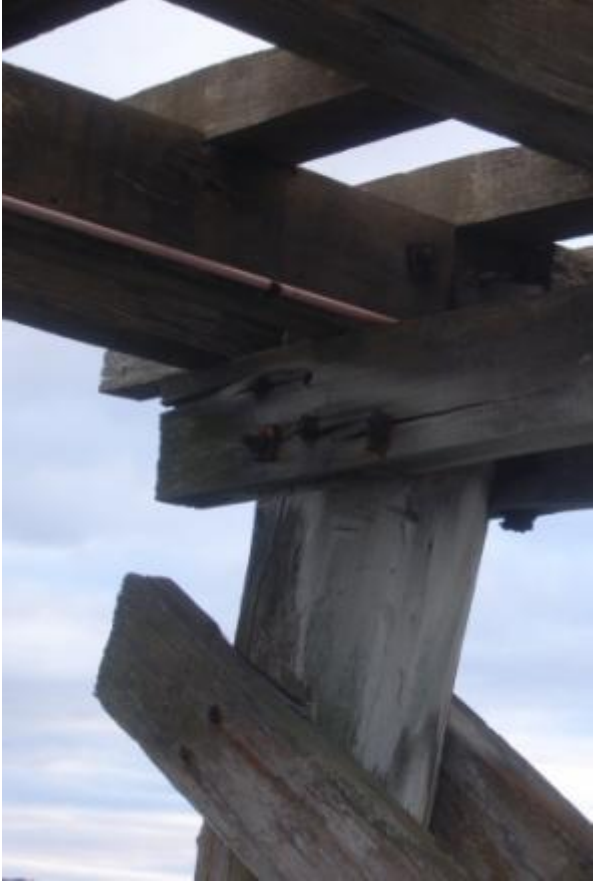
| Element | Defect | Example |
|---|--|--|
| Crosshead | Minor degree of splitting at bolted connection of crosshead to piles | |

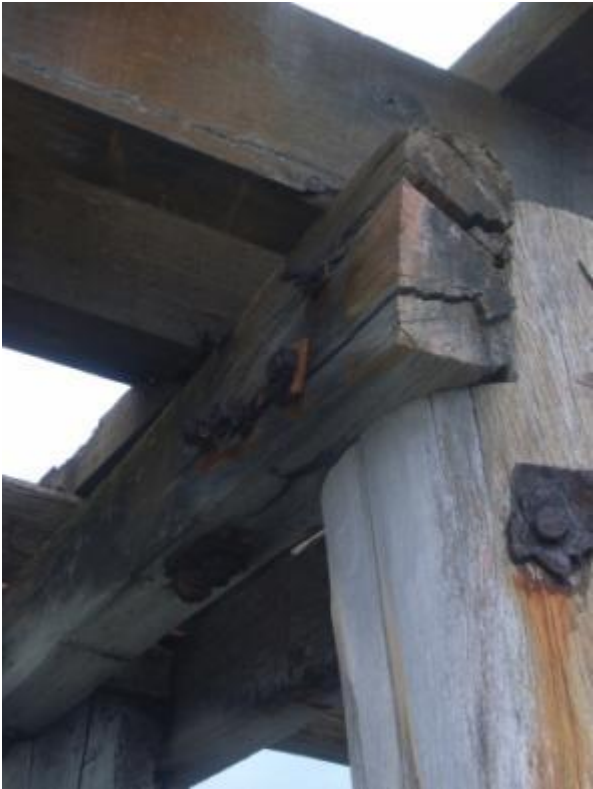
| Element | Defect | Example |
|---|---|--|
| Crosshead | Moderate degree of splitting at bolted connection of crosshead to piles | |

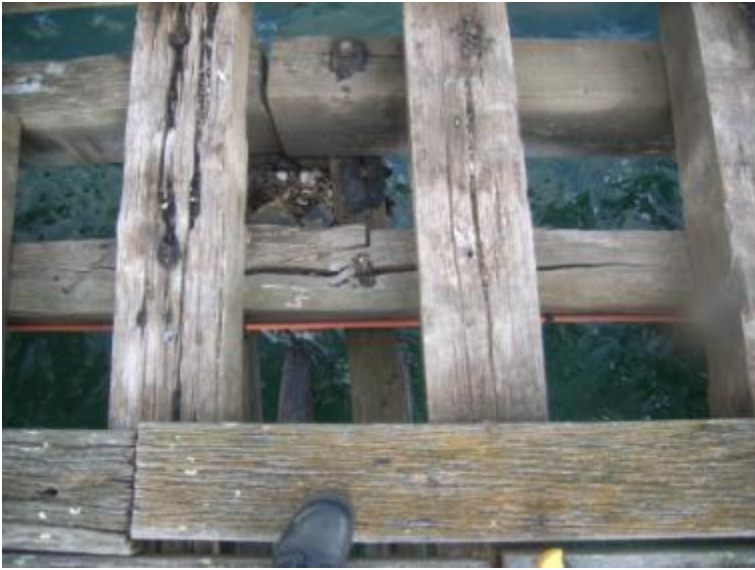
| Element | Defect | Example |
|---|---|--|
| Beam | Splitting at connections over crossheads | |

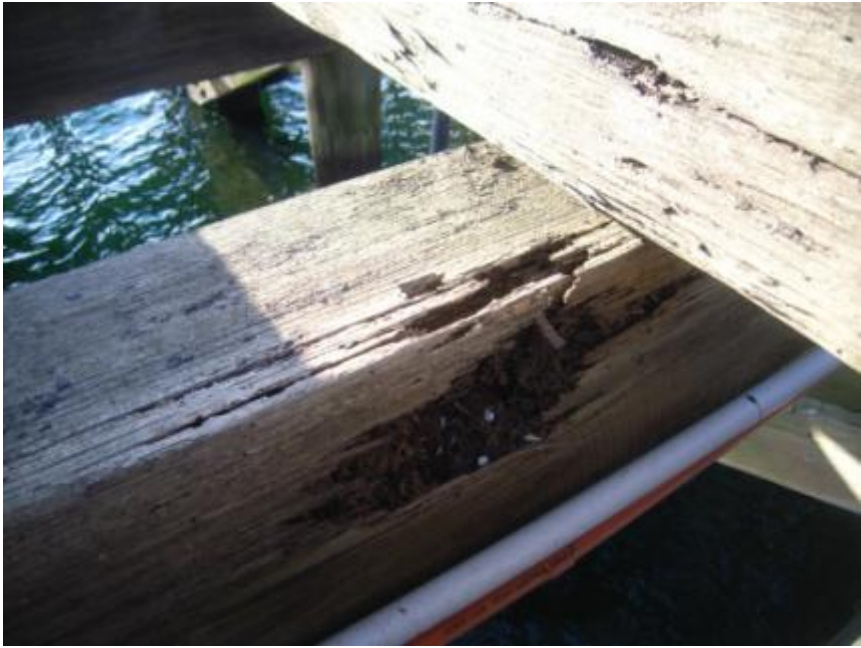
| Element | Defect | Example |
|---|---|--|
| Beam | Heavy termite attack in beam | |

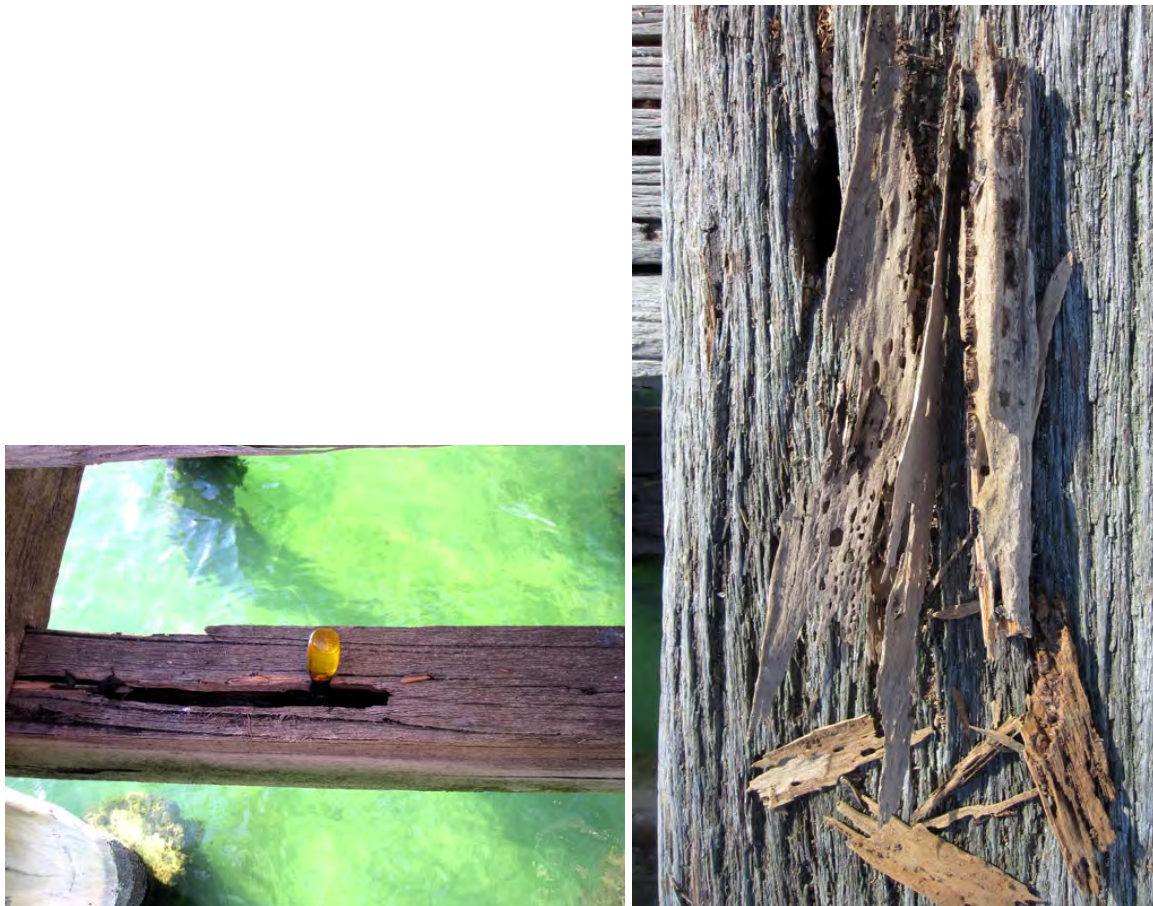
Bent 2 = One crosshead was mostly hollow due to termite damage (Figure 1). Live termites not found. Second crosshead was in good condition, with only 1-3 mm fungal decay.

**Figure 1: Crosshead hollowed out by termites. Right photo showing ‘paper thin’ layers of wood pulled from hollow, which is typical of termite attack.**

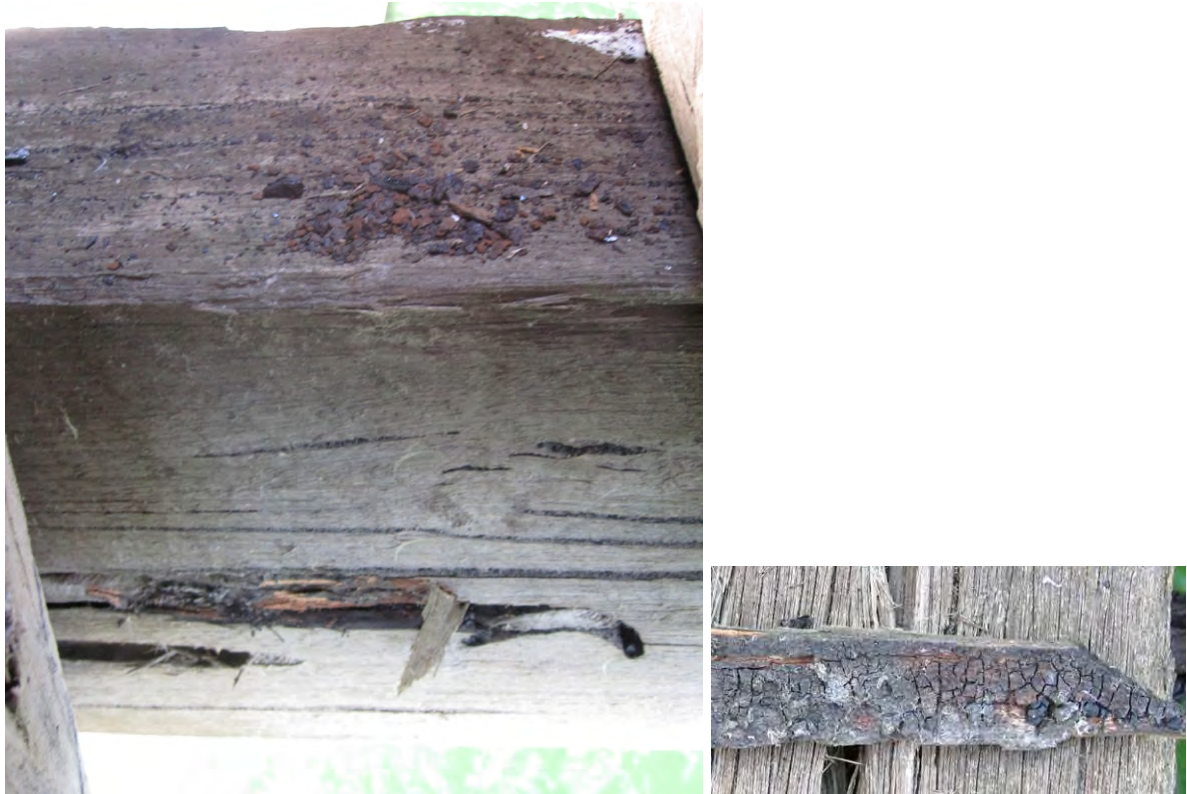
Bent 4 = Both crossheads generally in good condition, with only 1-3 mm decay. One crosshead has a damaged area 10-20 mm deep near a pile. This damage is of minor concern, as it is a pocket of kino and inner pith or heartwood, rather than a result of termites or fungi (Figure 2).

**Figure 2: Side of crosshead with 10-20 mm patch of damage from kino and pith, of minor concern. Right photo shows dried kino on removed piece.**

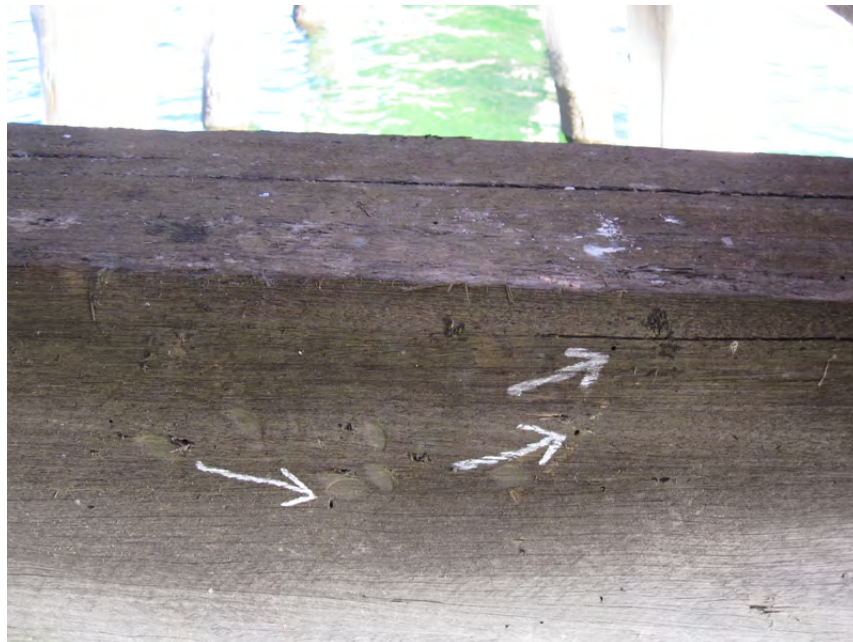
Bent 5 = Both crossheads in good condition, with only 1-3 mm decay. One crosshead has several small beetle borer holes caused in the living tree or log that are of no concern as the damage has not progressed in the seasoned sawn timber (Figure 3).

**Figure 3: Side of crosshead with minor borer damage caused before the log was sawn, of no concern.**

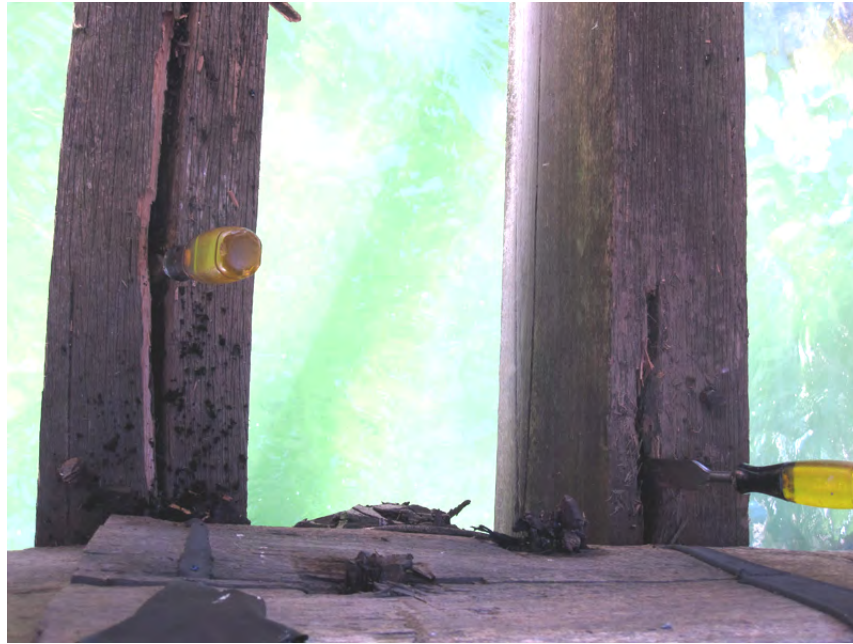
Bent 7 = Northern side crosshead with a crevice caused by termites up to 120 mm deep and 20-30 mm wide extending nearly full length of crosshead (Figure 4). Crosshead is probably still structural, as the majority of the remaining timber is in good condition, although the beam should not be reused. Southern side crosshead in better condition, with termite damage limited to one end of beam in a crevice 70 mm deep and 1000 mm long near a pile (Figure 4)

**Figure 4: Northern side crosshead (left) with 120 mm deep crevice of termite damage. Southern side crosshead (right) with moderate termite damage at one end.**

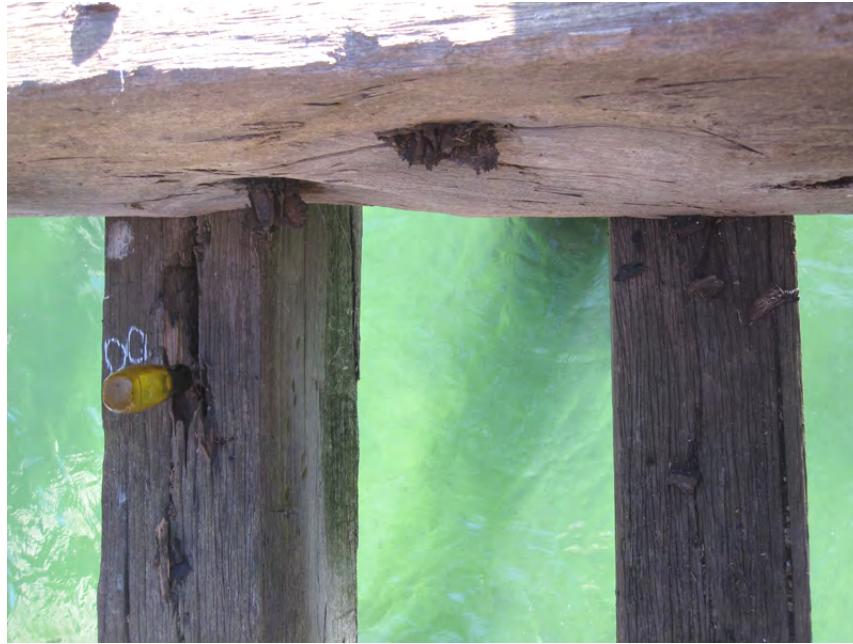
Bent 8 = Southern side crosshead (167B) identified as *E. obliqua* partially hollowed out by termites, unserviceable (Figure 5). Northern side crosshead with moderate termite attack, heavier damage on eastern end of beam near pile.

**Figure 5: Southern side crosshead (left) hollowed by termites. Northern side crosshead (right) with moderate termite damage, heavier damage other end.**

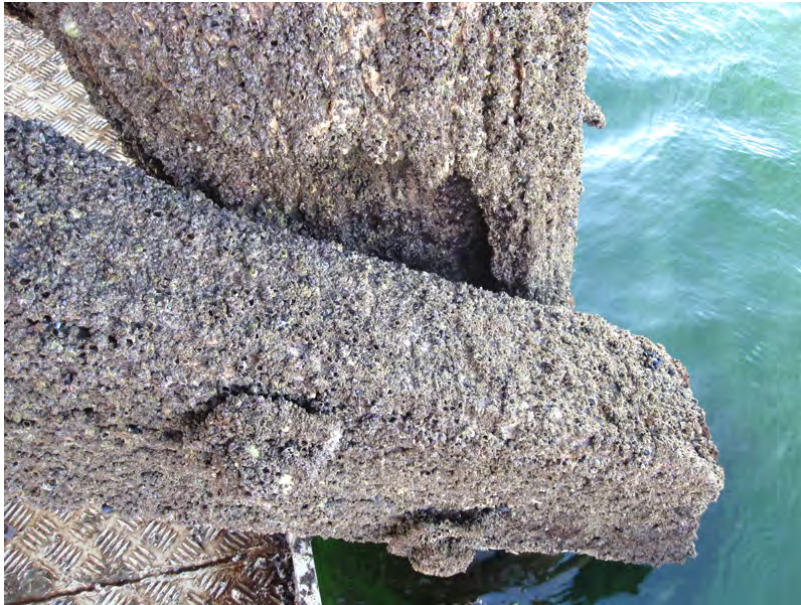
Pile 232B = Low tide with 60 mm deep cavity southern side and 90 mm cavity northern side due to low tide cross-bracing now lost. Heartwood with *Limnoria* damage a further 2-4 mm deep plus several streaks of *Limnoria* 10-30 mm deep, teredinids absent. Mid-tide region behind diagonal cross-brace with patch of *Limnoria* erosion 350 mm long x 180 mm wide x 50 mm deep (Figure 6). Estimated sound wood remaining 200 mm wide north/south direction and 320 mm wide east/west direction.

**Figure 6: Pile 232B, showing mid-tide region with erosion caused by *Limnoria* behind cross-brace.**

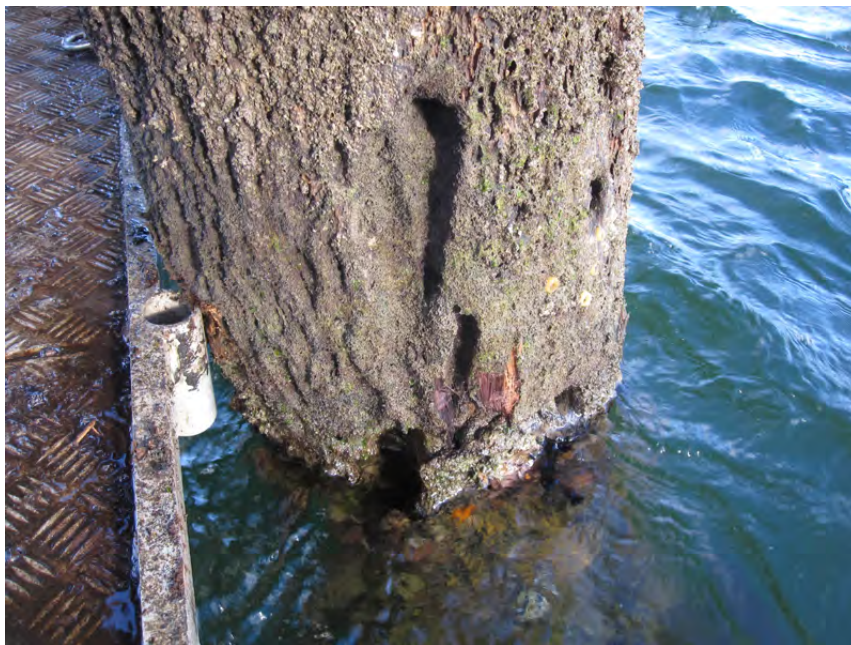
Pile 236A = Low tide with 50 mm deep cavity southern side and 60 mm cavity northern side due to low tide cross-bracing now lost. Heartwood with *Limnoria* damage a further 2-4 mm deep, teredinids absent. With two bolt holes excavated to 30 mm diameter by *Limnoria* and 150 mm deep. Several other patches eroded by *Limnoria* to 30 mm deep (Figure 7). Estimated sound wood remaining 210 mm wide north/south direction and 320 mm wide east/west direction.

**Figure 7: Pile 236A, showing low tide region with several areas eroded by *Limnoria* to 30 mm deep in north/south faces. Bolt just below waterline in low tide region.**

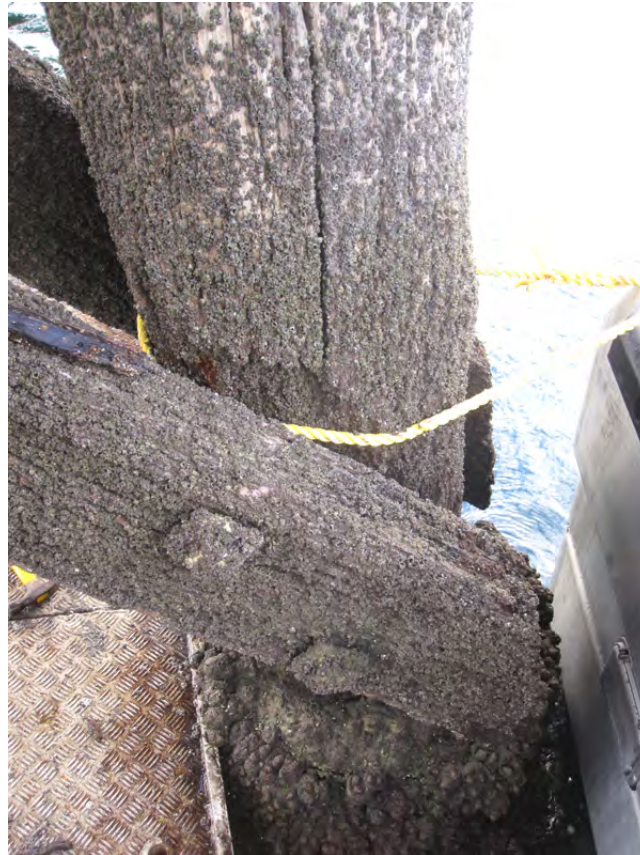
tidal zone, bottom edge of sapwood in high tide region with several 8-10 mm longitudinal tunnels 10-20 mm long caused by *Sphaeroma quoyana*, few fissures from weathering (wetting and drying in tidal zone) above mid-tide 10-15 mm deep. High tide with hole 50 mm diameter and 100 mm deep, perhaps an old bolt hole further hollowed by decay, slaters and *S. quoyana*. *Limnoria* and occasional teredinid present in lower tidal region. Region of pile behind cross-brace checked to fit cross-brace, with additional 40 mm cavity excavated by *Limnoria* into checked region (Figure 8). Estimated sound wood remaining 260 mm wide north/south direction and 300 mm wide east/west direction.

**Figure 8: Pile 236B, lower tide region, note pile area near rope notched to fit cross-brace. Concrete collar below cross-brace.**

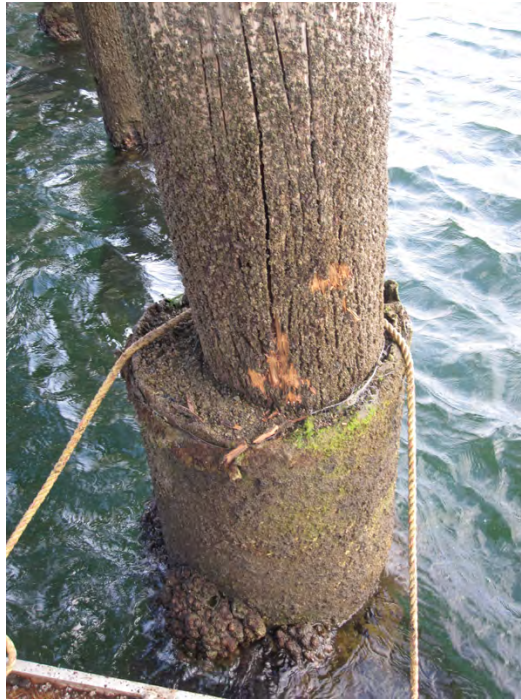
Pile 237A = With concrete collar to just above mid-tide (Figure 9). Sapwood 15 mm thick lost in tidal zone, few fissures from weathering (wetting and drying in tidal zone) above mid-tide 10-15 mm deep. Heartwood without active marine borers, although minor etchings into heartwood from teredinid activity in sapwood (when it was present) was apparent from the collar to 150 mm above the collar. Estimated sound wood remaining 320 mm diameter (present diameter 350 mm).

**Figure 9: Pile 237A, pile with concrete collar, without active marine borer attack in tidal zone.**

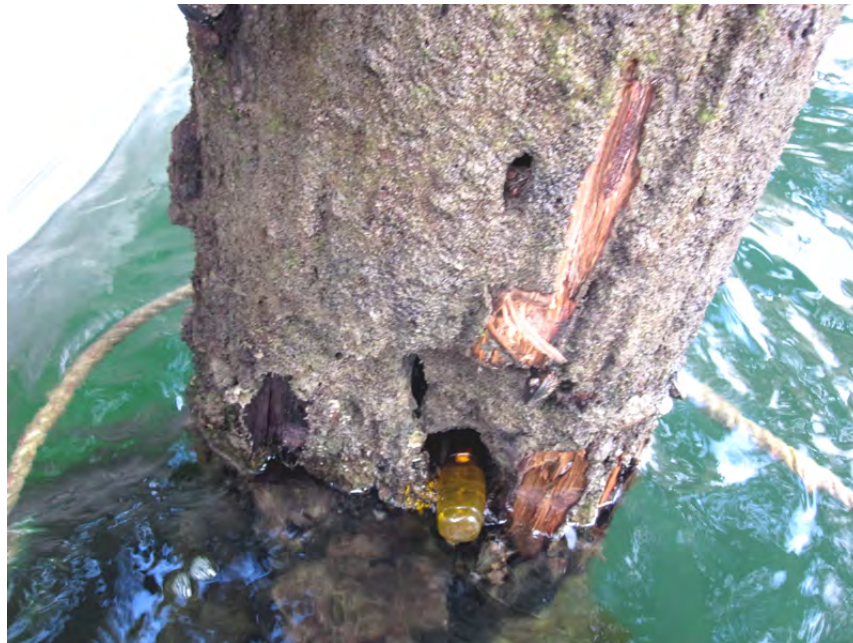
Pile 237B = Low tide with 70 mm deep cavity southern side and 40 mm cavity northern side due to low tide cross-bracing now lost. Heartwood with *Limnoria* damage a further 2-4 mm deep, with light teredinid attack only two specimens found. Heartwood also with two bolt holes 50 mm diameter excavated by *Limnoria* through full diameter of pile, exposing pile pith which is also partially hollowed by *Limnoria* (Figure 10). Estimated sound wood remaining 100 mm diameter, pile unserviceable.

**Figure 10: Pile 237B, low tide region showing chisel in one of the 50 mm diameter bolt holes, pile unserviceable.**

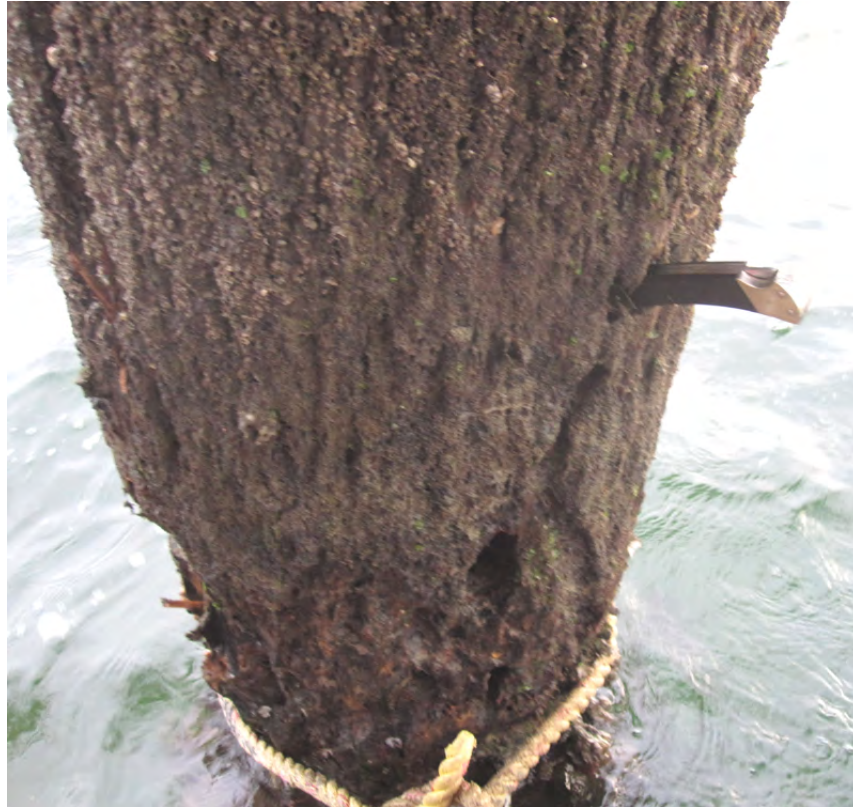
Pile 238A = Low tide with 70 mm deep cavity southern side and 40 mm cavity northern side due to low tide cross-bracing now lost. Heartwood with *Limnoria* damage a further 2-4 mm deep, teredinids absent. Heartwood also with five holes about 30 mm diameter between low and mid tide 50 to 70 mm deep, possibly arising from *Limnoria* excavation of old drilled holes or eaten out knots (Figure 11). Estimated sound wood remaining 200 mm diameter.

**Figure 11: Pile 238A, low tide region showing several 30 mm diameter holes 50-70 mm deep perhaps resulting from old bolt holes or eaten out knots.**

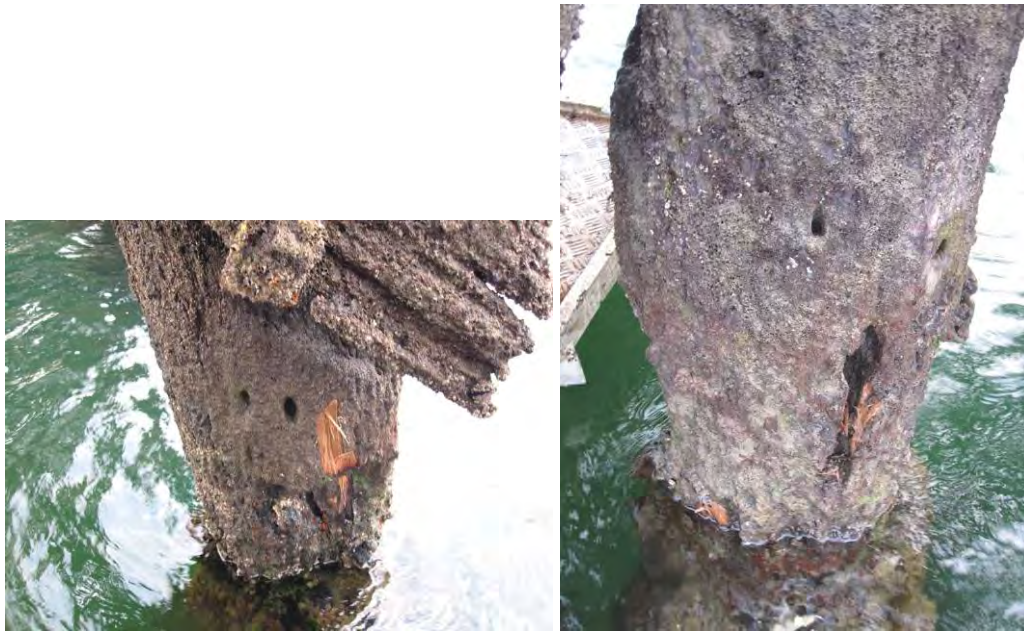
Pile 238B = Low tide with 70 mm deep cavity southern side and 70 mm cavity northern side due to low tide cross-bracing now lost. Heartwood with *Limnoria* damage a further 2-4 mm deep, teredinids absent. With several 20-30 mm diameter holes 40 mm deep. Outer face between low and mid tide with 70 mm deep longitudinal cavity 30 mm deep and 100 long excavated by *Limnoria* (possibly old bolt holes) (Figure 12). Estimated sound wood remaining 250 mm diameter.

**Figure 12: Pile 238B, left photo showing 70 mm deep cavity from lost cross-brace (below freshly chiseled wood), teredinids absent, two 40 mm deep holes also present. Right photo showing 70 mm deep longitudinal cavity caused by *Limnoria* in old bolt holes.**

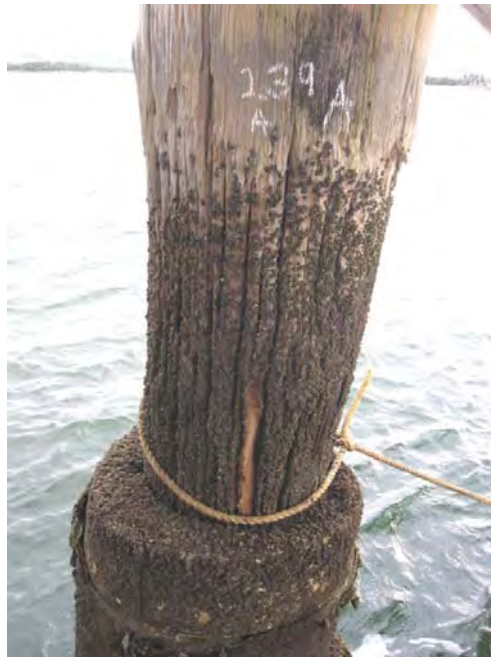
Pile 239A = With concrete collar to mid-tide (Figure 13), and perhaps extending to 1000 mm below low tide. Sapwood 12 mm thick lost in tidal zone, original diameter of heartwood (450 mm diameter) sound, except for minor weathering fissures 10-15 mm deep. *Limnoria* and teredinids absent, although minor etchings into heartwood from teredinid activity in sapwood (when it was present) was apparent just above the collar. Pile in good condition in the tidal zone.

**Figure 13: Pile 239A with concrete collar to about mid-tide, showing fissures 10-15 mm deep due to weathering, marine borer damage mostly absent in tidal zone.**

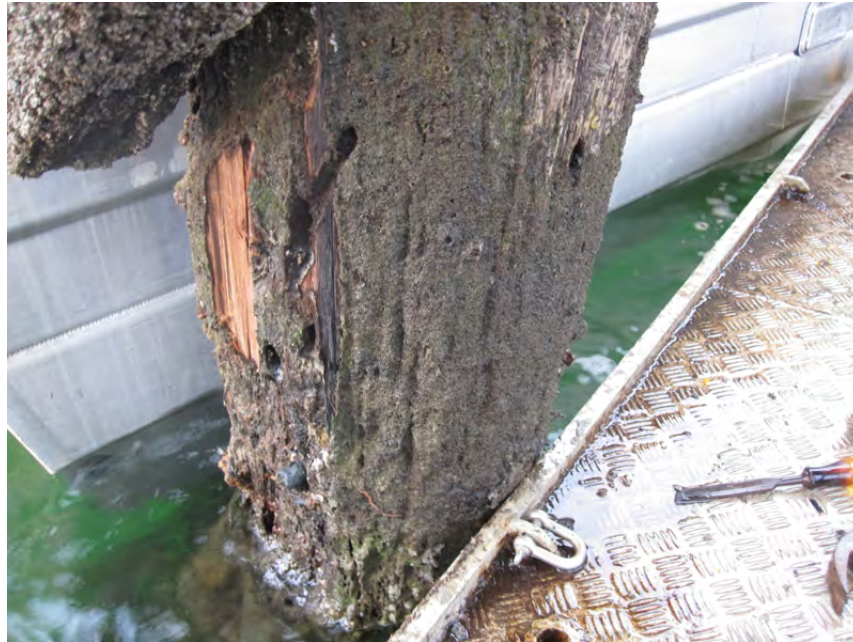
Pile 239B = Identified as *E. ?muelleriana* (probably yellow stringybark). Low tide with 70 mm deep cavity southern side and 80 mm cavity northern side due to low tide cross-bracing now lost (Figure 14). Heartwood with *Limnoria* damage a further 2-4 mm deep and light teredinid attack to 10 mm depth. Estimated sound wood remaining 190 mm wide north/south direction and 250 mm wide east/west direction. Mid-tide region with several cavities 20-30 mm deep into heartwood caused by teredinids and *Limnoria*.

**Figure 14: Pile 239B, low tide region showing flattened (checked) face for cross-brace now lost, and projecting end of bolt visible above waterline. Light teredinid attack, freshly chiseled area without teredinid damage.**

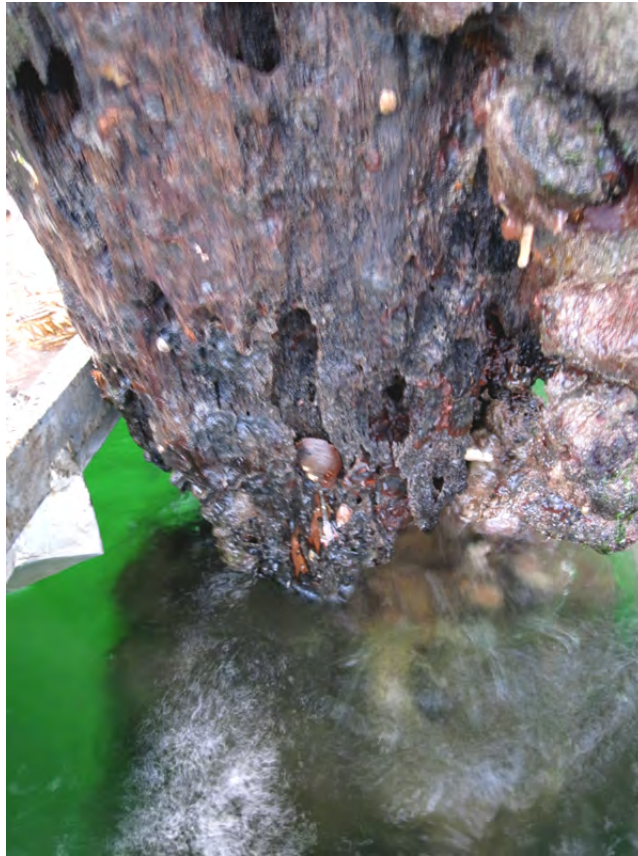
**Figure 15: Pile 240B, low tide region showing deep southern cavity at water line on right (below clump of fouling), and shallower cavity on left side. Pile in poor condition.**

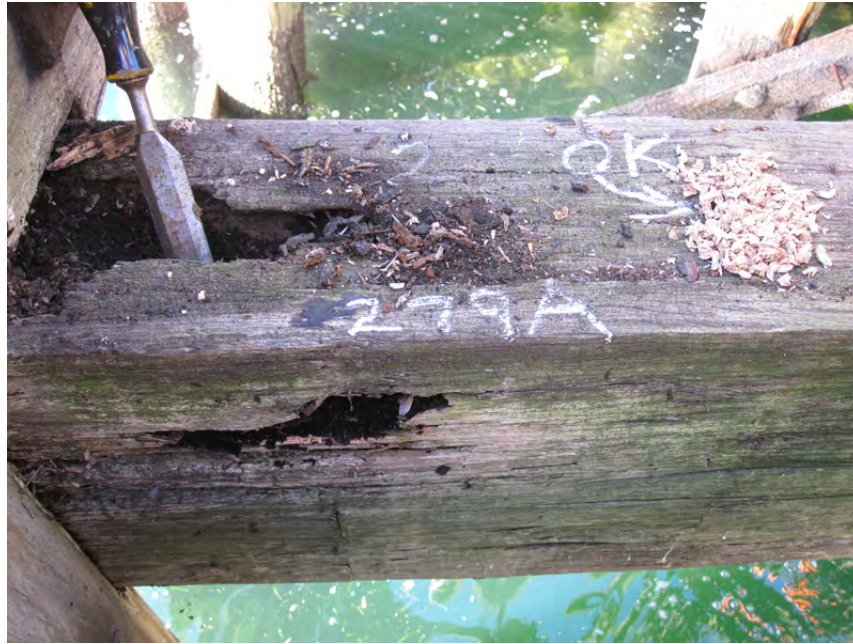
**Figure 16: Crosshead 279A showing end with extensive termite damage, and drilled shavings ('OK') further from end from which sound timber begins.**

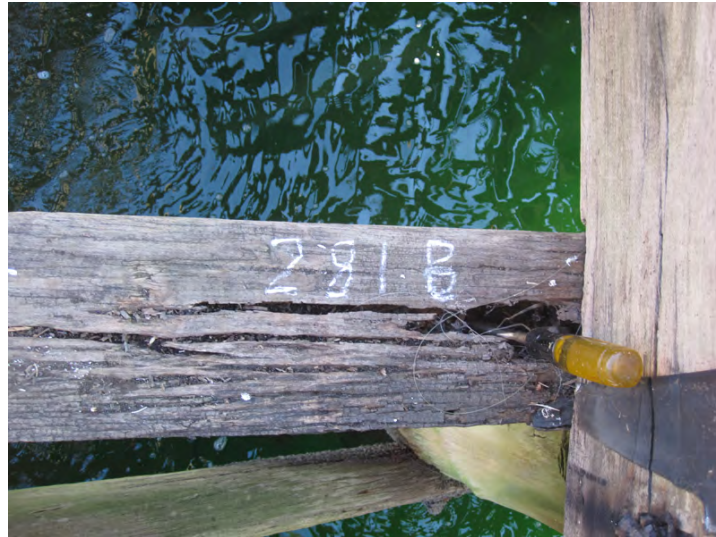
**Figure 17: Crosshead 281B with termite damage 600 mm along end of beam.**

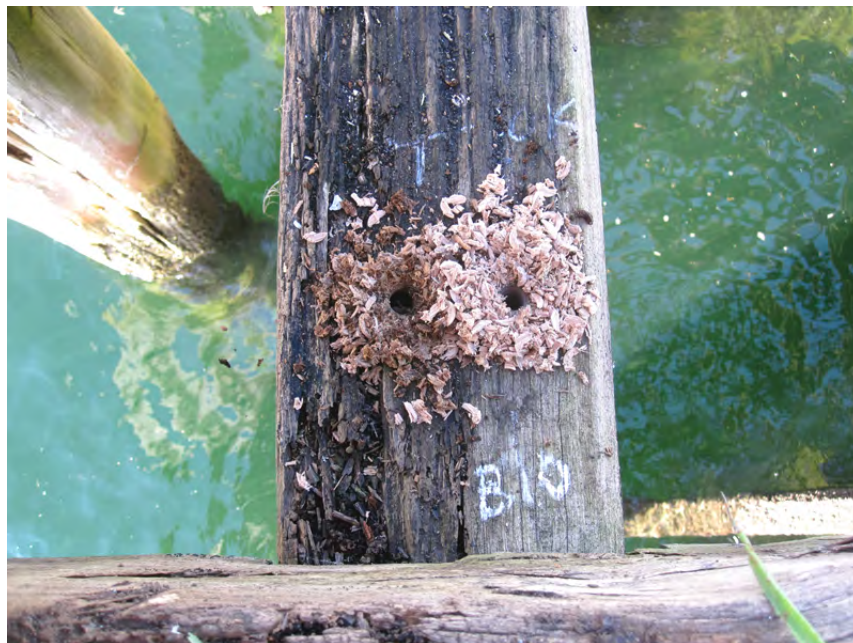
**Figure 18: Longitudinal beam 10 over crosshead 279A showing left side of beam damaged by termites and decay (dark coloured shavings) and right side of beam sound (light coloured shavings).**

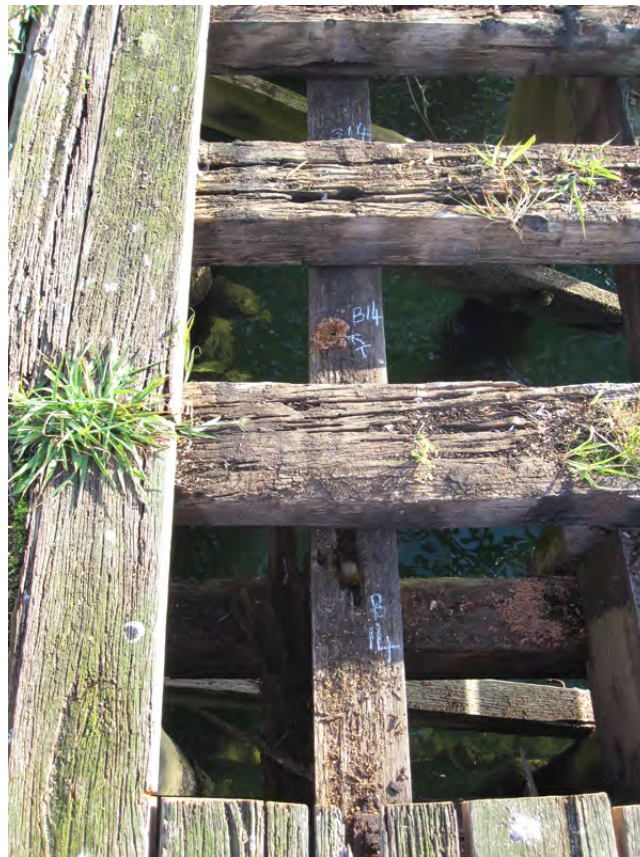
**Figure 19: Longitudinal beam 14 near crosshead 278 with severe termite attack one end for approximately 2000 mm length.**

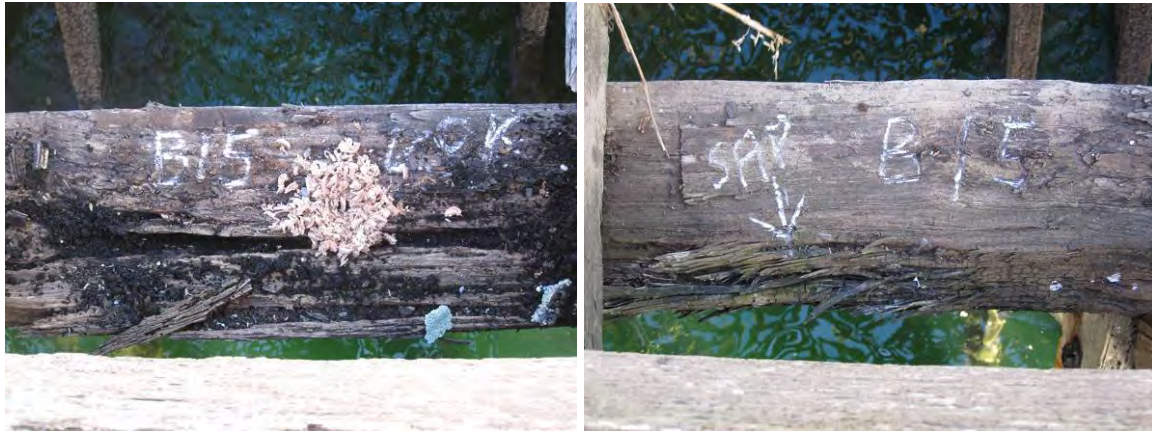
**Figure 20: Longitudinal beam 15. Left photo shows streak of decay 15 mm wide, adjacent drilled timber (note shavings) sound. Right photo showing wane and sapwood edge lost or decayed/breaking away.**

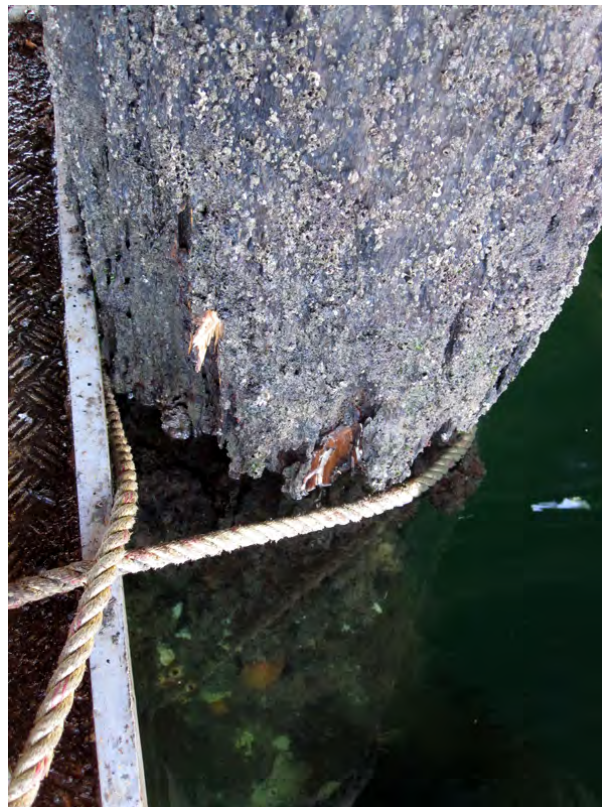
**Figure 21: Pile 296A, with only 100-120 mm sound wood remaining. Freshly chiseled region near rope showing some white calcareous-lined teredinid tunnels.**

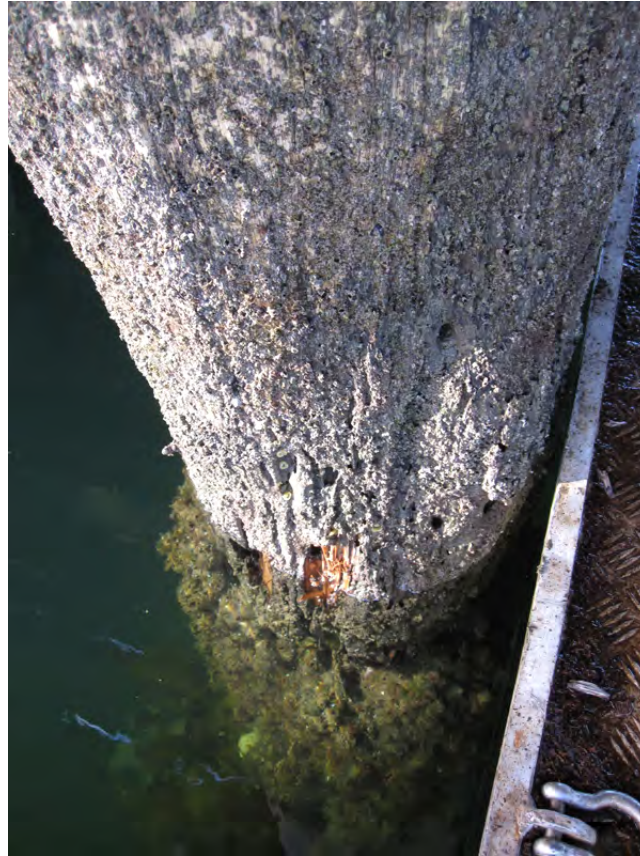
**Figure 22: Pile 296B, with ~270 mm sound heartwood remaining. Freshly chiseled region near waterline showing some white calcareous-lined teredinid tunnels.**

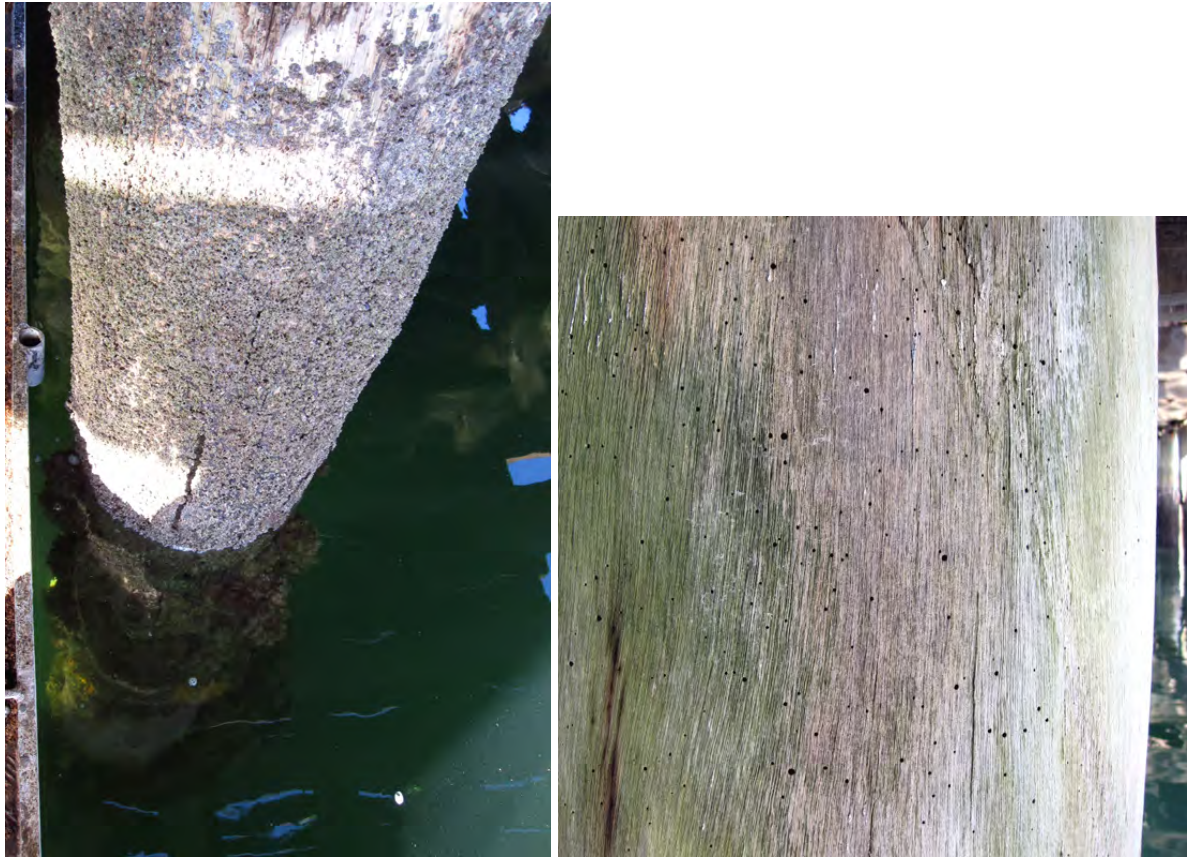
**Figure 23: Pile 297B, without necking of heartwood and ~270 mm sound heartwood remaining. Left photo showing heavy *Lyctus* borer damage to sapwood (not heartwood) above the tidal zone.**

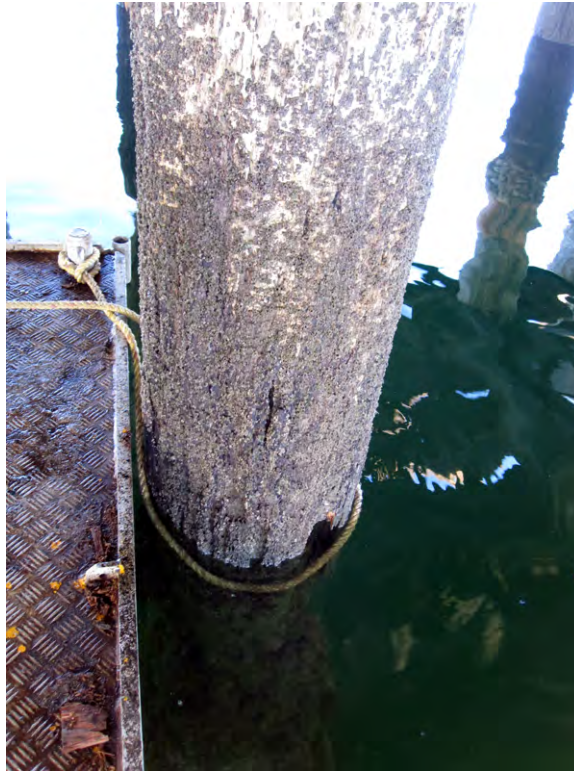
**Figure 24: Pile 297C, with cavity caused by *Limnoria* (right side near rope), and probably with ~230 mm sound heartwood remaining. Pile in poor condition.**

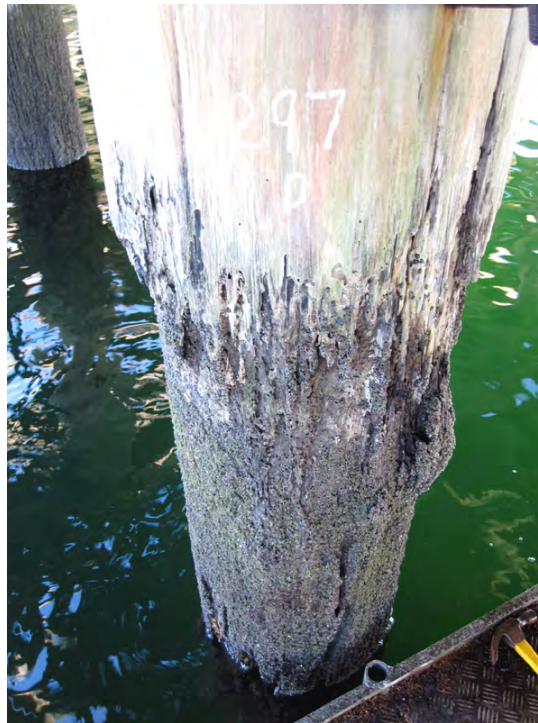
**Figure 25: Pile 297D, with several cavities at low tide and 30-40 mm teredinid attack, with ~100 mm sound heartwood remaining. Pile unserviceable.**

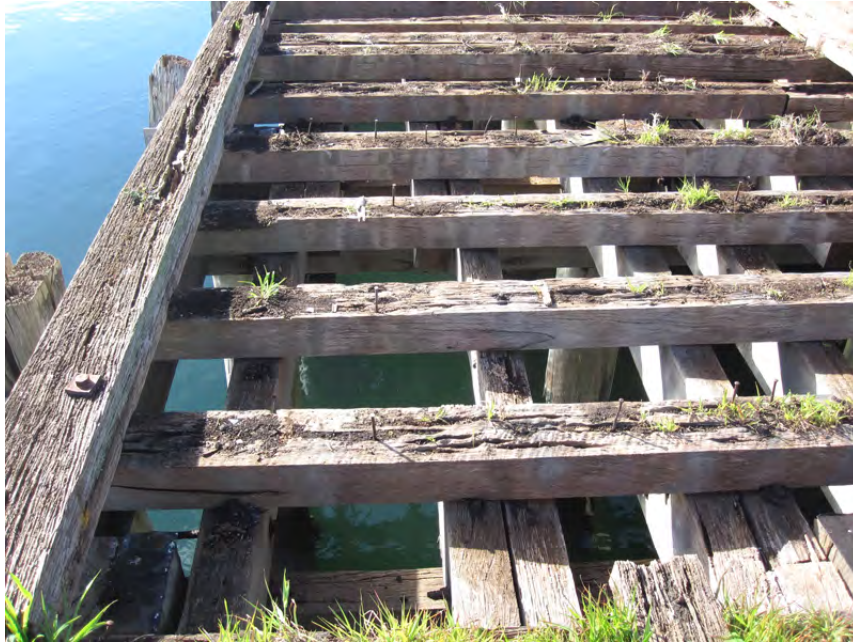
Decking transoms (not inspected, generally in poor condition) on longitudinal beams, which rest upon crossheads (Figure 26).

**Figure 26: Area 5, transom resting on longitudinal beams resting on crossheads.**

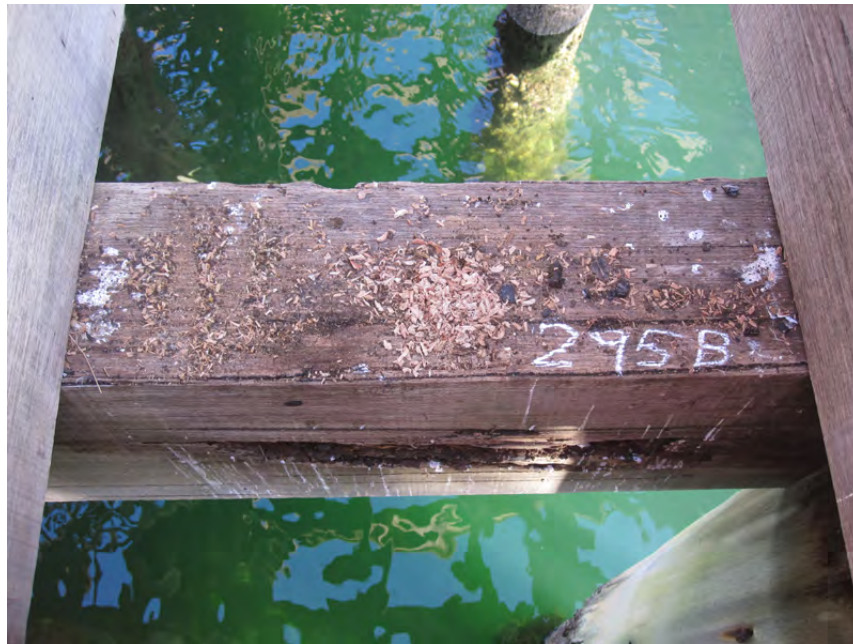
**Figure 27: Crosshead above 295B pile, showing damaged pith area (closest face) on side, drilled shavings on top face indicate remaining heartwood in good condition.**

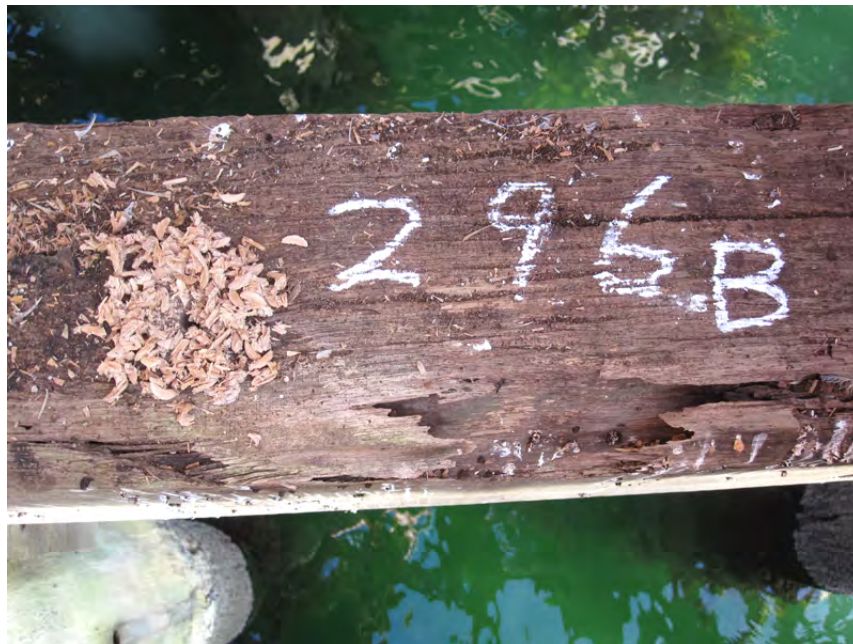
**Figure 28: Crosshead above 296B pile, showing sapwood edge lost to decay (lower edge in photo) and drill shavings 20 mm in from sapwood edge indicating heartwood is sound.**
