GIPPSLAND PORTS

**PORT WELSHPOOL LONG JETTY –  
CONDITION ASSESSMENT VALIDATION  
ASSESSMENT REPORT**

F0001-AA004066-AAR-03

15 JULY 2011

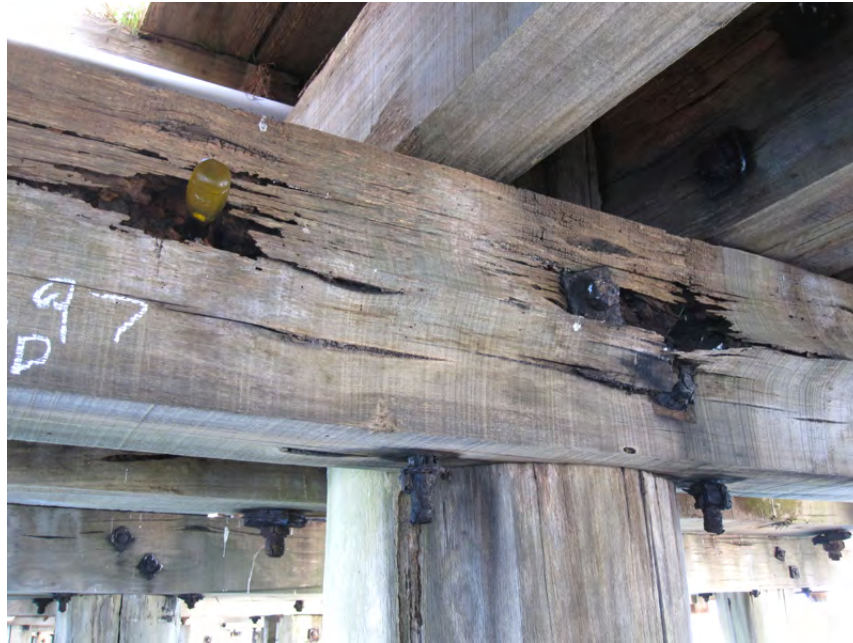
**Figure 29: Crosshead above 297 row of piles, heavily attacked by termites (note chisel pushed through timber).**

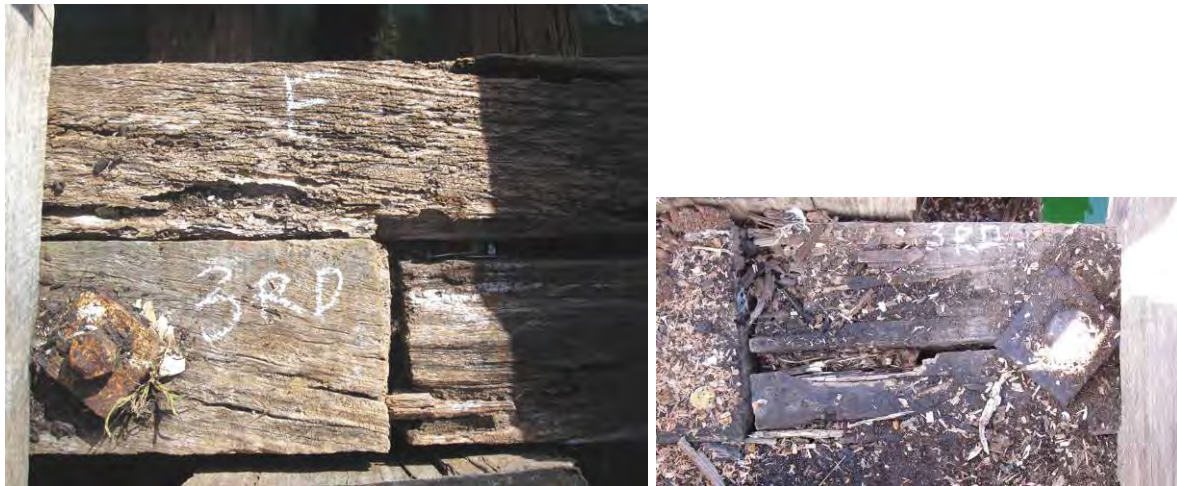
**Figure 30: Longitudinal beams, '3rd' shows southern beam in good condition, joining northern beam to right with 20 mm decay on top surface. 'F' is fish beam with up to 60 mm decay on inner face adjacent to other timbers. Right photo shows northern end of northern beam with 100 mm white rot to 250 mm from end.**
