PORT WELSHPOOL LONG  
JETTY – CONDITION  
ASSESSMENT VALIDATION

## GIPPSLAND PORTS

## ASSESSMENT REPORT

**Report No** F0001-AA004066-AAR-02

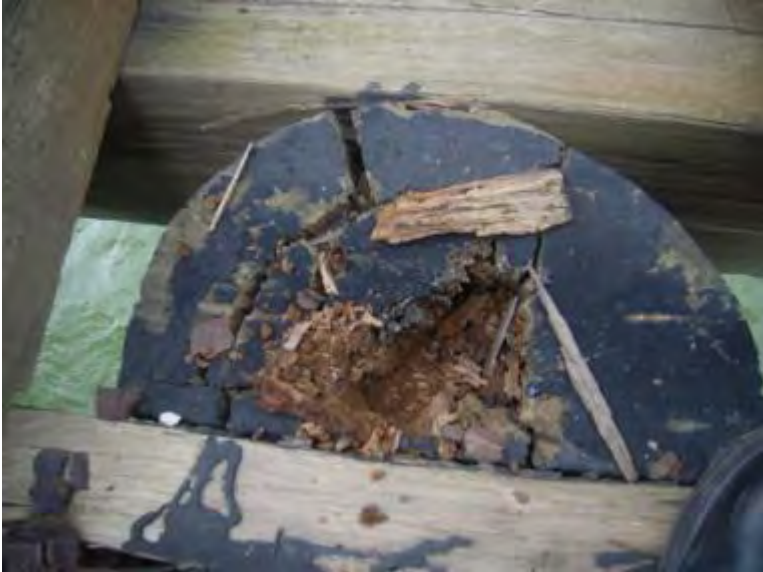
Element	Defect	Example
Pile	Rot through inner heart wood at pile top

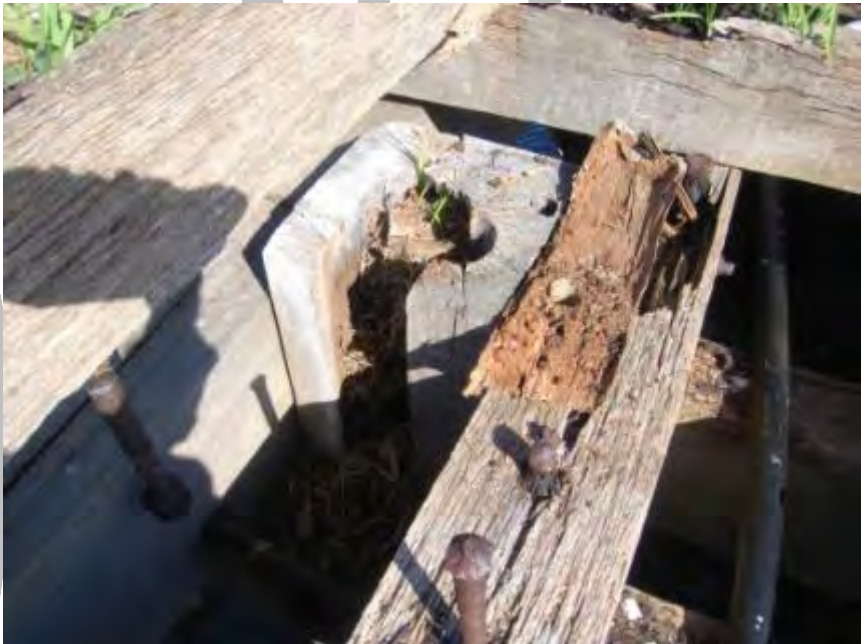
Pile	Termite attack in pile top

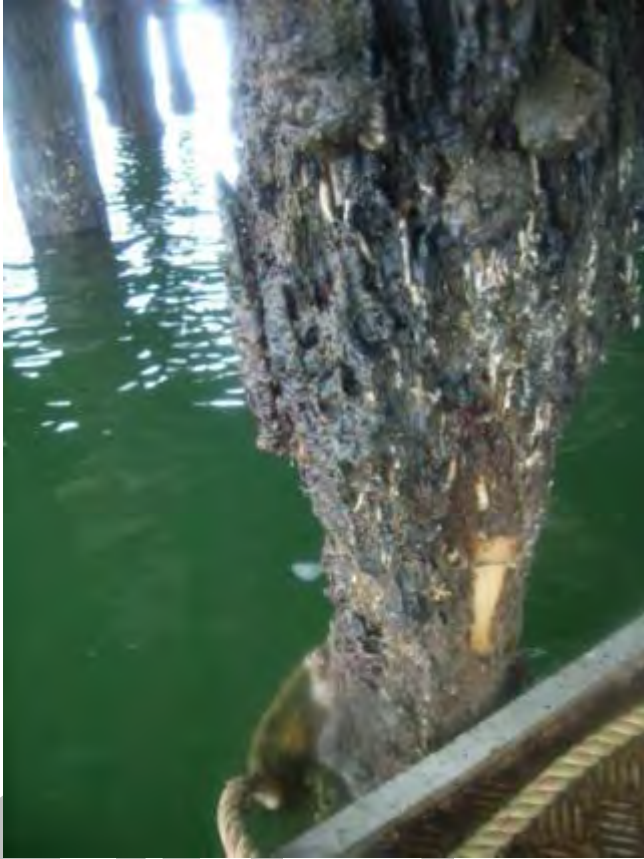
Element	Defect	Example
Pile	Pile with heavy Teredo and Limnoria attack.

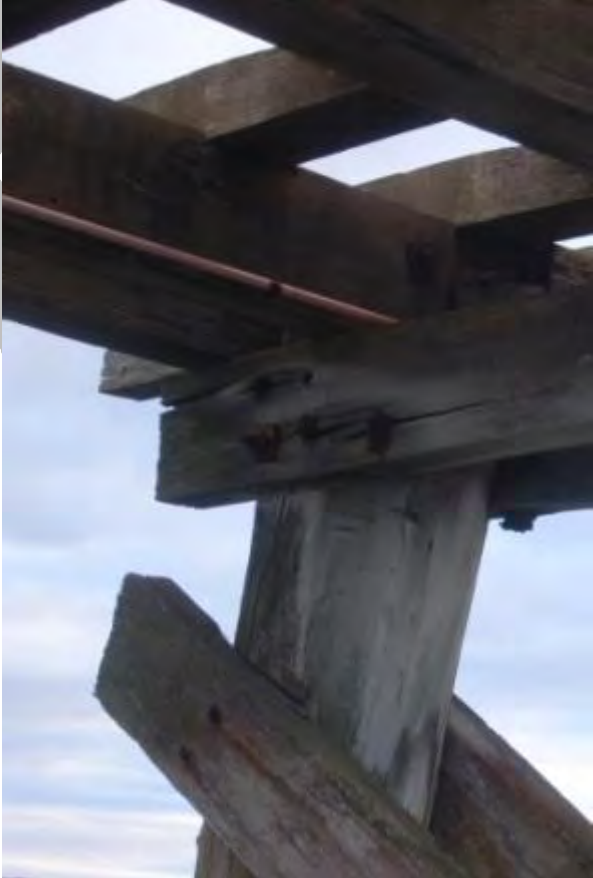
Crosshead	Minor degree of splitting at bolted connection of crosshead to piles

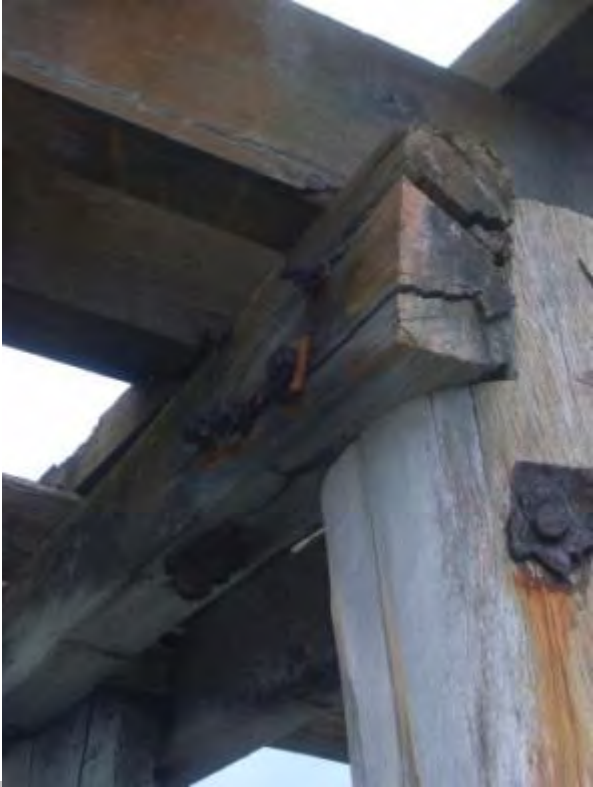
Element	Defect	Example
Crosshead	Moderate degree of splitting at bolted connection of crosshead to piles

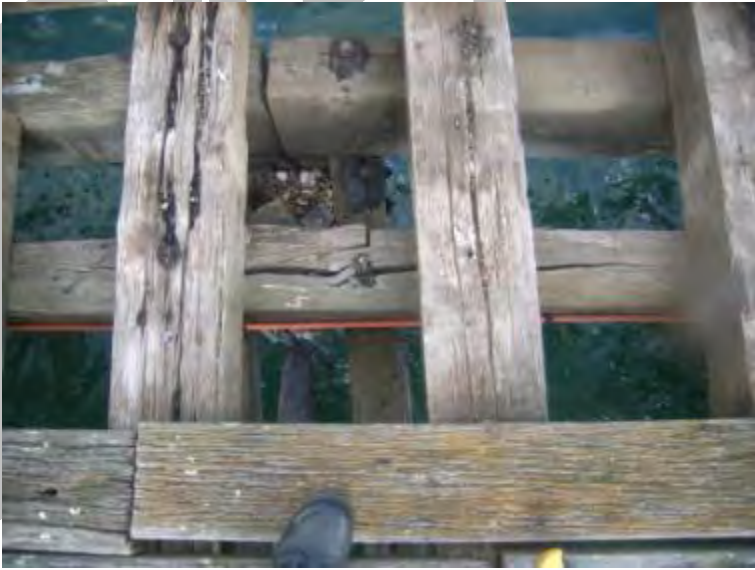
Beam	Splitting at connections over crossheads

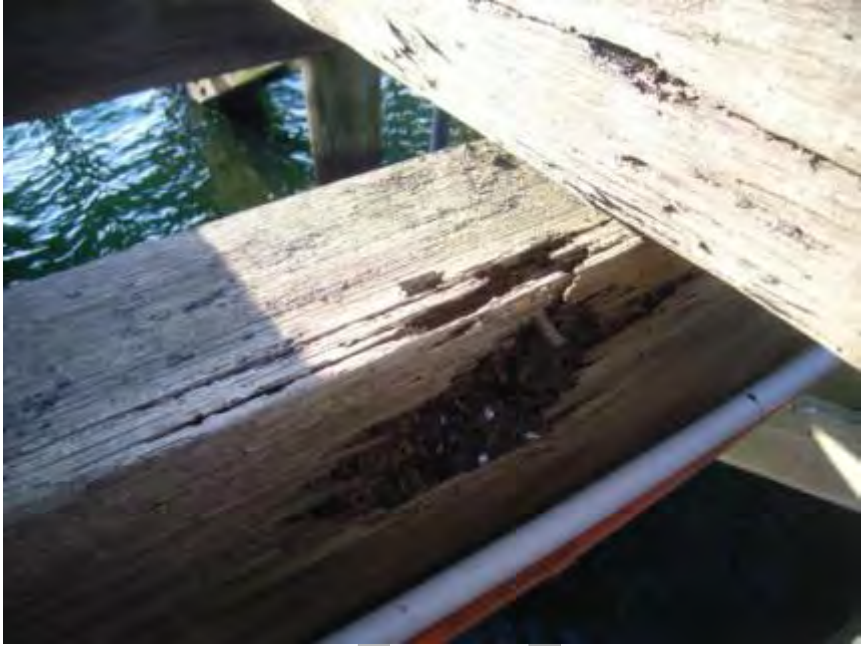
Element	Defect	Example
Beam	Heavy termite attack in beam

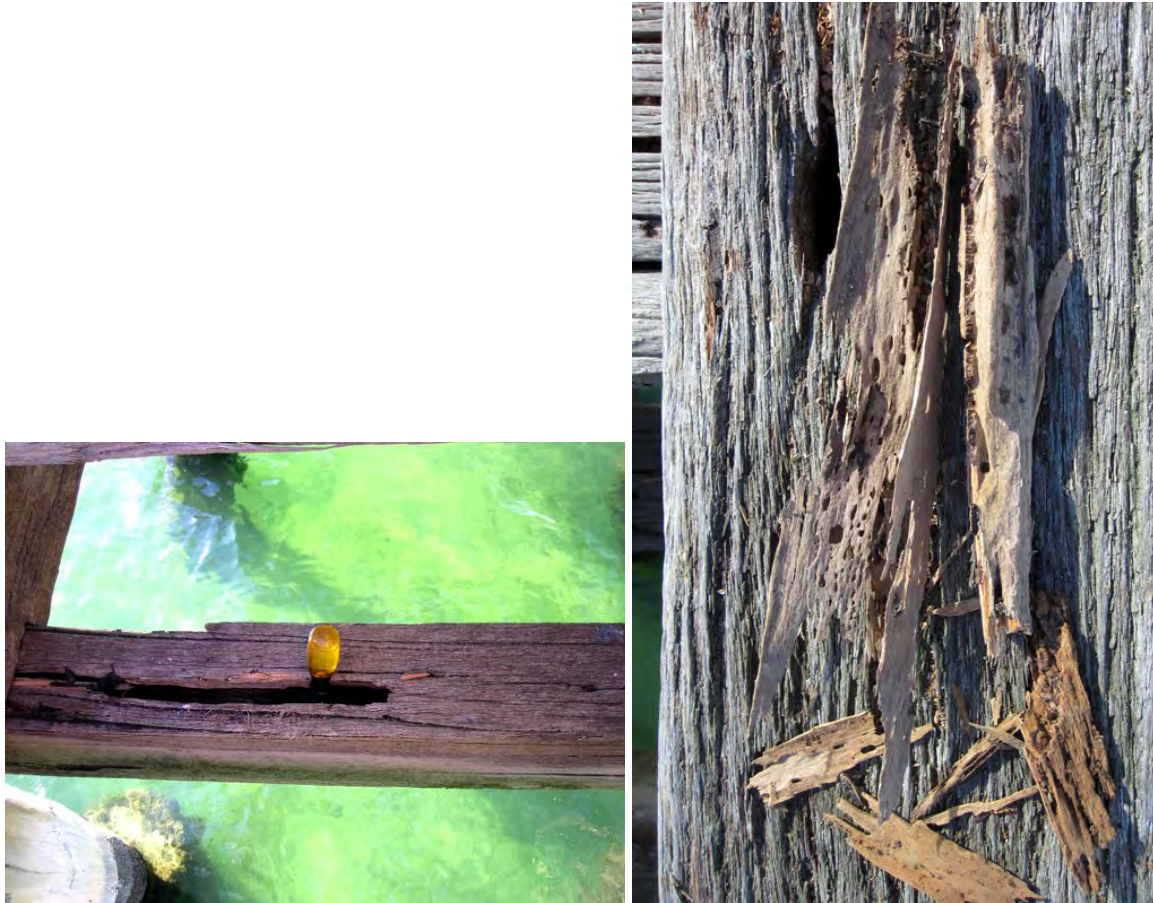
Bent 2 = One crosshead was mostly hollow due to termite damage (Figure 1). Live termites not found. Second crosshead was in good condition, with only 1-3 mm fungal decay.

**Figure 1: Crosshead hollowed out by termites. Right photo showing 'paper thin' layers of wood pulled from hollow, which is typical of termite attack.**

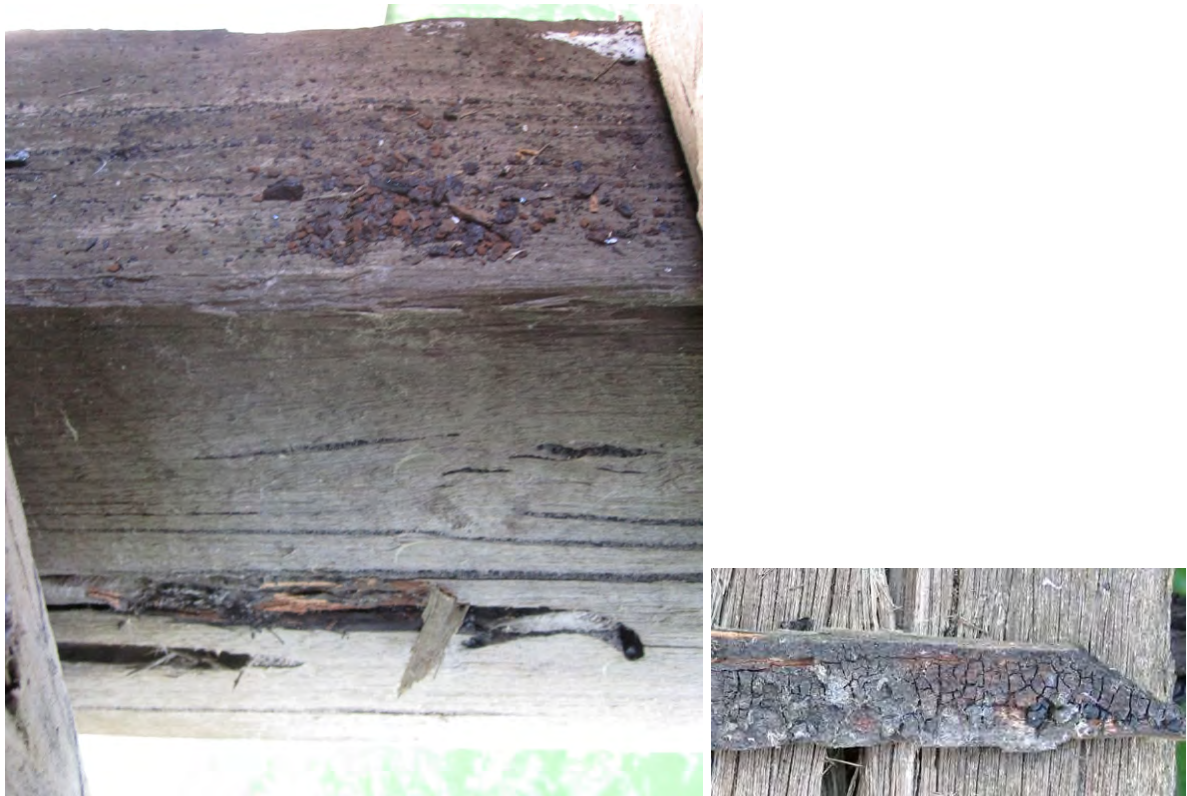
Bent 4 = Both crossheads generally in good condition, with only 1-3 mm decay. One crosshead has a damaged area 10-20 mm deep near a pile. This damage is of minor concern, as it is a pocket of kino and inner pith or heartwood, rather than a result of termites or fungi (Figure 2).

**Figure 2: Side of crosshead with 10-20 mm patch of damage from kino and pith, of minor concern. Right photo shows dried kino on removed piece.**

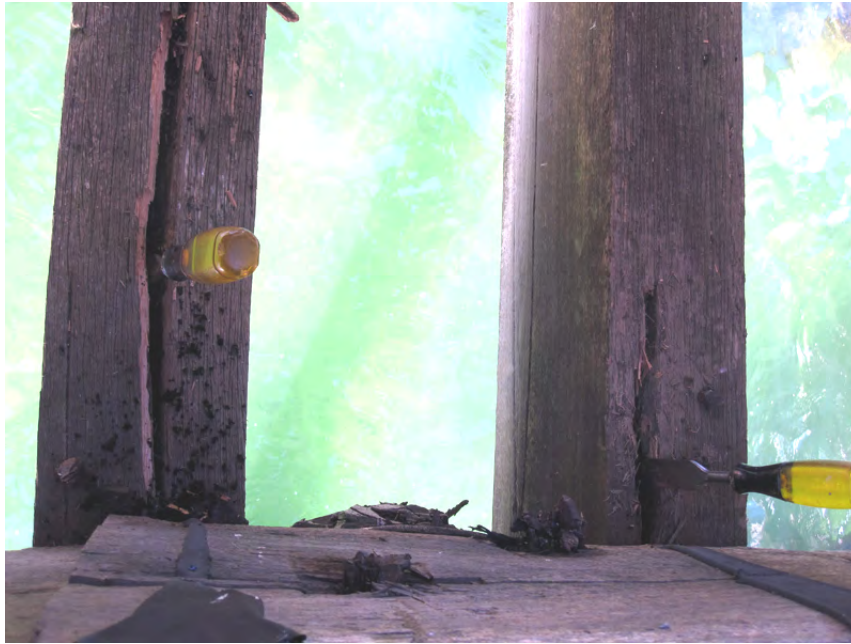
Bent 7 = Northern side crosshead with a crevice caused by termites up to 120 mm deep and 20-30 mm wide extending nearly full length of crosshead (Figure 4). Crosshead is probably still structural, as the majority of the remaining timber is in good condition, although the beam should not be reused. Southern side crosshead in better condition, with termite damage limited to one end of beam in a crevice 70 mm deep and 1000 mm long near a pile (Figure 4)

**Figure 4: Northern side crosshead (left) with 120 mm deep crevice of termite damage. Southern side crosshead (right) with moderate termite damage at one end.**

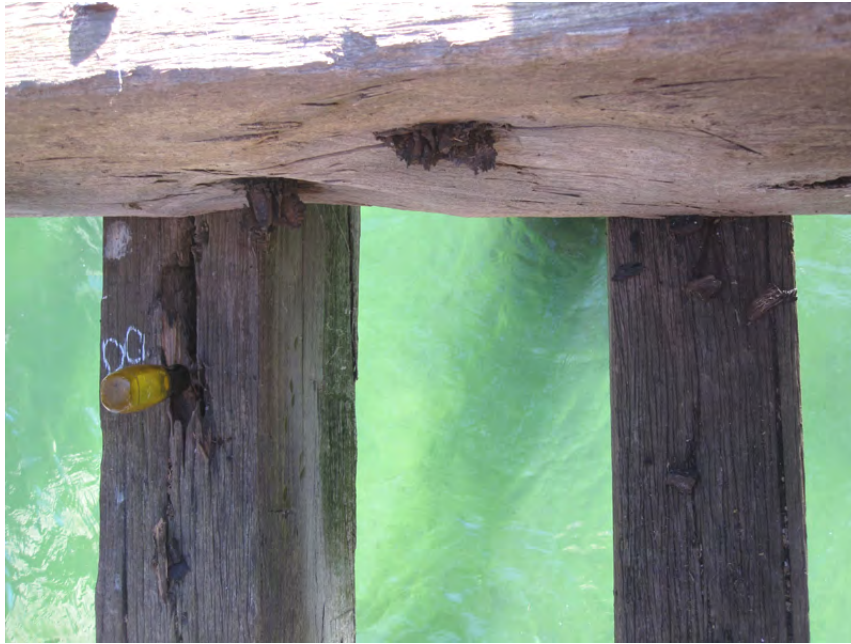
Bent 8 = Southern side crosshead (167B) identified as *E. obliqua* partially hollowed out by termites, unserviceable (Figure 5). Northern side crosshead with moderate termite attack, heavier damage on eastern end of beam near pile.

**Figure 5: Southern side crosshead (left) hollowed by termites. Northern side crosshead (right) with moderate termite damage, heavier damage other end.**

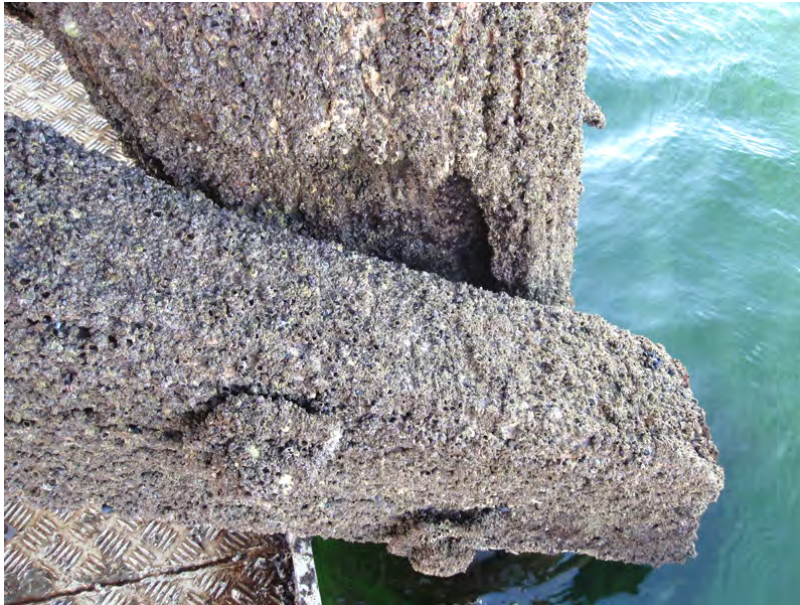
Pile 232B = Low tide with 60 mm deep cavity southern side and 90 mm cavity northern side due to low tide cross-bracing now lost. Heartwood with *Limnoria* damage a further 2-4 mm deep plus several streaks of *Limnoria* 10-30 mm deep, teredinids absent. Mid-tide region behind diagonal cross-brace with patch of *Limnoria* erosion 350 mm long x 180 mm wide x 50 mm deep (Figure 6). Estimated sound wood remaining 200 mm wide north/south direction and 320 mm wide east/west direction.

**Figure 6: Pile 232B, showing mid-tide region with erosion caused by *Limnoria* behind cross-brace.**

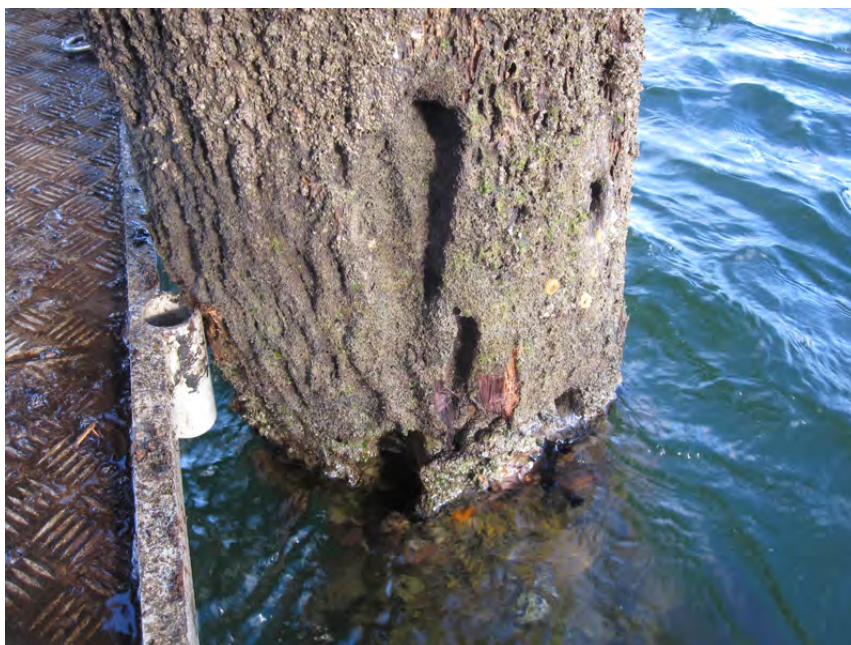
Pile 236A = Low tide with 50 mm deep cavity southern side and 60 mm cavity northern side due to low tide cross-bracing now lost. Heartwood with *Limnoria* damage a further 2-4 mm deep, teredinids absent. With two bolt holes excavated to 30 mm diameter by *Limnoria* and 150 mm deep. Several other patches eroded by *Limnoria* to 30 mm deep (Figure 7). Estimated sound wood remaining 210 mm wide north/south direction and 320 mm wide east/west direction.

**Figure 7: Pile 236A, showing low tide region with several areas eroded by *Limnoria* to 30 mm deep in north/south faces. Bolt just below waterline in low tide region.**

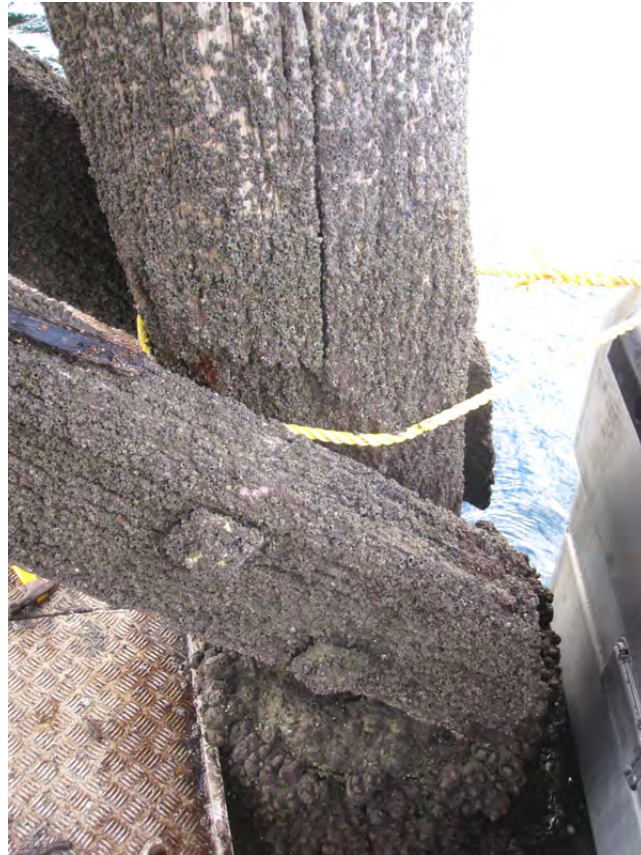
**Figure 8: Pile 236B, lower tide region, note pile area near rope notched to fit cross-brace. Concrete collar below cross-brace.**

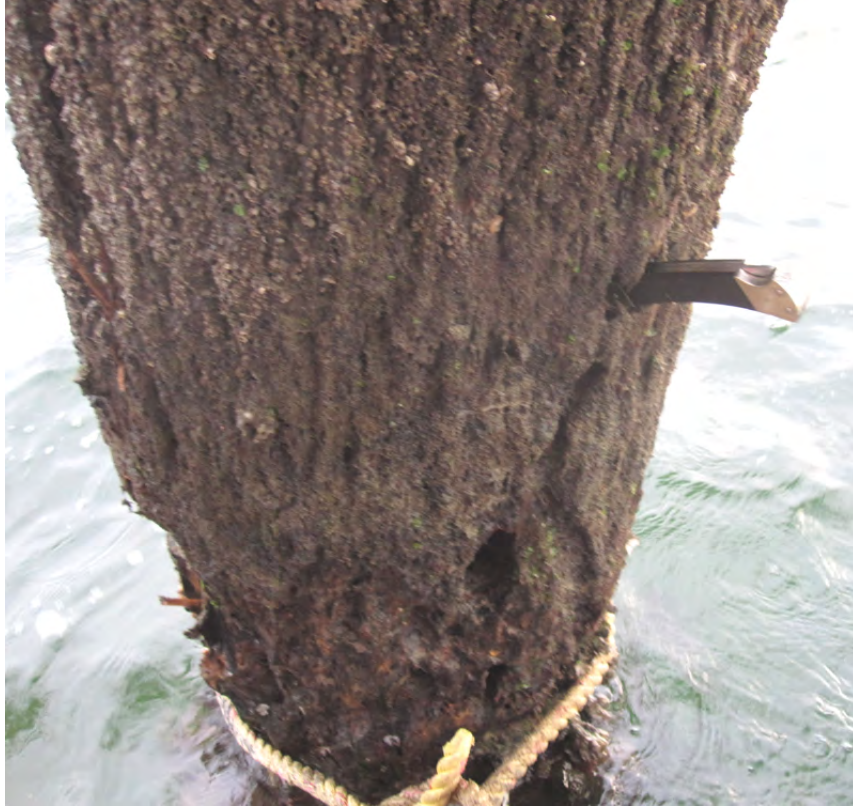
**Figure 11: Pile 238A, low tide region showing several 30 mm diameter holes 50-70 mm deep perhaps resulting from old bolt holes or eaten out knots.**

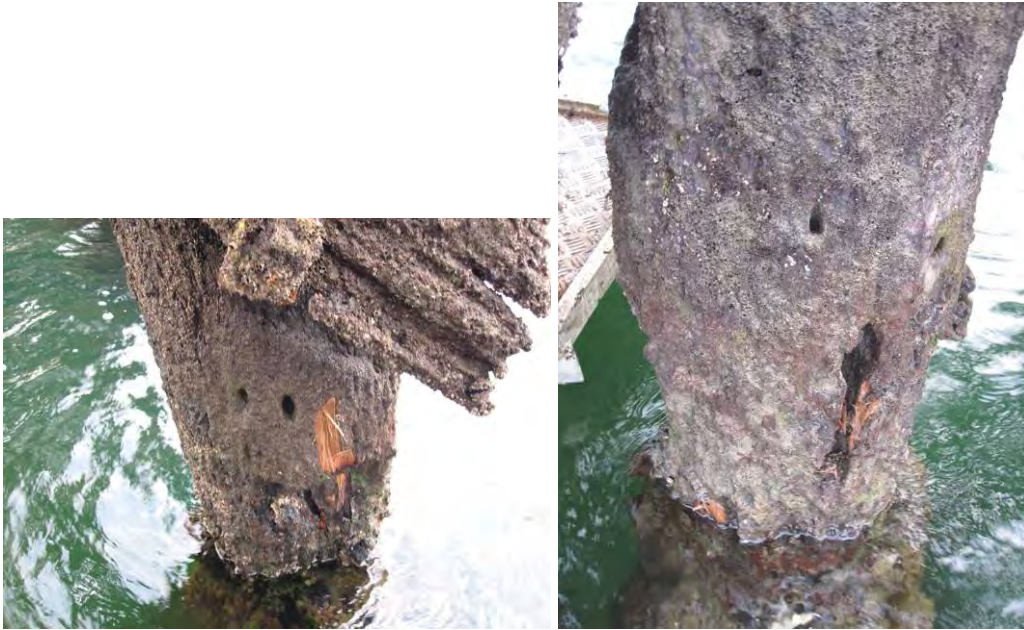
**Figure 12: Pile 238B, left photo showing 70 mm deep cavity from lost cross-brace (below freshly chiseled wood), teredinids absent, two 40 mm deep holes also present. Right photo showing 70 mm deep longitudinal cavity caused by *Limnoria* in old bolt holes.**

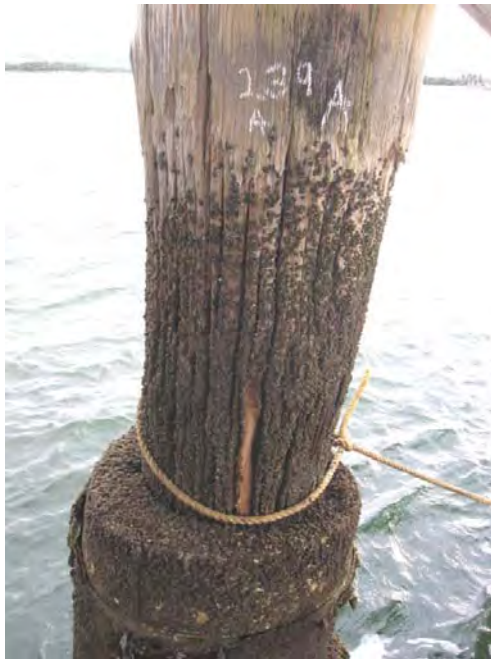
**Figure 13: Pile 239A with concrete collar to about mid-tide, showing fissures 10-15 mm deep due to weathering, marine borer damage mostly absent in tidal zone.**

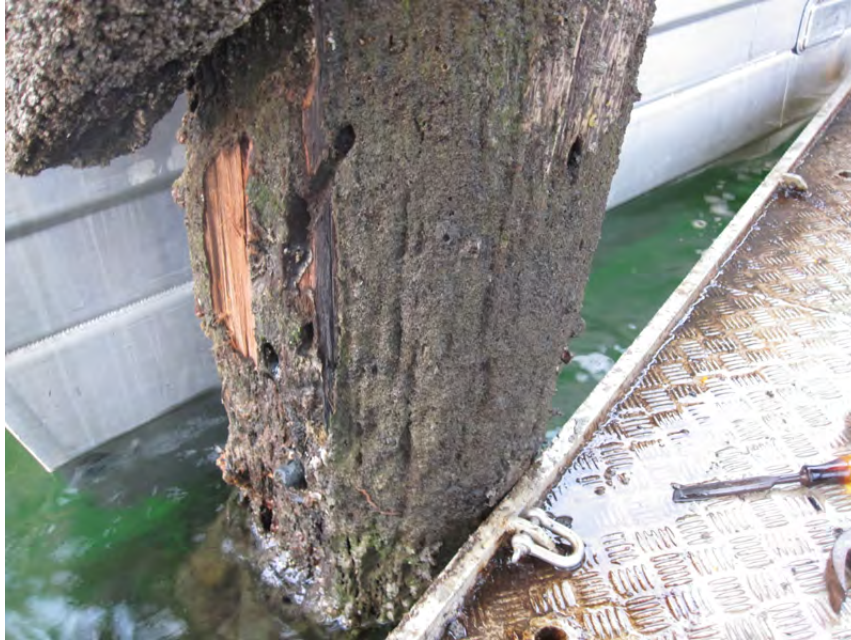
**Figure 14: Pile 239B, low tide region showing flattened (checked) face for cross-brace now lost, and projecting end of bolt visible above waterline. Light teredinid attack, freshly chiseled area without teredinid damage.**

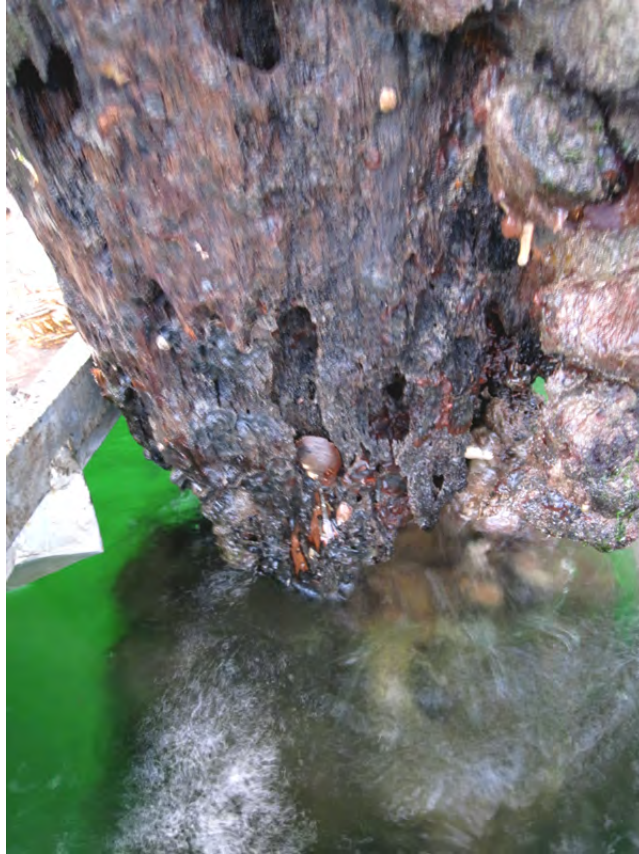
**Figure 15: Pile 240B, low tide region showing deep southern cavity at water line on right (below clump of fouling), and shallower cavity on left side. Pile in poor condition.**

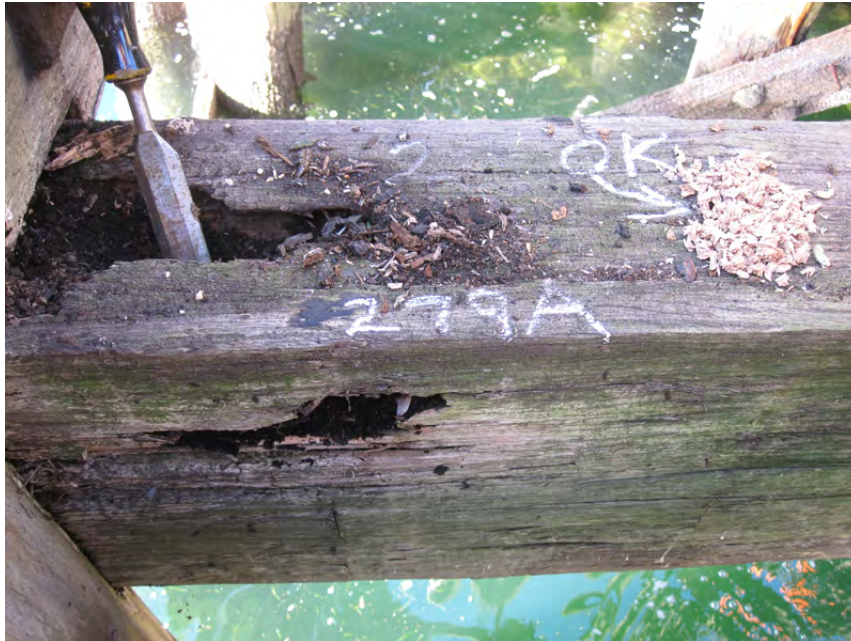
**Figure 16: Crosshead 279A showing end with extensive termite damage, and drilled shavings ('OK') further from end from which sound timber begins.**

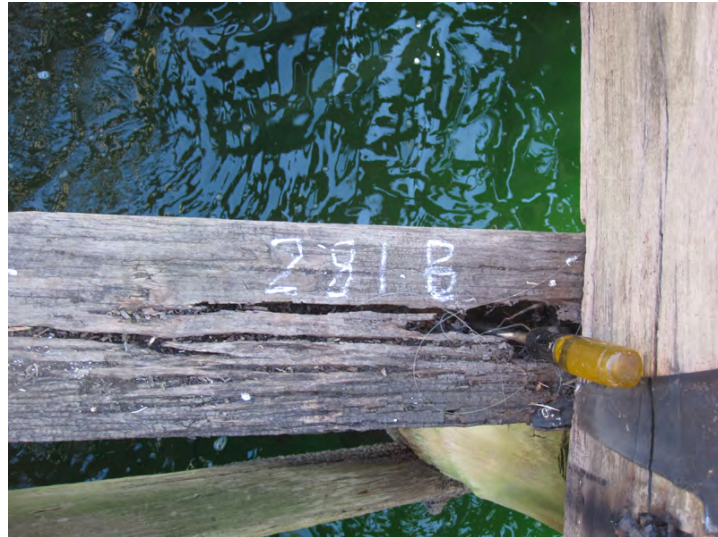
Crosshead 281B = generally in reasonable condition with 2-20 mm decay on top surface, except for one end with 600 mm long cavity caused by termites 100 mm deep and 50 mm wide (Figure 17).

**Figure 17: Crosshead 281B with termite damage 600 mm along end of beam.**

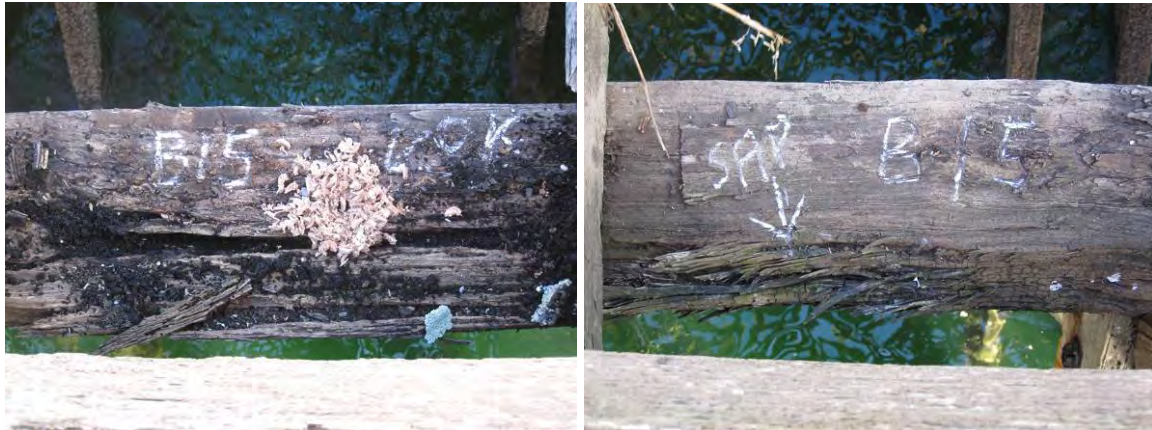
**Figure 20: Longitudinal beam 15. Left photo shows streak of decay 15 mm wide, adjacent drilled timber (note shavings) sound. Right photo showing wane and sapwood edge lost or decayed/breaking away.**

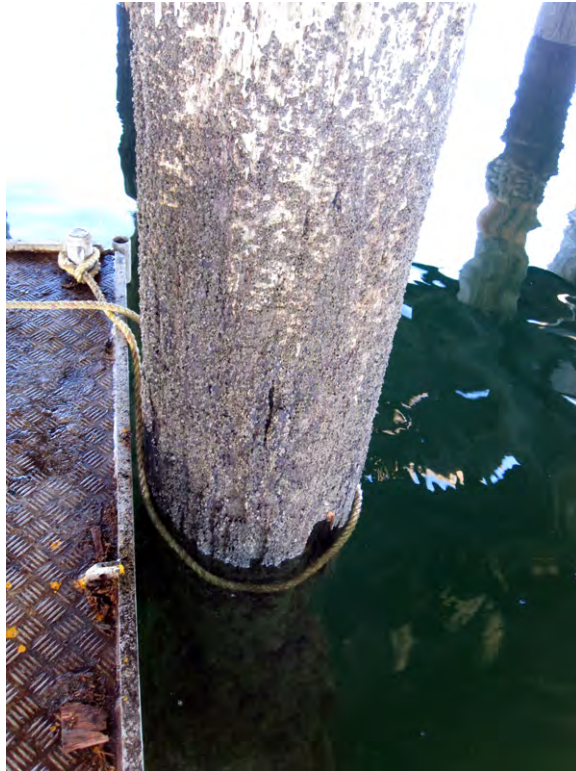
**Figure 24: Pile 297C, with cavity caused by *Limnoria* (right side near rope), and probably with ~230 mm sound heartwood remaining. Pile in poor condition.**

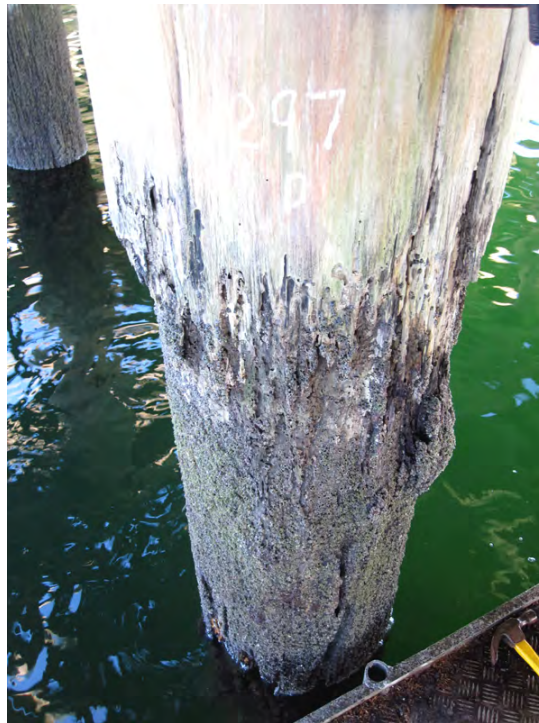
**Figure 25: Pile 297D, with several cavities at low tide and 30-40 mm teredinid attack, with ~100 mm sound heartwood remaining. Pile unserviceable.**

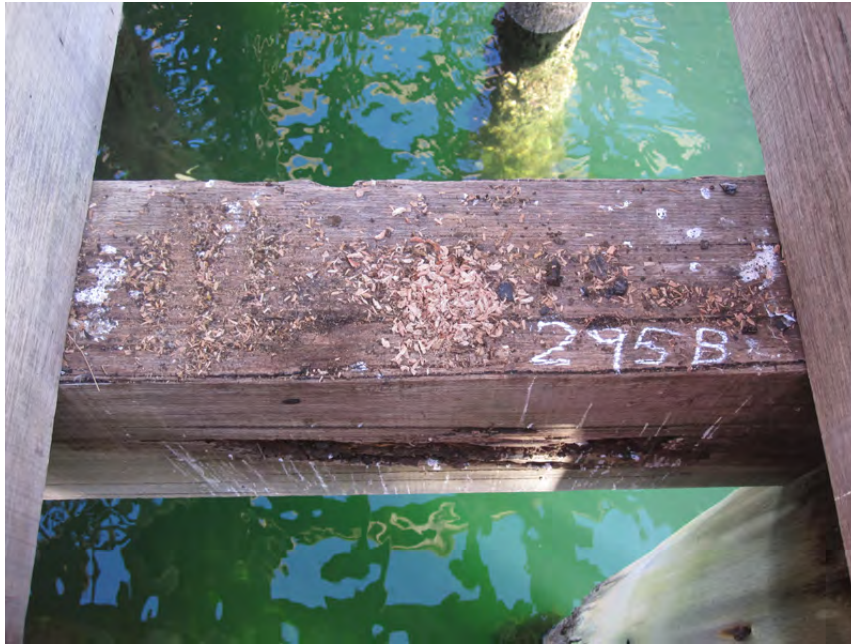
**Figure 27: Crosshead above 295B pile, showing damaged pith area (closest face) on side, drilled shavings on top face indicate remaining heartwood in good condition.**

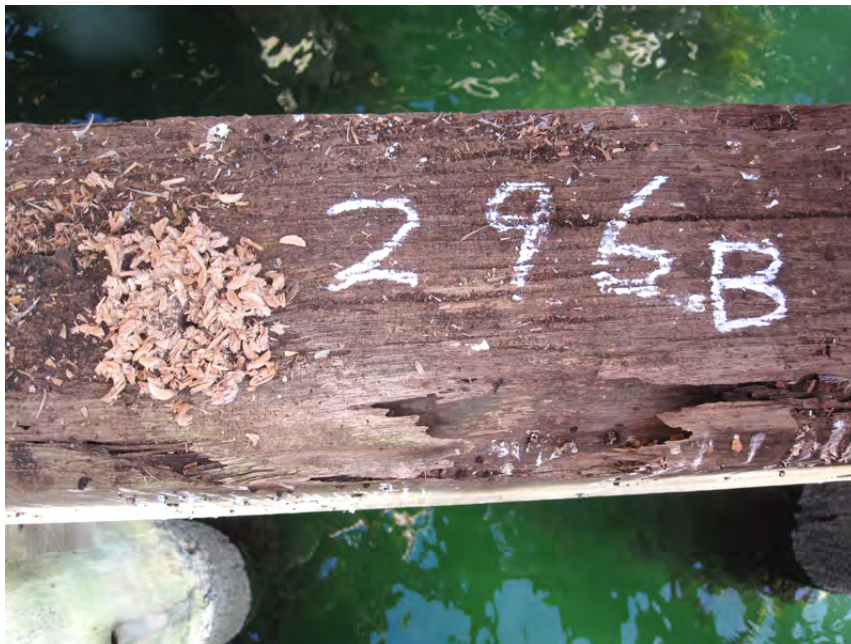
**Figure 28: Crosshead above 296B pile, showing sapwood edge lost to decay (lower edge in photo) and drill shavings 20 mm in from sapwood edge indicating heartwood is sound.**

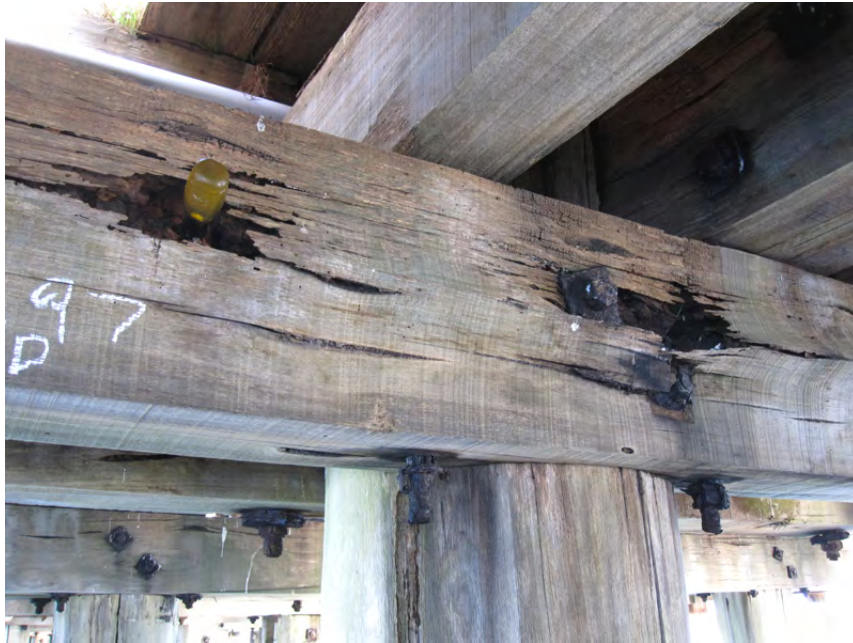
**Figure 29: Crosshead above 297 row of piles, heavily attacked by termites (note chisel pushed through timber).**

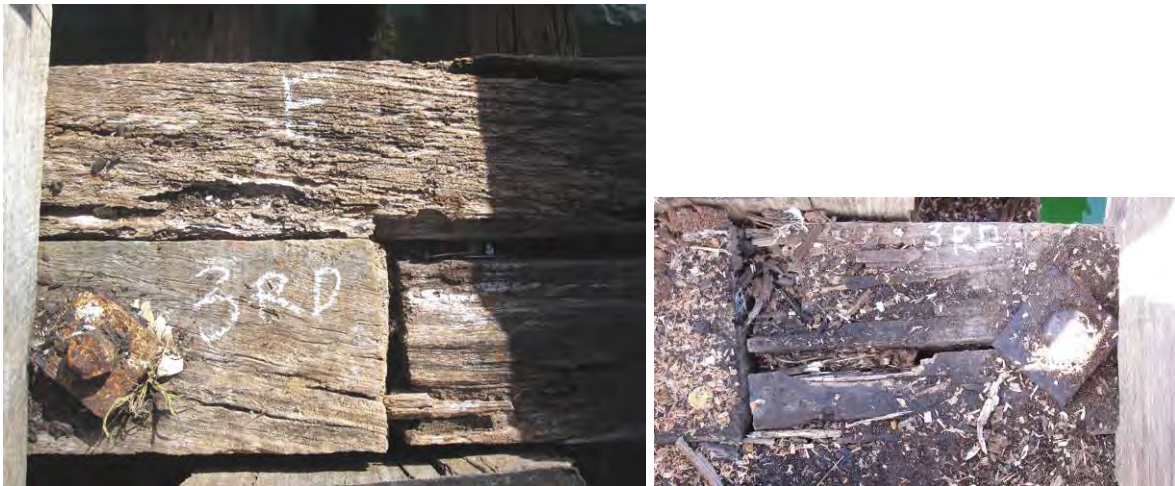
**Figure 30: Longitudinal beams, '3rd' shows southern beam in good condition, joining northern beam to right with 20 mm decay on top surface. 'F' is fish beam with up to 60 mm decay on inner face adjacent to other timbers. Right photo shows northern end of northern beam with 100 mm white rot to 250 mm from end.**
