Shipping Pier Inspection – Port Welshpool

GIPPSLAND PORTS

KINA DIVING PTY LTD

2,3,4,5 August 2011

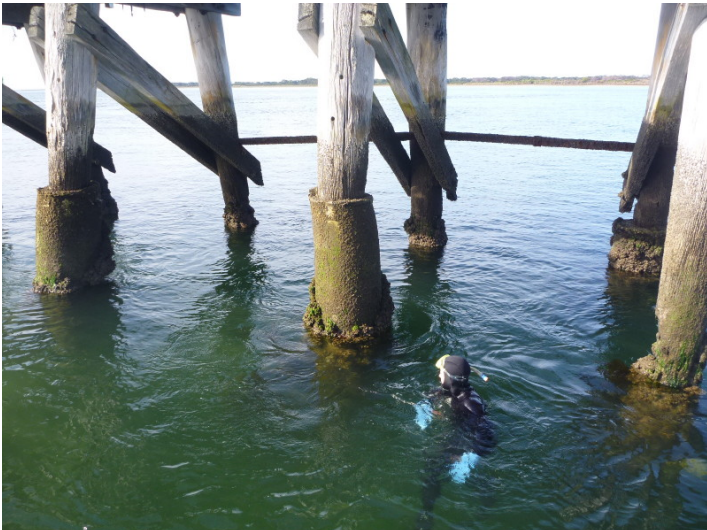
Typical concrete Repairs Trestle pile section

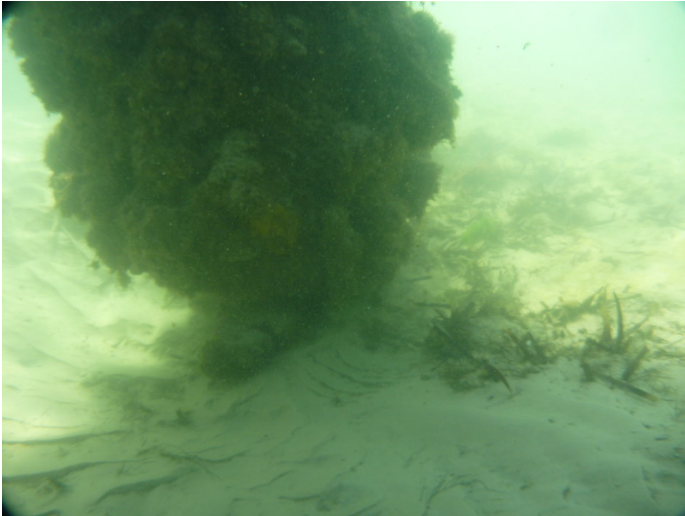
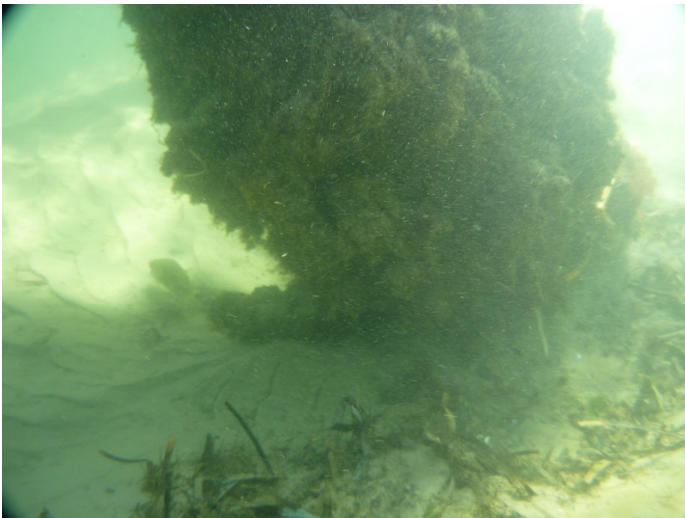
Images of seabed scour at the base of concrete repair

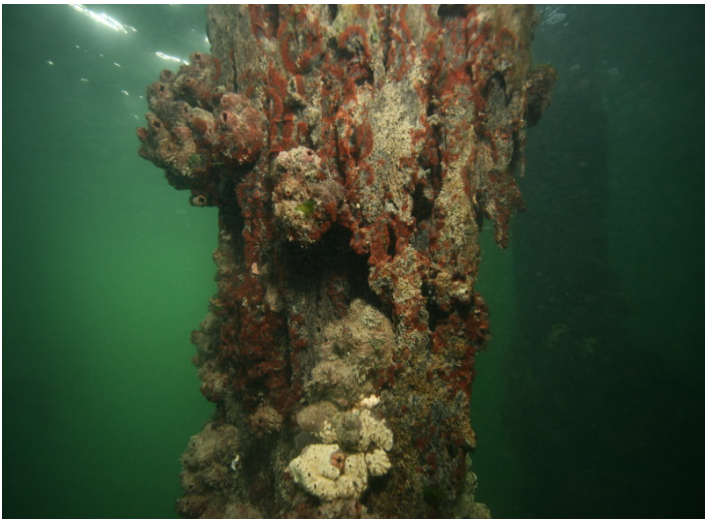
Intertidal Zone: 40% coverage

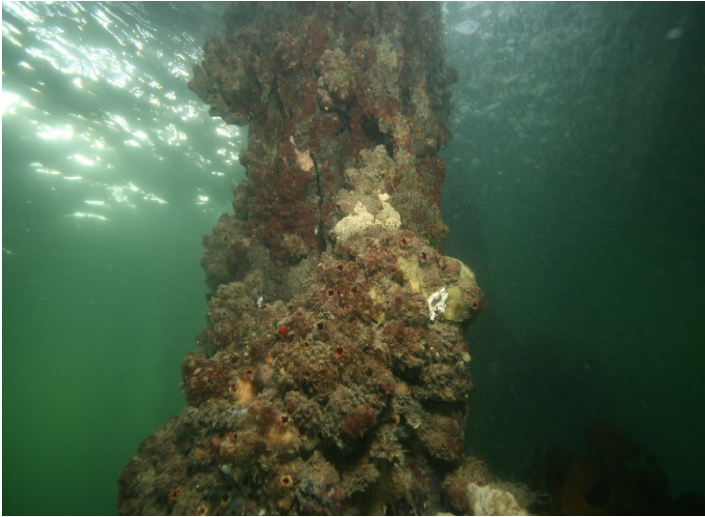
Mid Water: 90% coverage

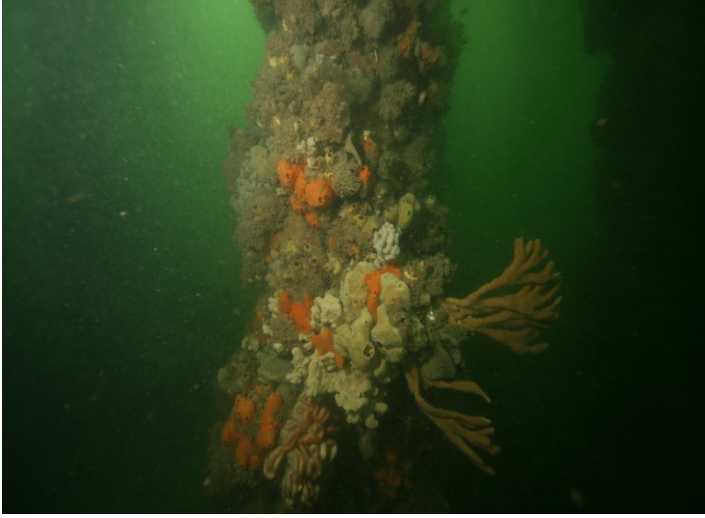
Seabed: 100% coverage

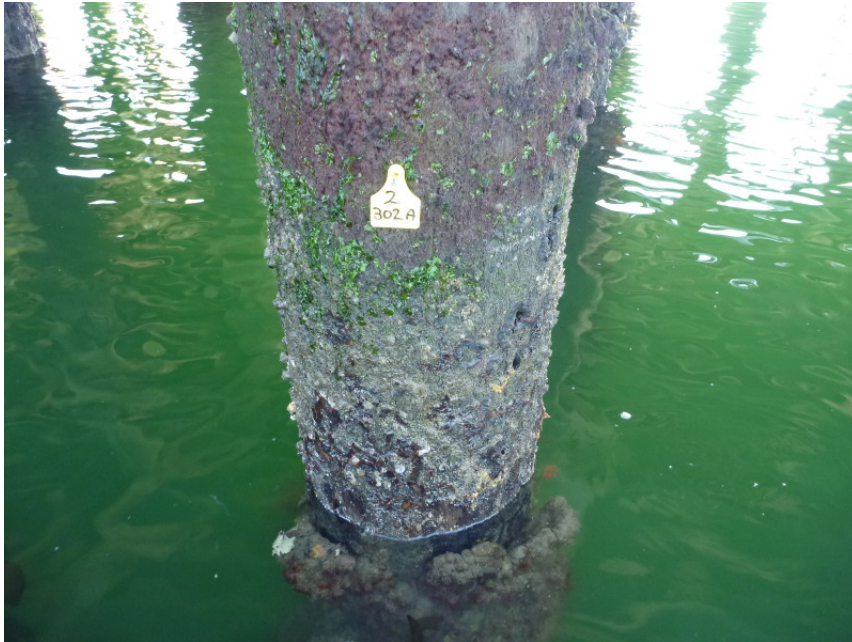
Pile: 302 A

Rating: 2

Comments: Good condition for age, minimal wear, rot and borer activity.

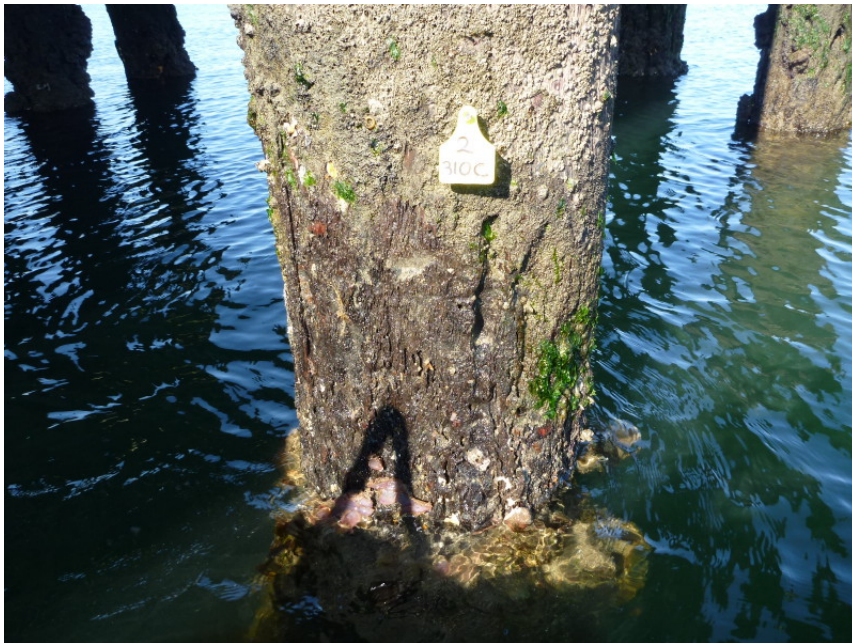
Pile: 310 C

Rating: 2

Comments: Good condition for age, minimal wear, rot and borer activity.

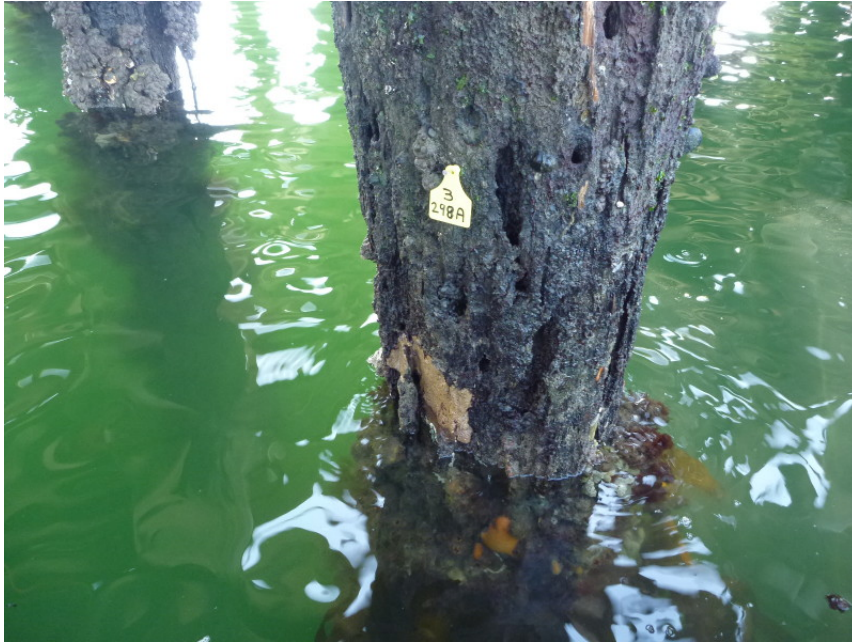
Pile: 298 A

Rating: 3

Comments: Fair condition for age, wear, rot and borer activity in splash zone

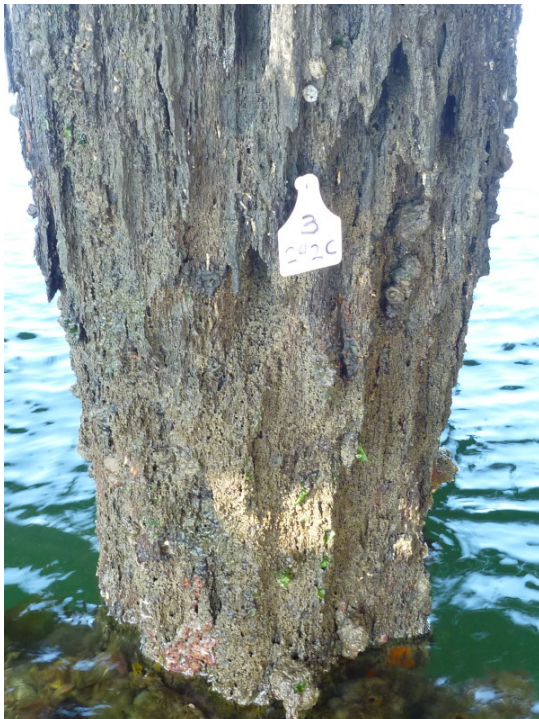
Pile: 292 C

Rating: 3

Comments: Fair condition for age, wear, rot and borer activity in splash zone.

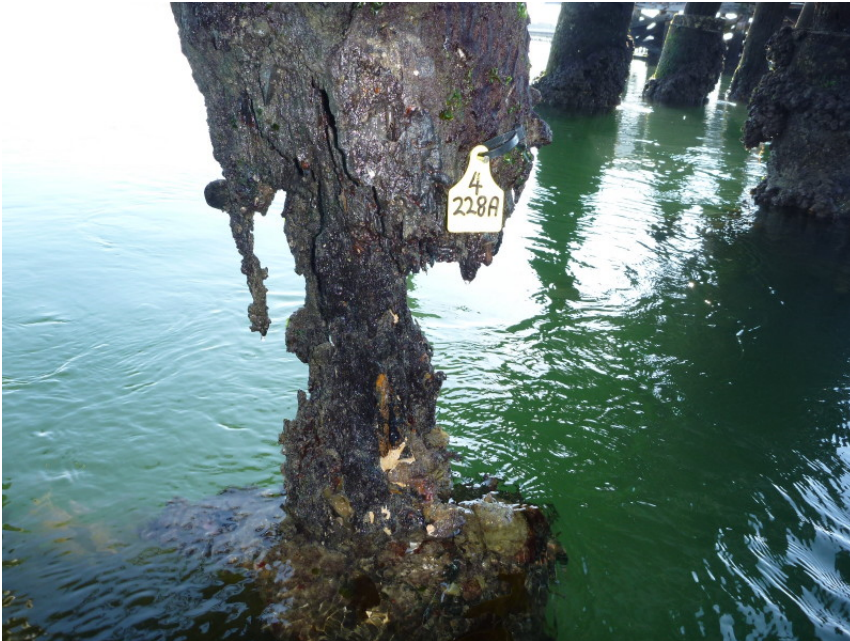
Pile: 228 A

Rating: 4

Comments: Poor condition, excessive wear, timber loss, rot and borer activity in splash zone.

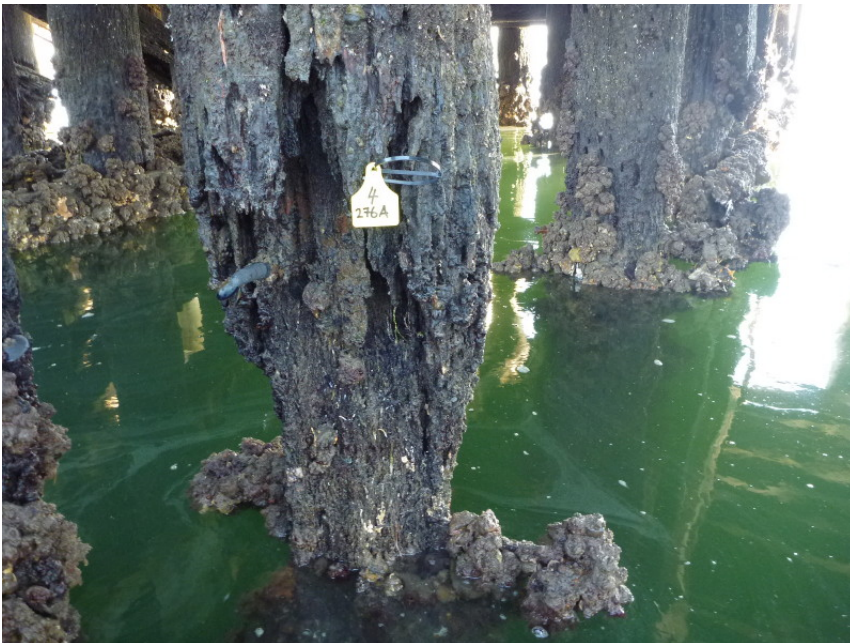
Pile: 276 A

Rating: 4

Comments: Poor condition, excessive wear, timber loss, rot and borer activity in splash zone.
