Slope Stability Assessment

**No. 99, Bena Road, Korumburra,
Victoria, 3950**

175232-PRJ75208-GEO-REP 01

19/10/2022

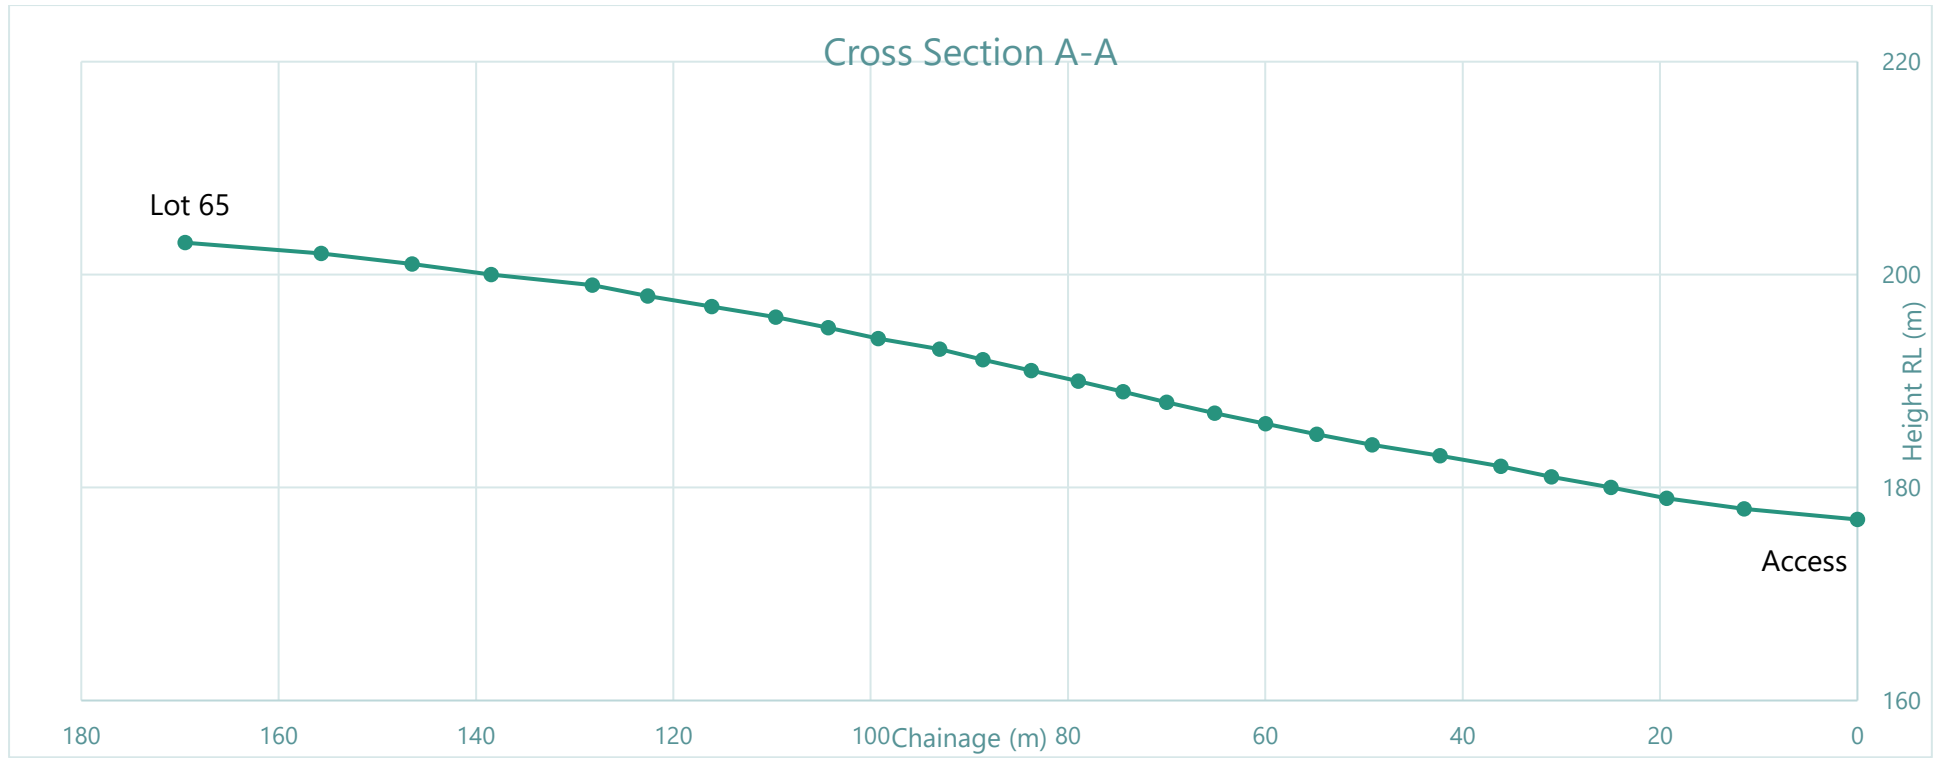
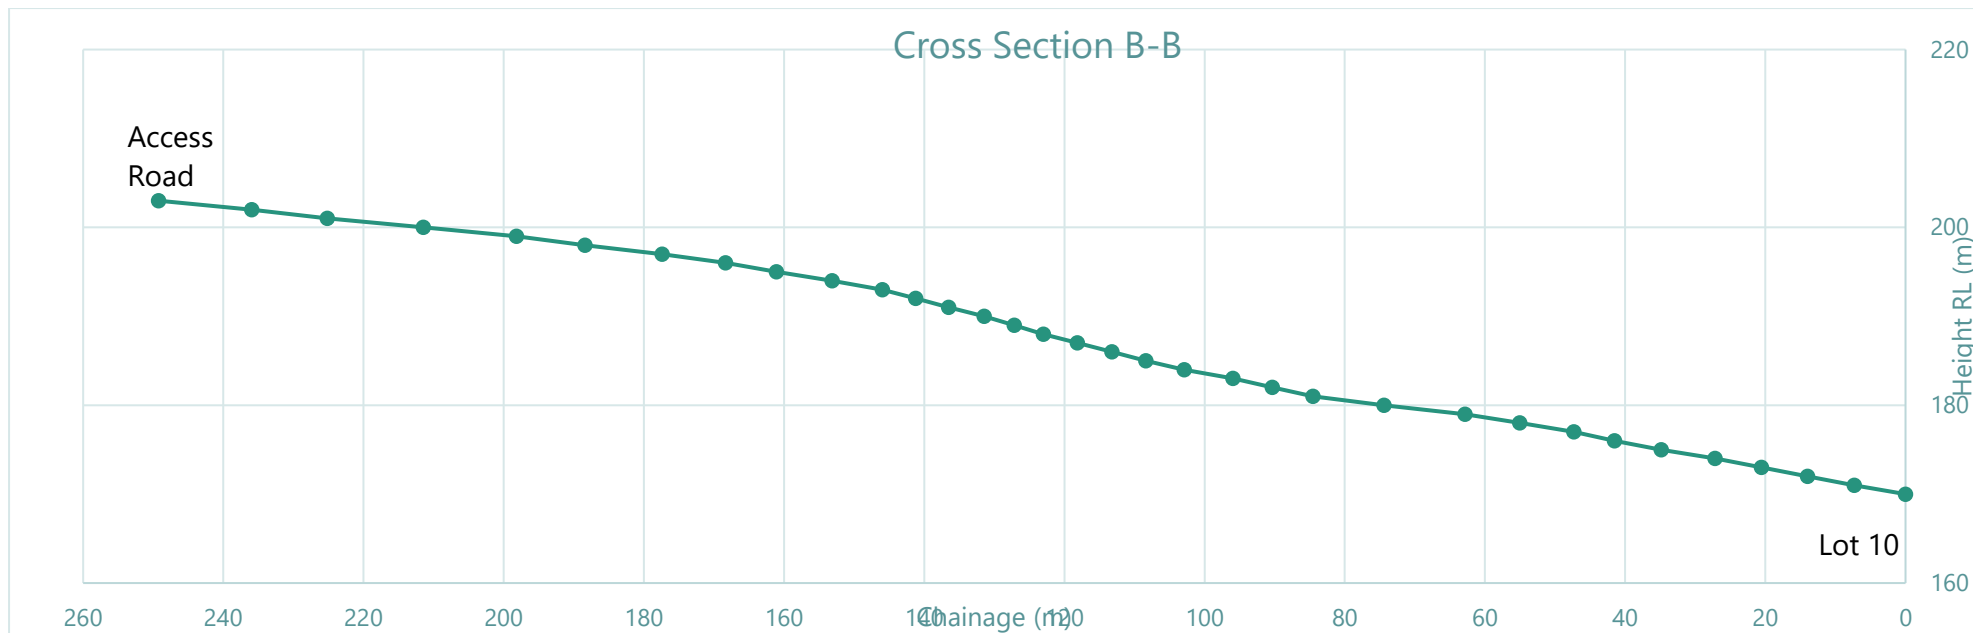
Cross Sections

The identified hazards associated with the site are presented based on the cross sections attached in Appendix B and are summarised as follows:
