## Appendix H Arborist Report

## **Tree Assessment Report**

108 & 110 Parr street, Leongatha. 29,30,31/03/2022 & 01/04/2022

#### TREE INSPECTION REPORT

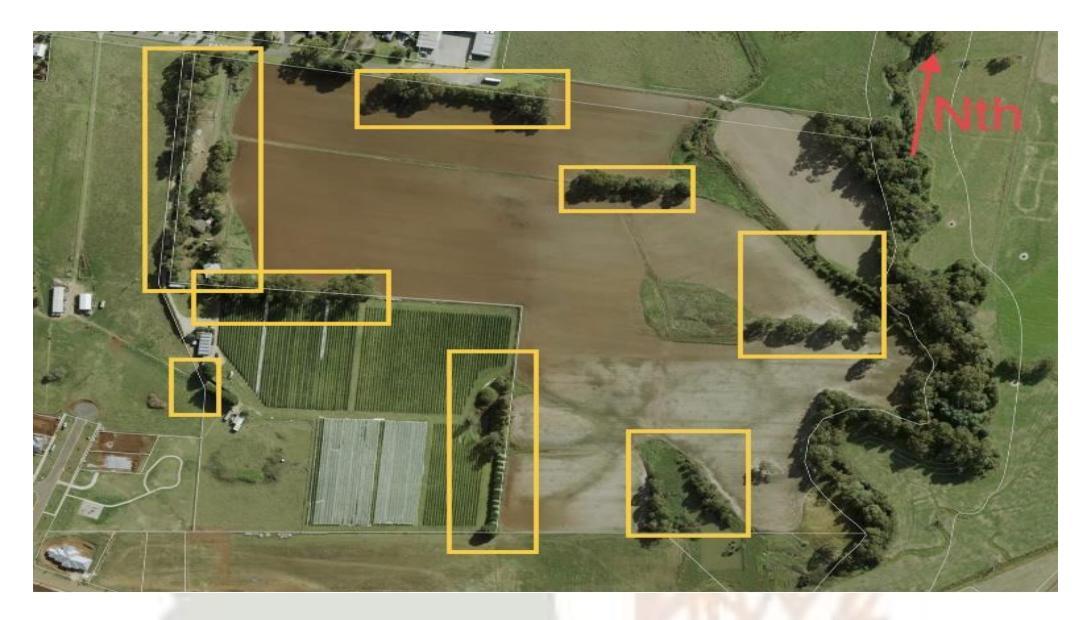
#### 6.1.1. Picture 1- Aerial map of the area, assessed areas in yellow

There were a total of 244 trees assessed

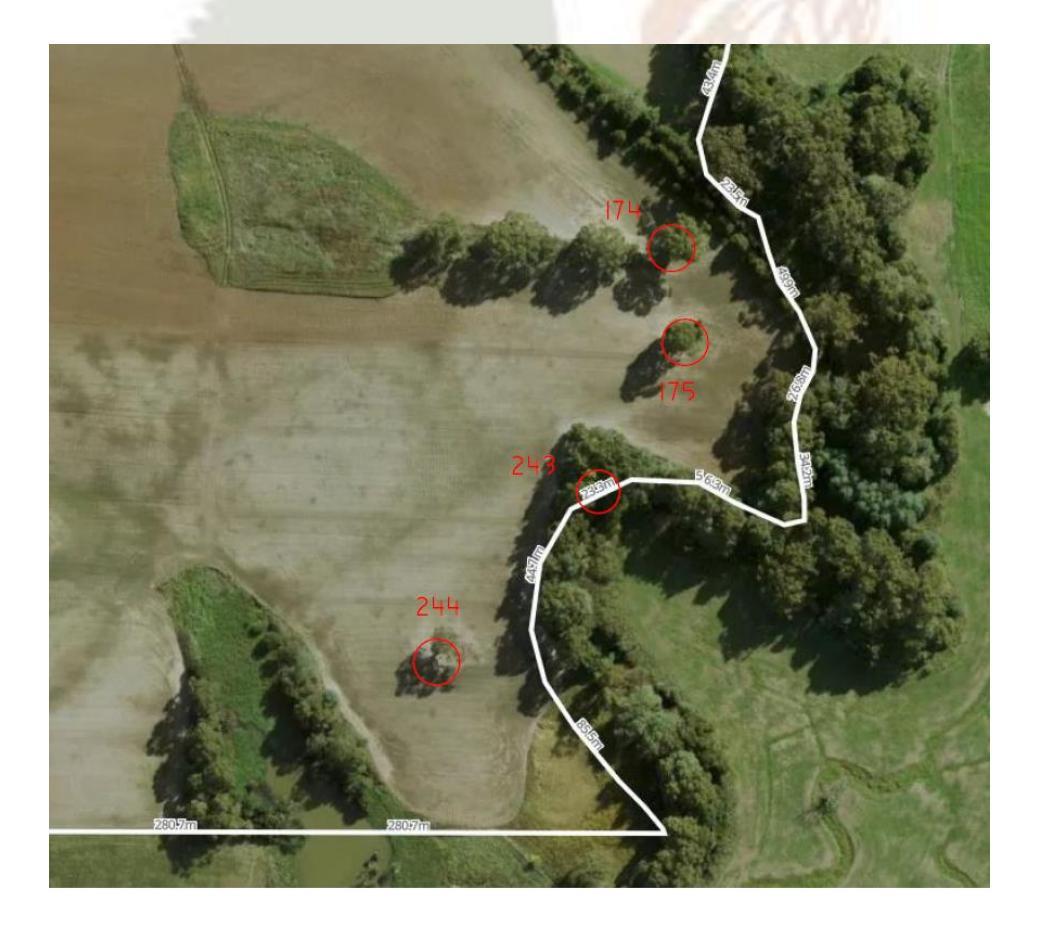
**8.3.** It is noted that all the planted trees can be removed without the requirement to obtain a permit, as per Clause 52.17-7 and Clause 42.01-3, as shown above. The attached historical aerial imagery of the site in 1965 and 1972, show that practically all the trees subject to this investigation have been planted sometime after 1972. The 4 trees identified as possibly not planted have been included in Attachment 3 and require a permit for their removal. It should be noted that tree 243 will not be removed as part of the proposed development, and is only assumed lost as it is within a lot less than 4000sqm, an offset will be paid as part of the corresponding Ecology Investigation/Reporting and this tree will be kept. See the image below for the locations of the 4 trees discussed.
