Phase 1 Environmental Site Assessment

77 Gibson Street

Leongatha

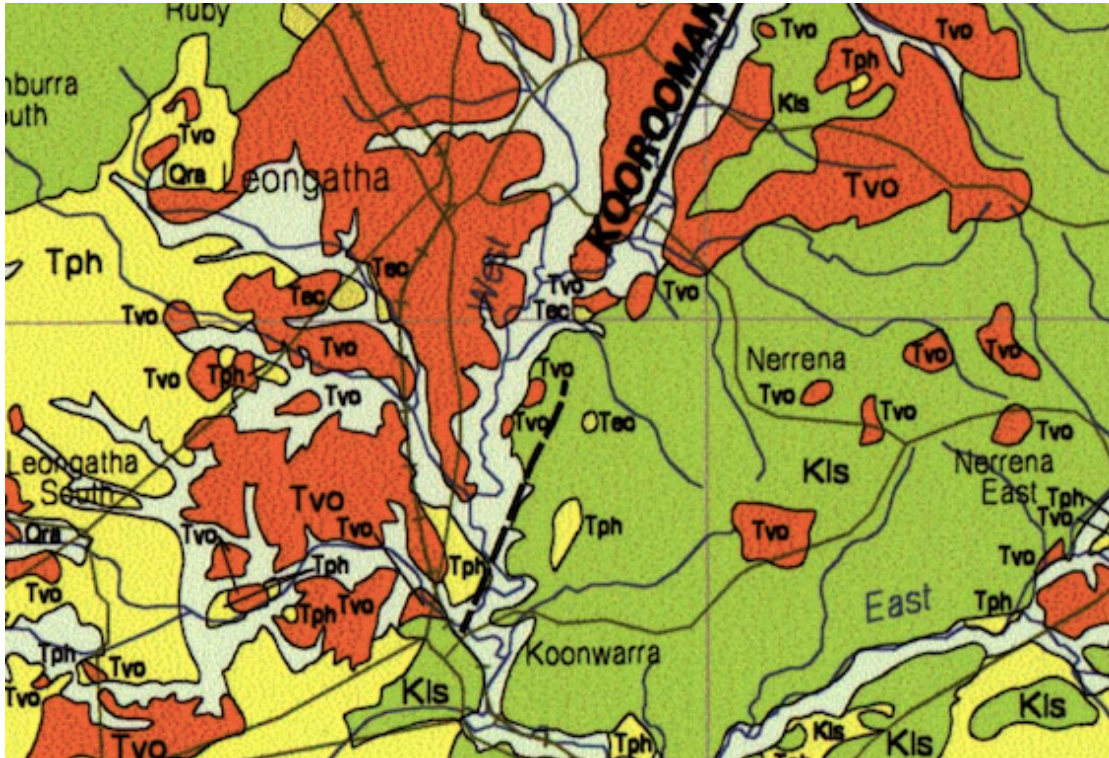
Figure 2 Excerpt from Geoscience Australia 1:250000 Warragul Sheet

Referring to the Geoscience Australia 1:250000 Warragul Sheet, the site is situated on undulating slopes underlain by Tertiary-aged Volcanic rocks parting to lower areas associated with Quaternary-aged Alluvium. The proposed site occupies a top-mid slope position within the localised landscape, parting to moderate to steep side slopes terminating in the lower Quaternary alluvial plain.

Qrt Fluvial: alluvial terraces: gravel, sand, silt

Tvo Extrusive: tholeiitic and minor alkaline basalts

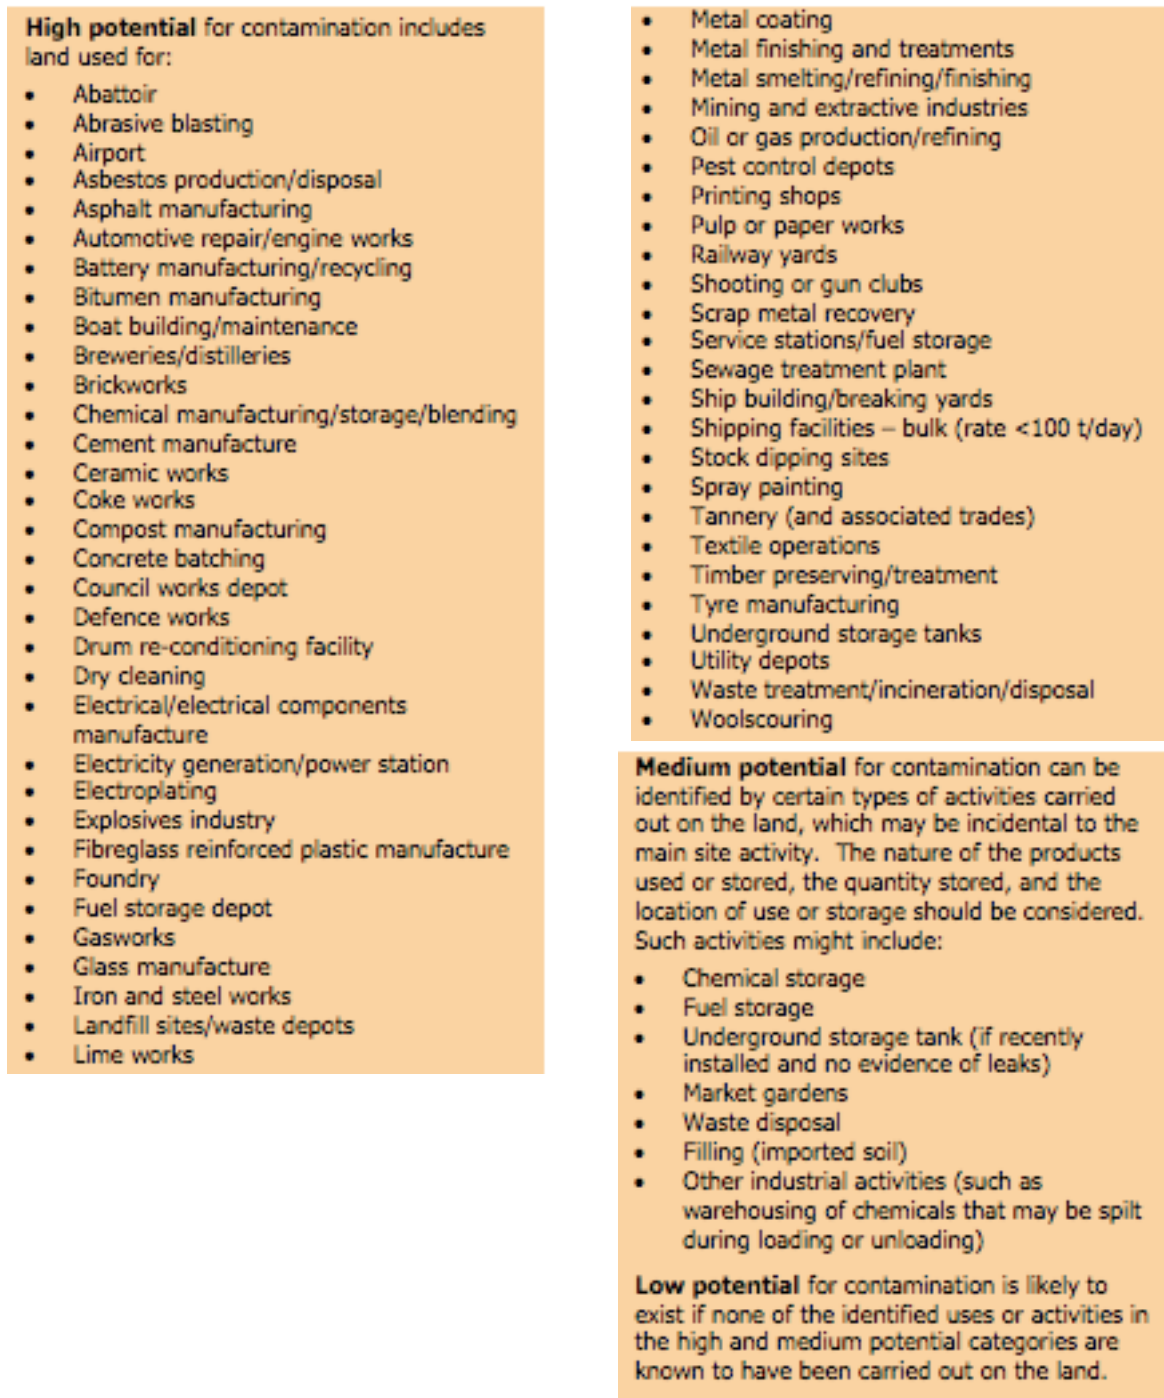
Figure 4 Exerpt from DSE (2005)

The DSE ranking scheme also identifies the “contamination assessment response” required by the responsible planning authority when considering an application for development or rezoning of land for either a “sensitive” or “non-sensitive” land use. An extract from the DSE guideline illustrating this scheme is presented in Figure 4.

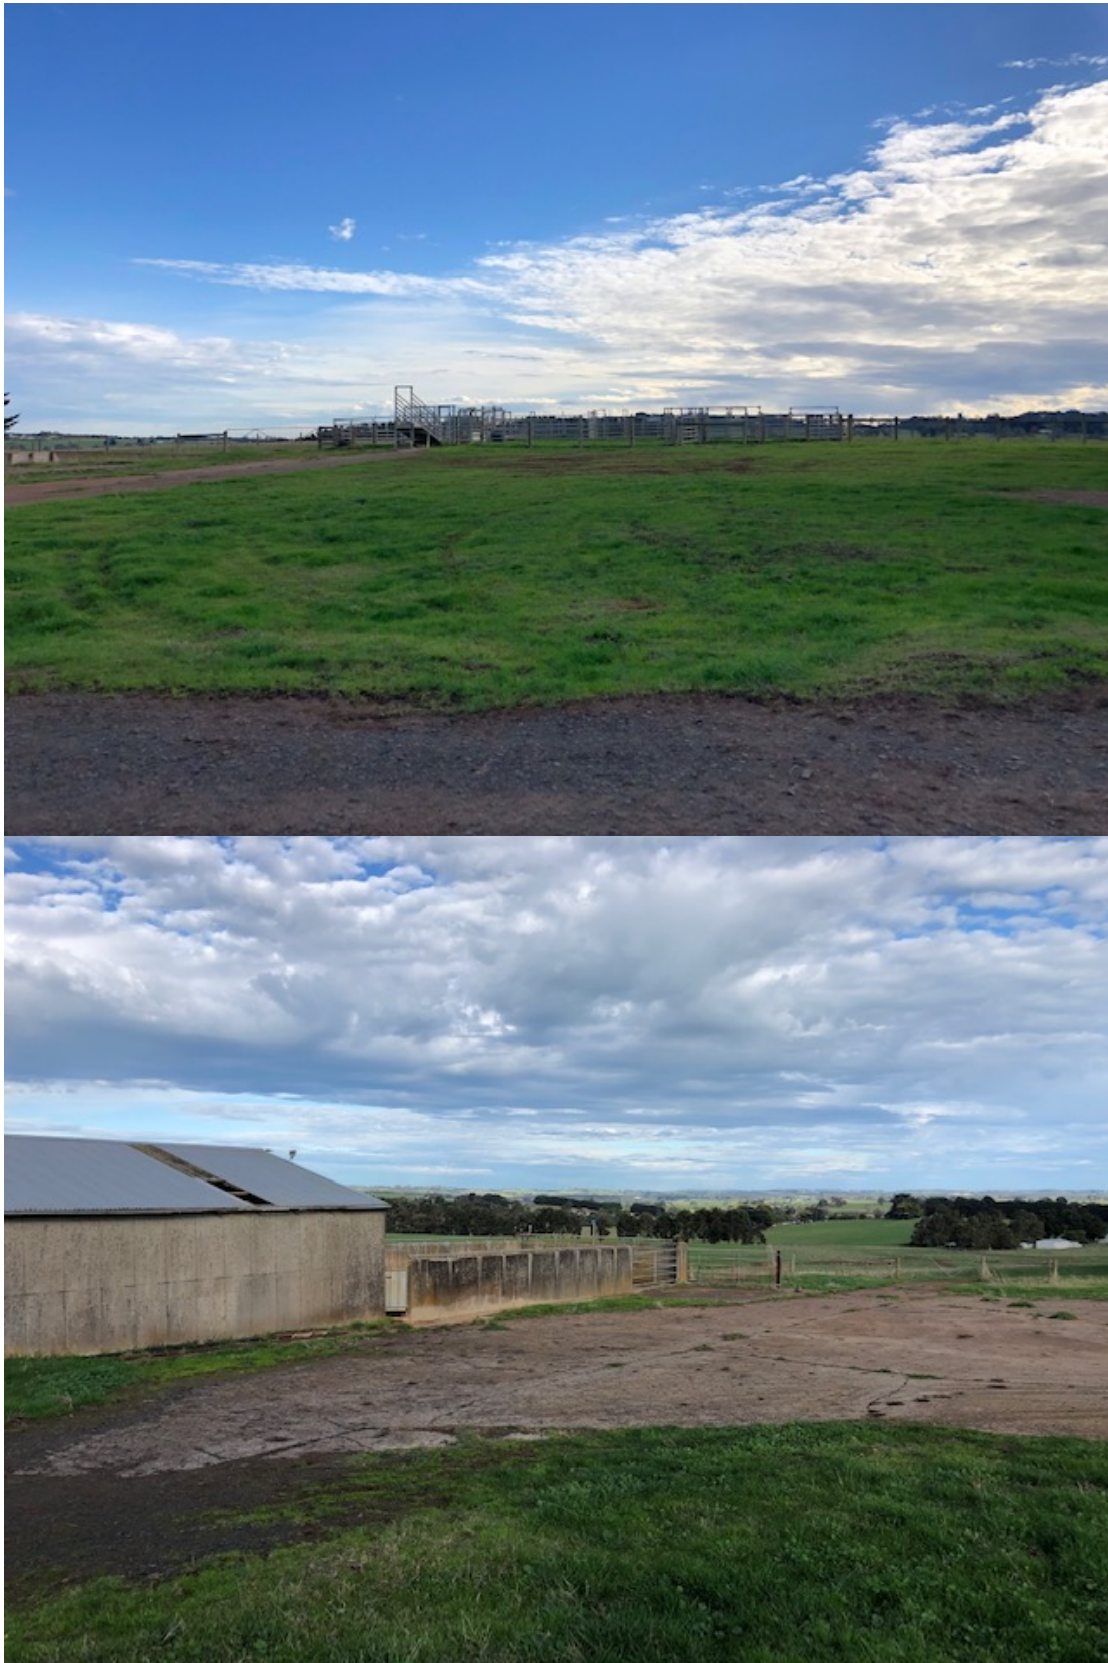
- The site is currently being actively farmed for beef production.
- Stock handling yards were observed onsite.
- No sheep dips were observed.
- Two residential dwellings and associated outbuildings were observed.
- A septic tank sewage system was observed.
- Minor evidence of emplaced fill observed onsite.
- Minor disturbances in the main drainage line was observed
- No Asbestos containing building materials were observed.
- No above/underground fuel storage infrastructure was observed.
- No staining of soil surface indicating previous chemical/fuel storage/spills was observed.
- A moderate sized farm dam and two drainage lines were observed
- No groundwater was observed.
- No groundwater bores were observed.

Plate 1 (Above) and Plate 2 (below) Stockyards (28/5/19)

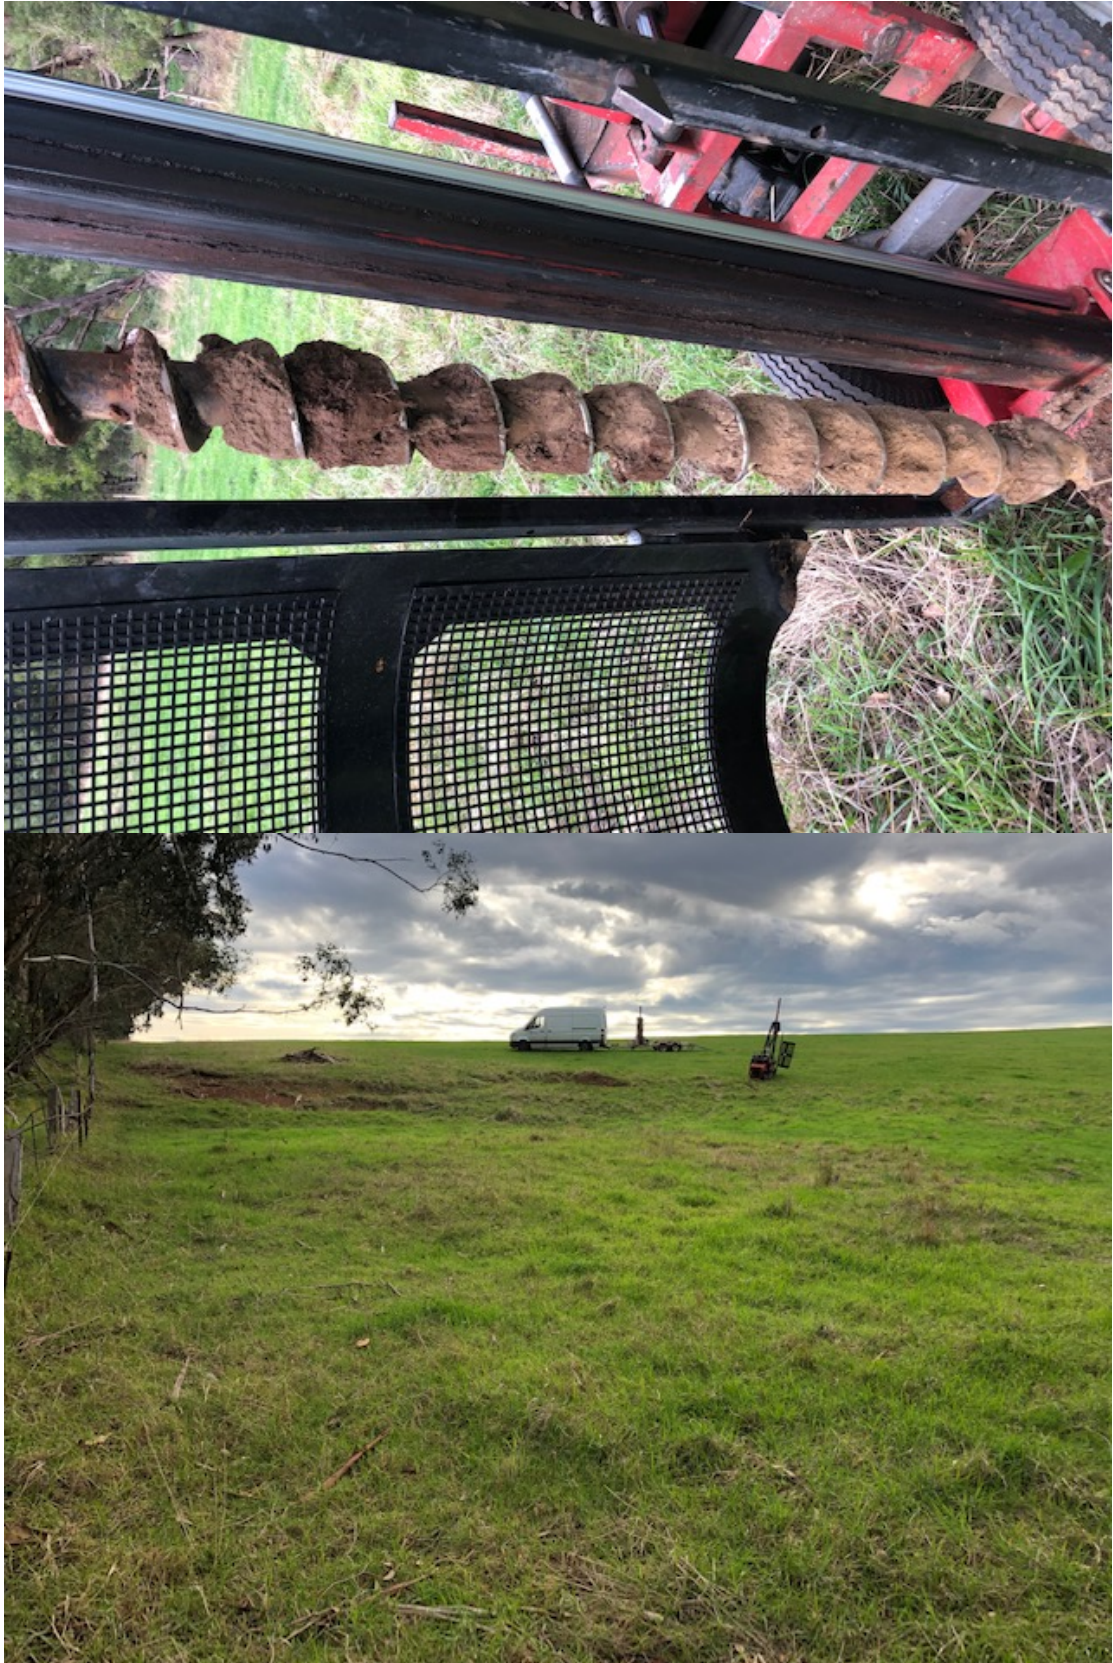
Plate 3 (Above) and Plate 4 (below) Inferred uncontrolled fill (28/5/19)
