# Preliminary Site Investigation, 99 Bena Road Korumburra

**14 February 2023**

**DRC PSI – 99 Bena Road Korumburra FINAL 140223**

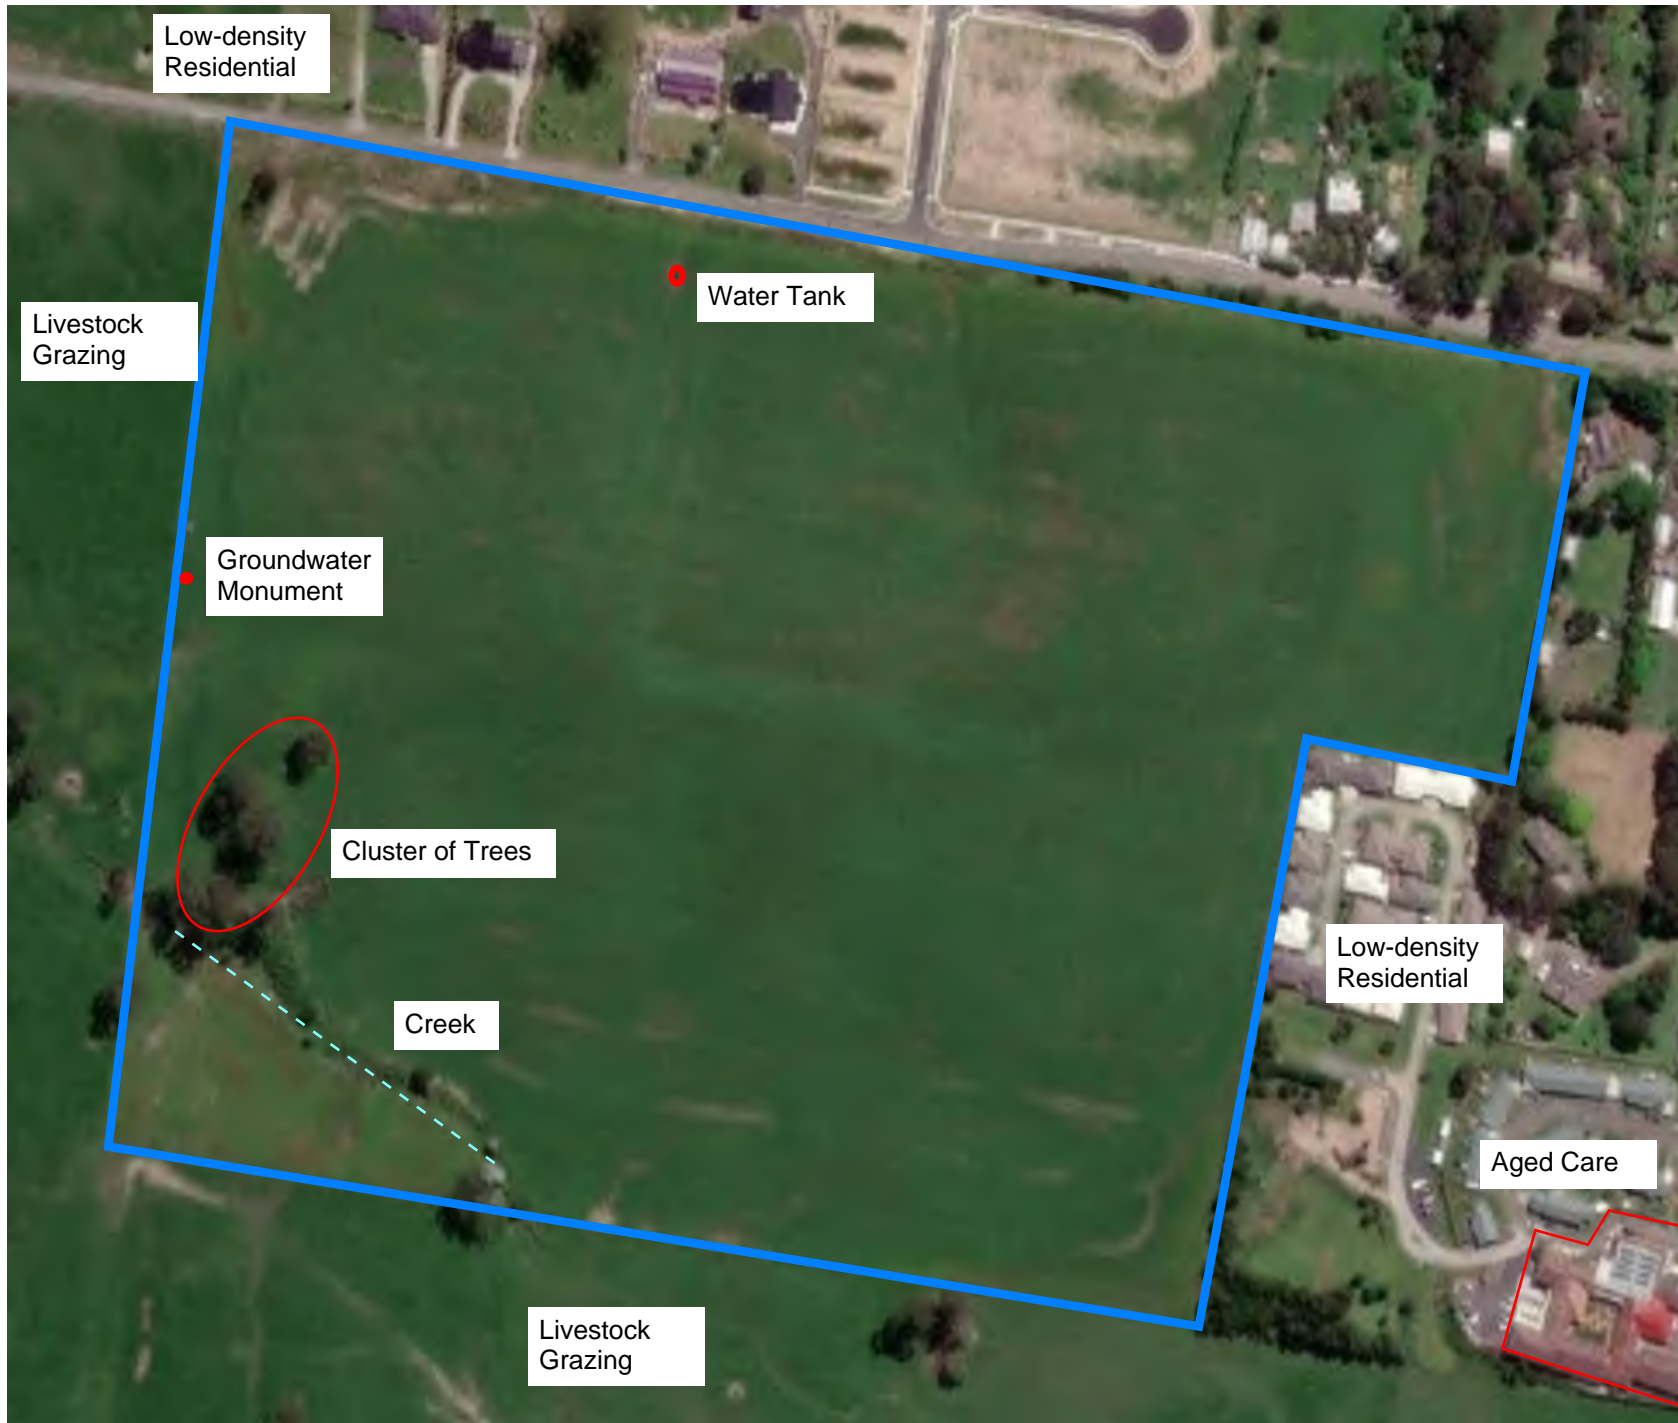
The **Plates** section of the report details site photographs taken at the time of the site inspection and **Figure 2** in the **Figures** section of the report shows the features present on site.

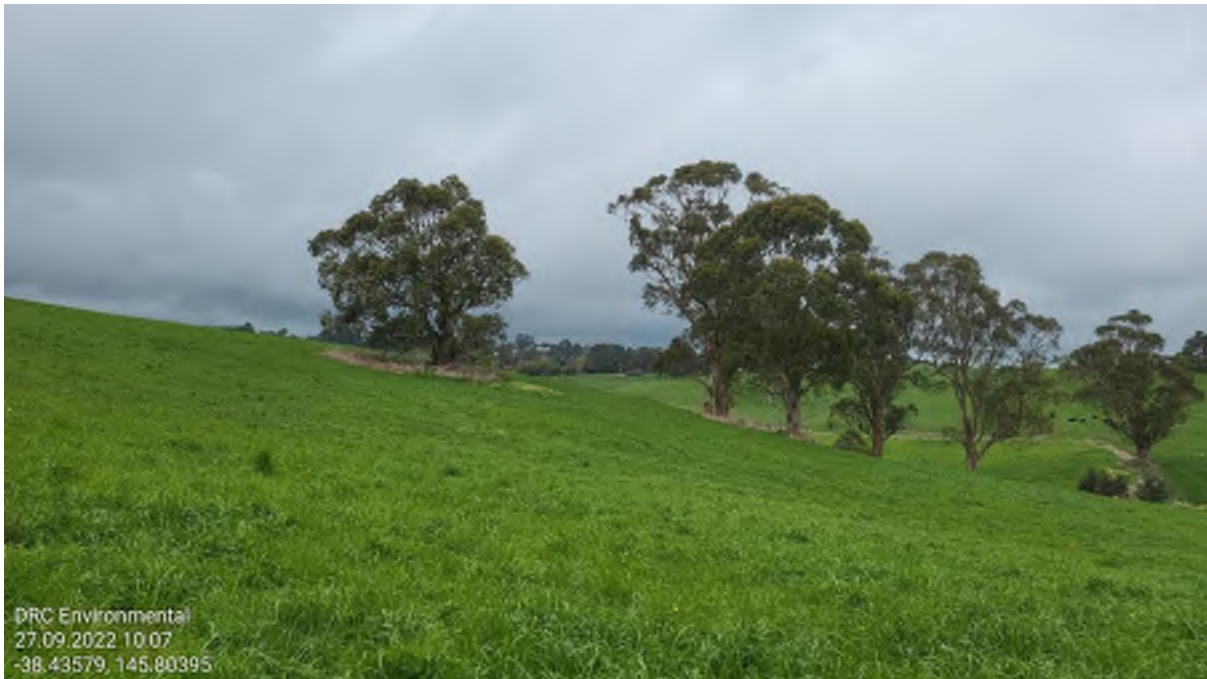
*Plate 1: Southwest side of the site with scattered trees*

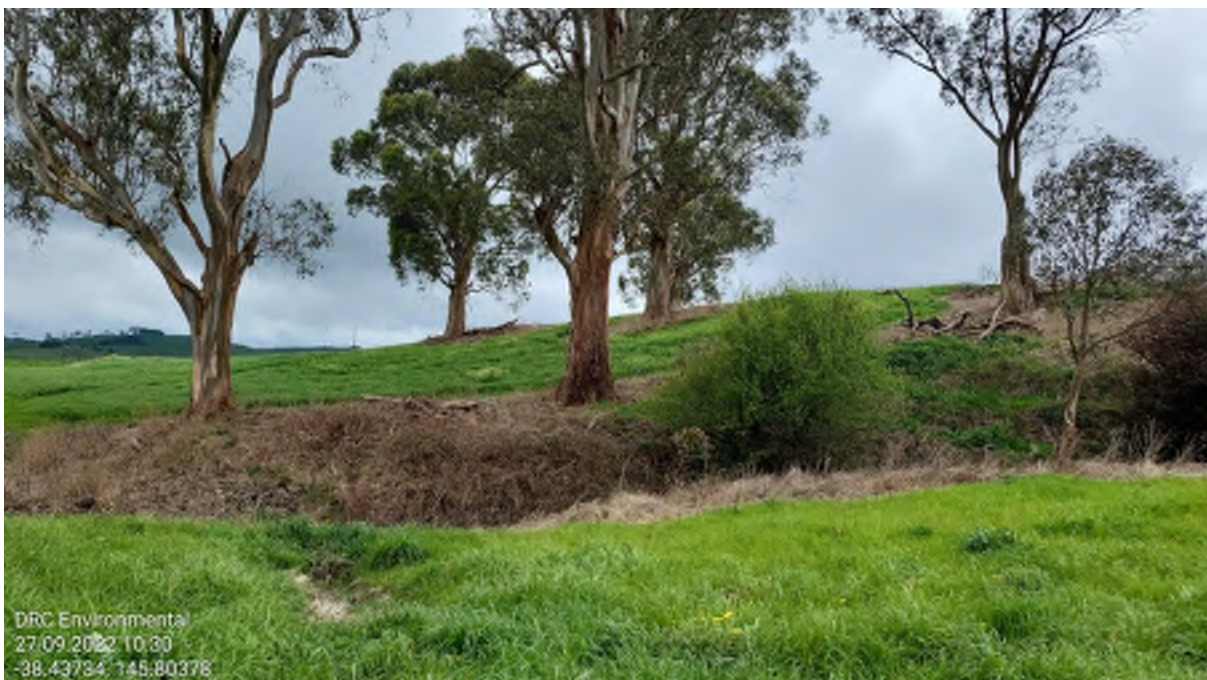
*Plate 2: Southwest side of the site with trees and organic debris such as branches, leaf litter, dead grass surrounding the tree*

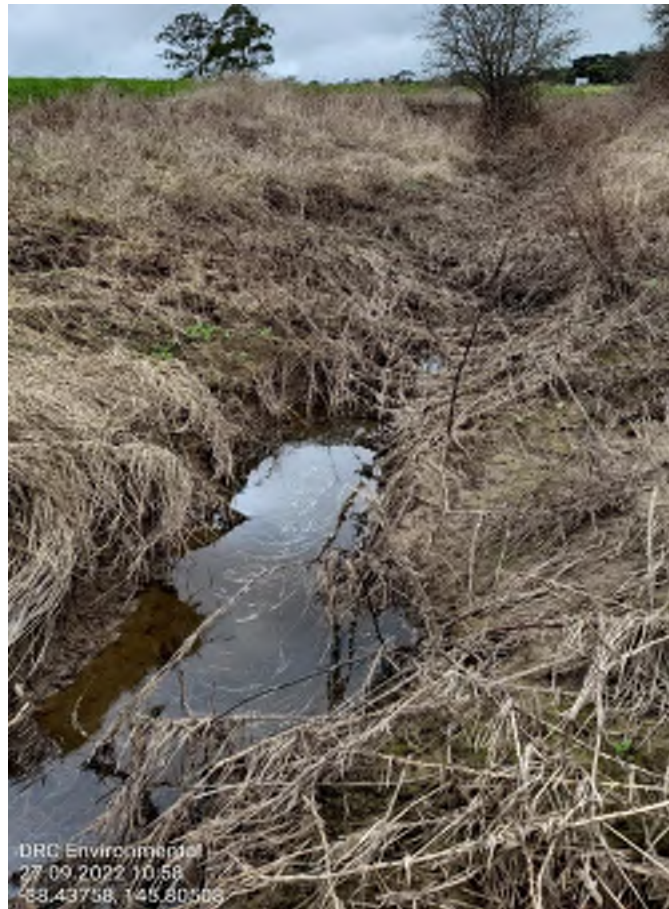
- A groundwater monument was identified on site at the western boundary of the site;
- A creek is present running southwest in the southern portion of the site. The creek's flow was blocked off by sediment which is used as a crossing path at two sections along the creek;

*Plate 3: Creek along the southwest side*

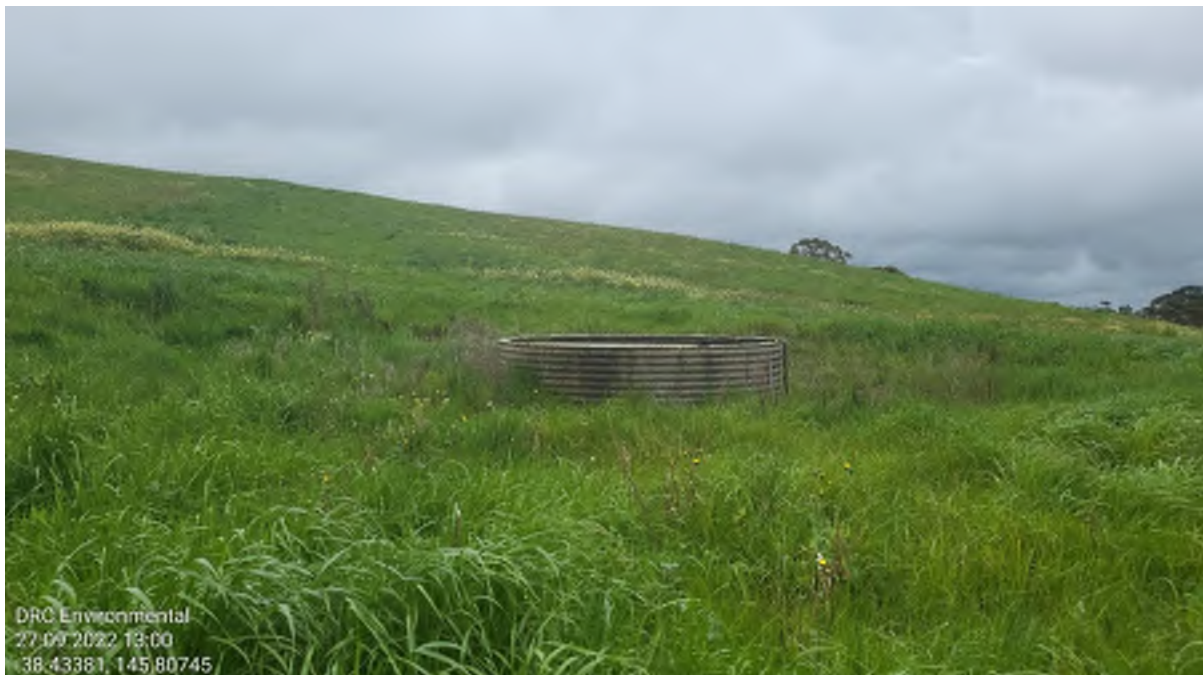
- A water tank is present in the northern portion of the site, sealed off with concrete on top with a pipe connected to the water tank that runs into the ground;

*Plate 4: Concrete Water Tank present towards the north side, sealed off on top with one pipe connected to the water tank that runs into the ground*

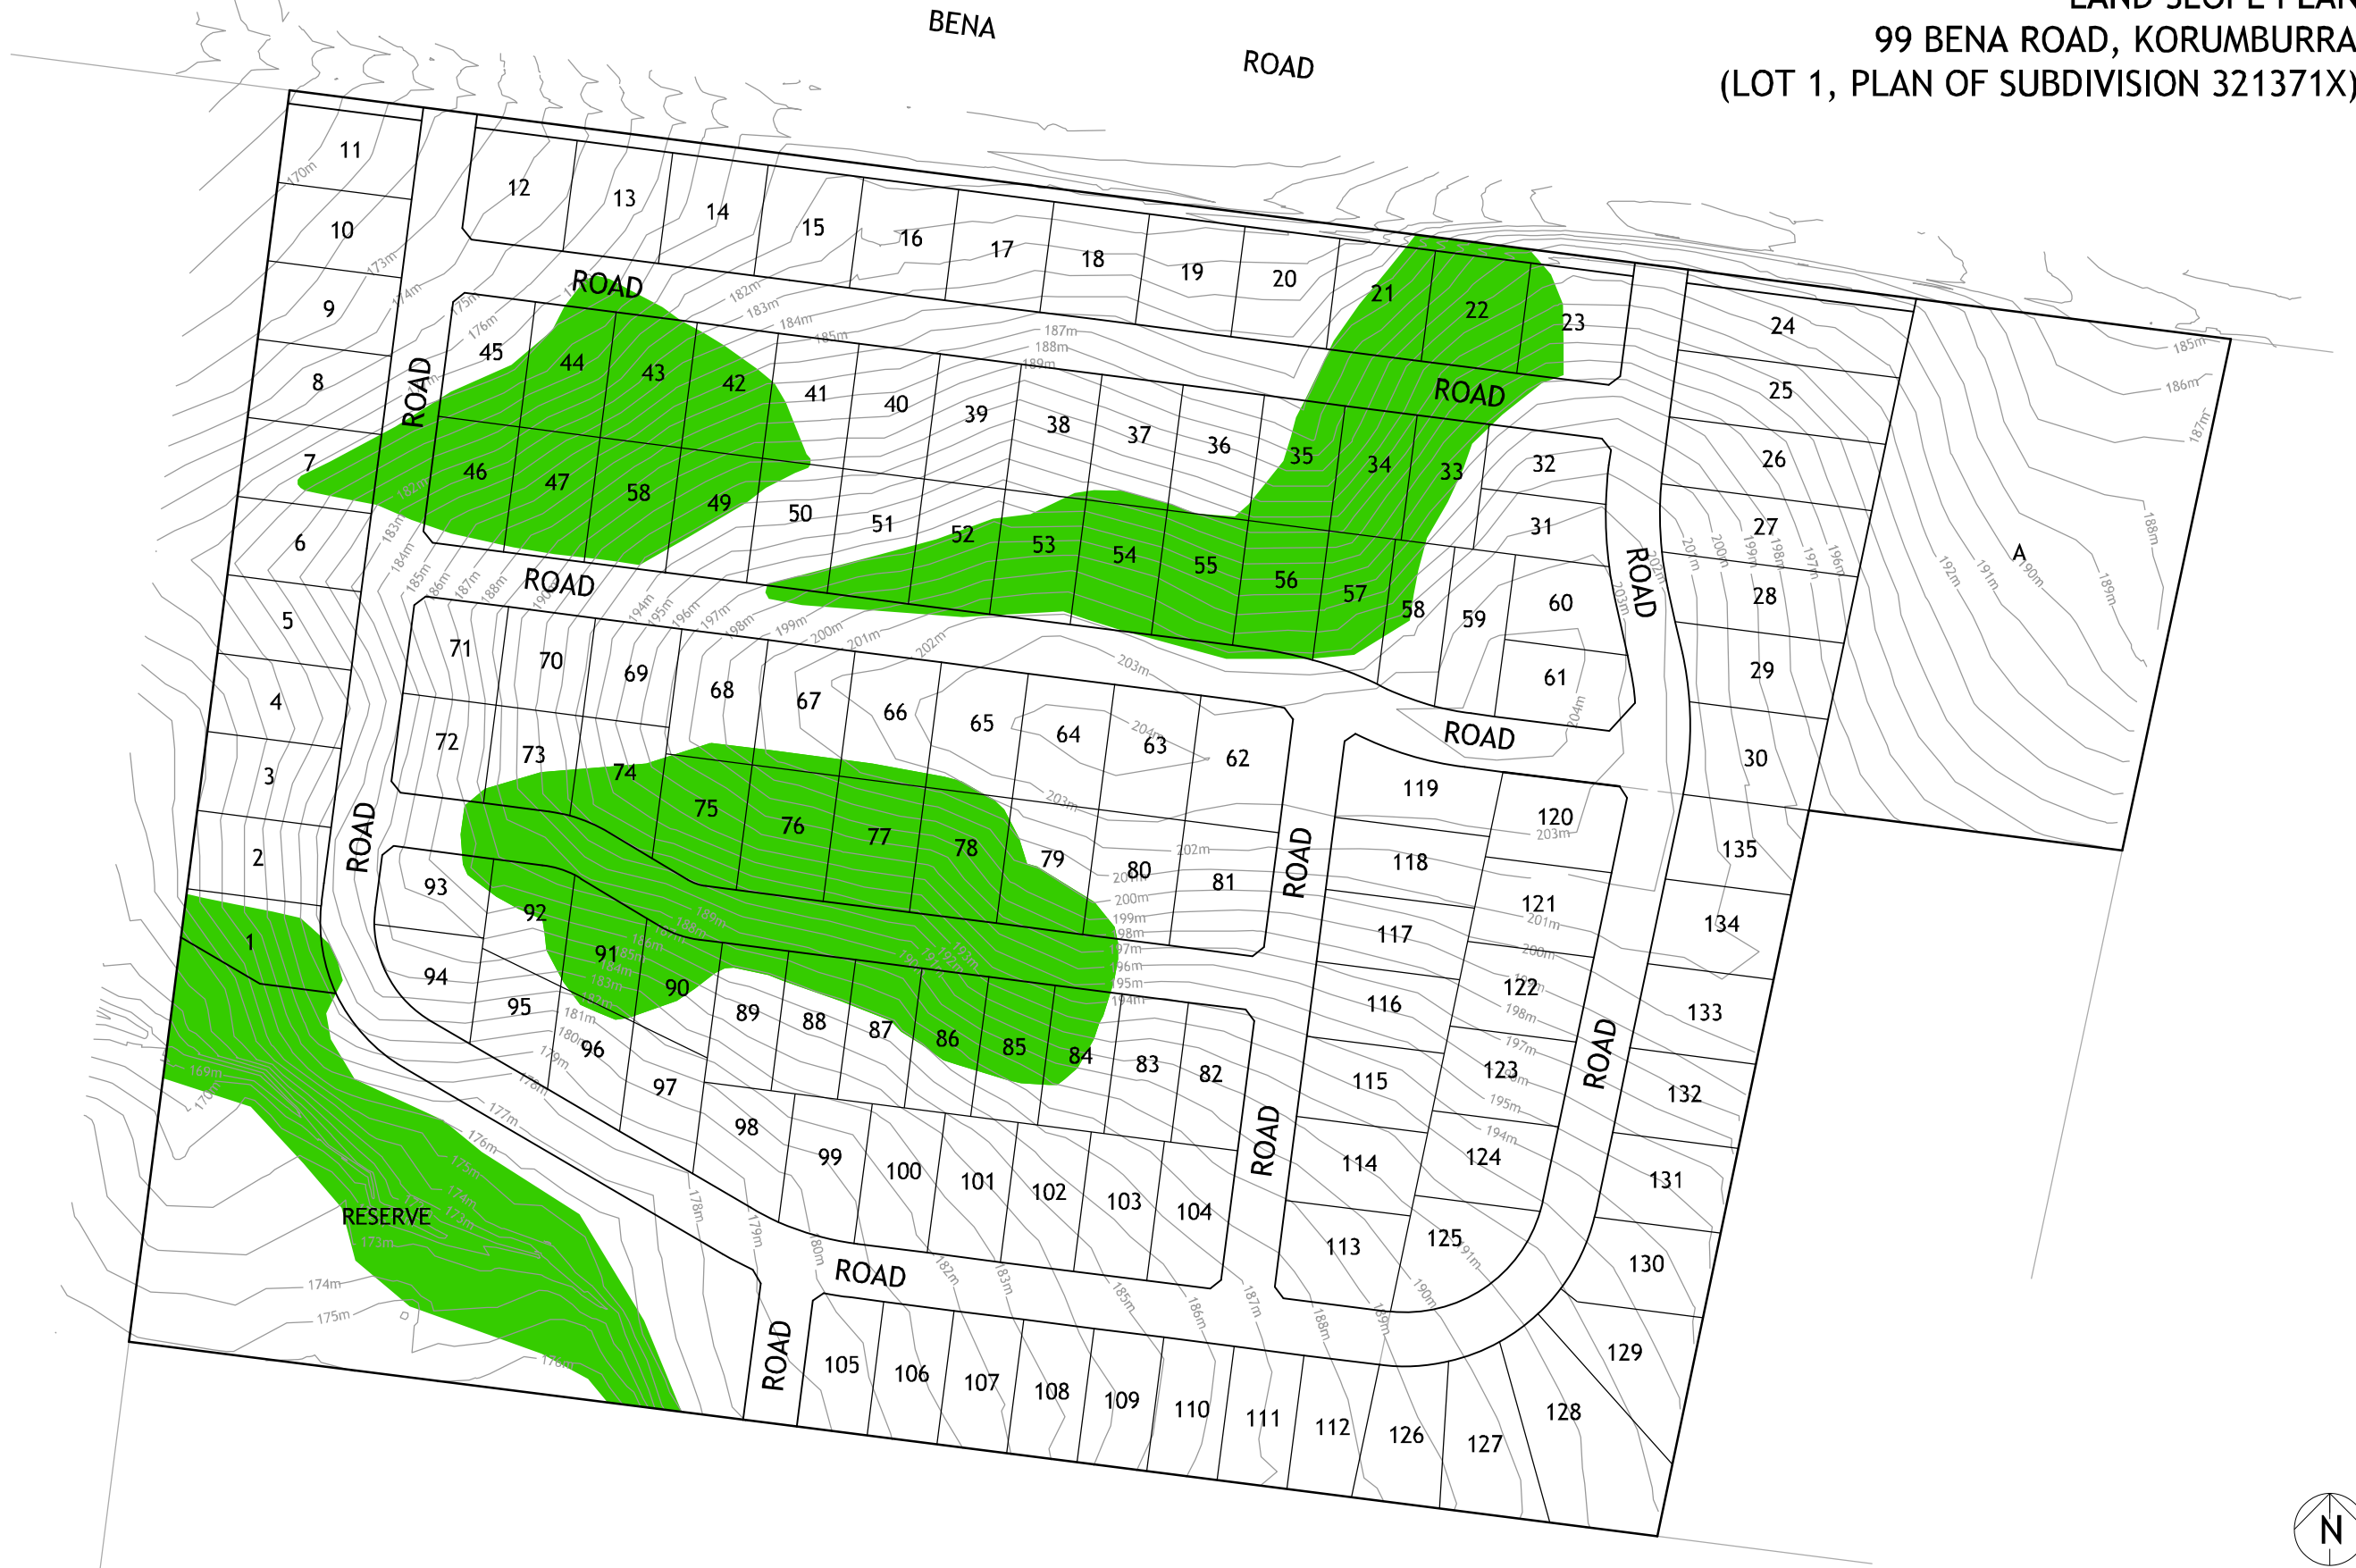
LAND SLOPE PLAN  
 99 BENA ROAD, KORUMBURRA  
 (LOT 1, PLAN OF SUBDIVISION 321371X)

The site is hilly and uneven and the elevation is approximately 169 to 204m Australian height datum (m AHD). The highest elevation is at the northeast area and lowest elevation is present towards the western boundary. Information regarding the topography at the site is provided by Brosnan Engineering Solutions, which is provided in **Appendix B**.
