Tarwin Lower Flood Study

Report No. J155/R01

FINAL REPORT

January 2007

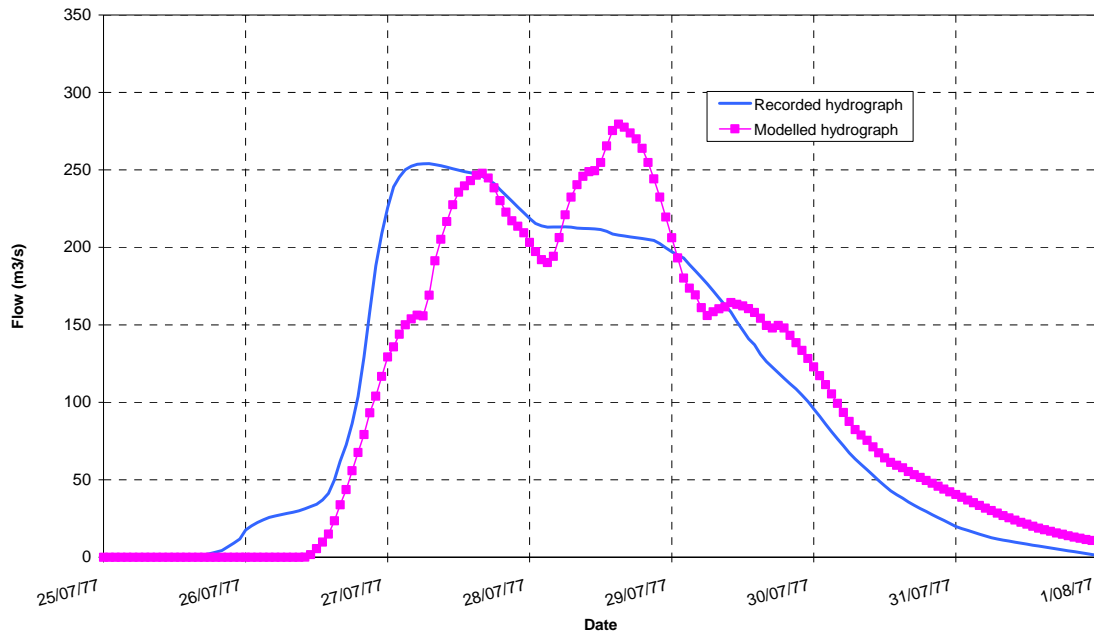
Figure 4-2: RORB calibration – Tarwin River at Meeniyan: July 1977 event ($k_c = 46$, IL = 30 mm, CL = 0.26 mm/h)

Figure 4-2 to Figure 4-4 displays the modelled and recorded flood hydrographs for the calibration events at the Meeniyen gauge. The recorded hydrographs shown in Figure 4-2 to Figure 4-4 are following the baseflow removal.

The fits of the modelled and observed flood hydrographs were considered reasonable. Some differences in the timing of the peak flow were found. These differences were considered to be due to the assumed representation of the spatial and temporal variation of rainfall across the catchment. Attempts were made to improve the timing of the modelled peak flows by varying the assignment of observed temporal pattern from the pluviographic rainfall data to the RORB model sub-areas. During the calibration, the modelled flood hydrographs, both peak flow and shape, were found to be sensitive to the assignment of the observed pluviographic rainfall data.

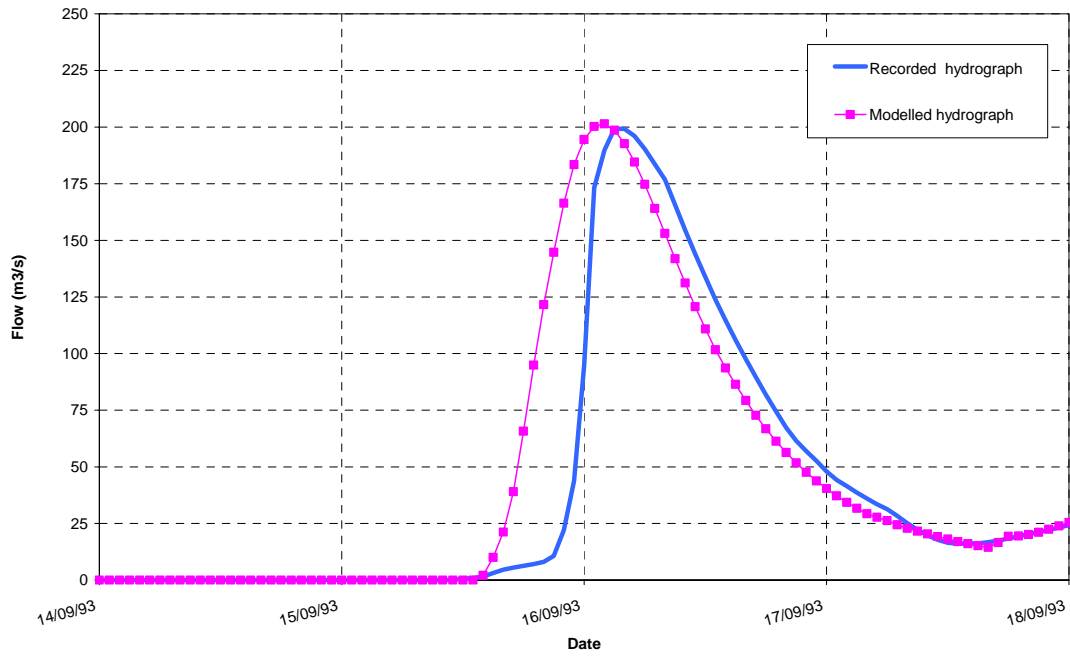
Figure 4-3: RORB calibration – Tarwin River at Meeniyan: September 1993 event ($k_c = 46$, IL = 44 mm, CL = 0.37 mm/h)

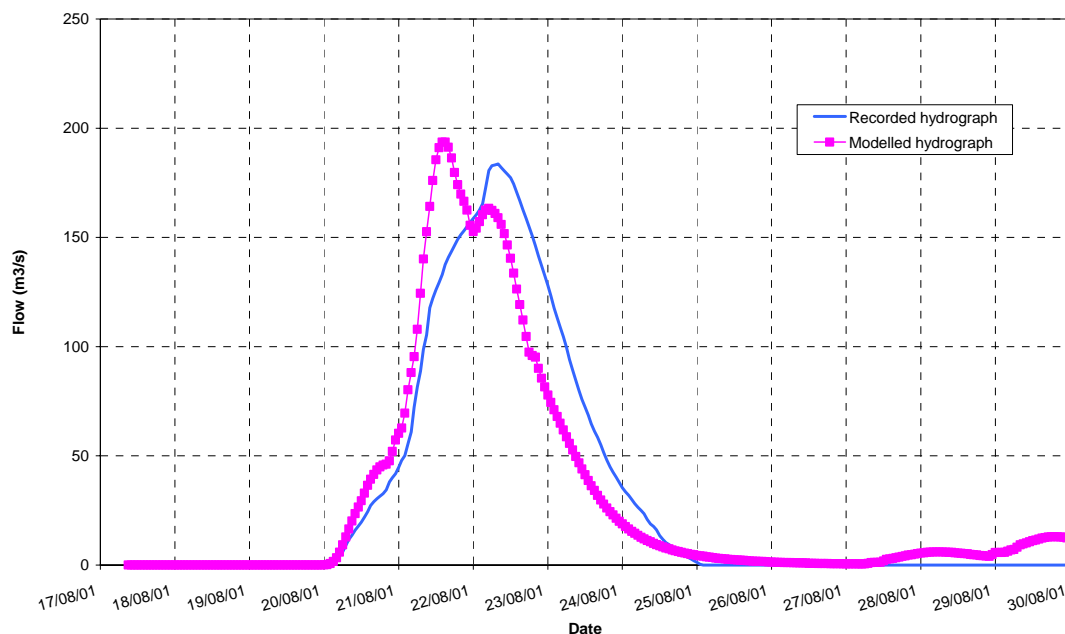
Figure 4-4: RORB calibration – Tarwin River at Meeniyan: August 2001 event ($k_c = 46$, IL = 30 mm, CL = 0.22 mm/h)

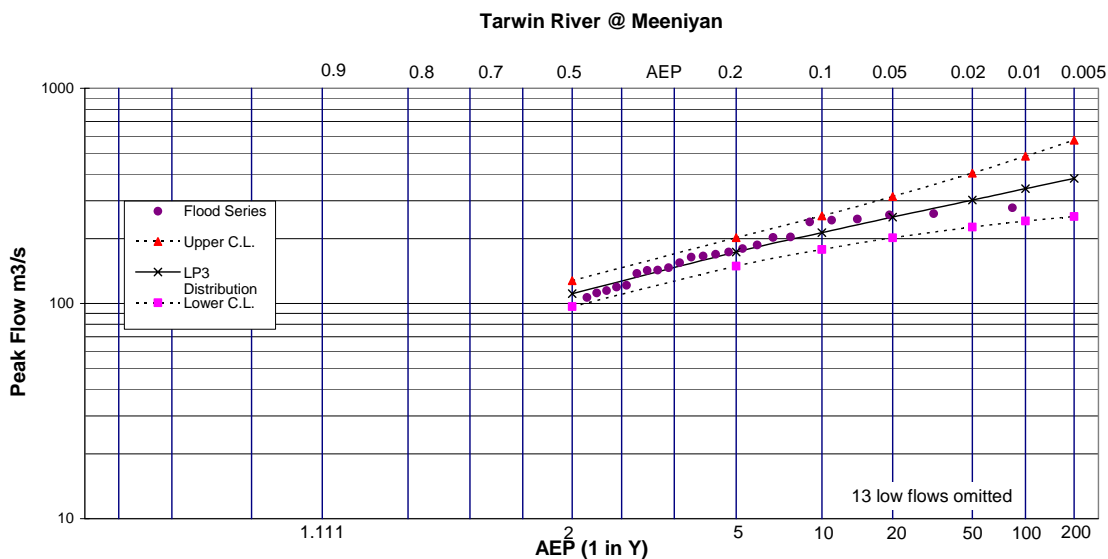
Figure 4-5 Flood frequency analysis - Tarwin River at Meeniyán – Peak Flow (annual series)

Annual flood frequency analysis was undertaken for Tarwin River at Meeniyán. For the annual flood series a Log Pearson 3 (LP3) distribution was fitted by the method of moments (ARR 1999). The annual peak flow series was assembled from data retrieved for the period 1955 to date. Prior to 1972, only mean daily flows were available at Meeniyán. These mean daily flows were adjusted to estimate peak instantaneous flow for the period 1955 to 1971. Figure 4-5 shows the flood frequency analysis for the Tarwin River at Meeniyán. It indicates a 100 year peak flow at Meeniyán of 341 m³/s.

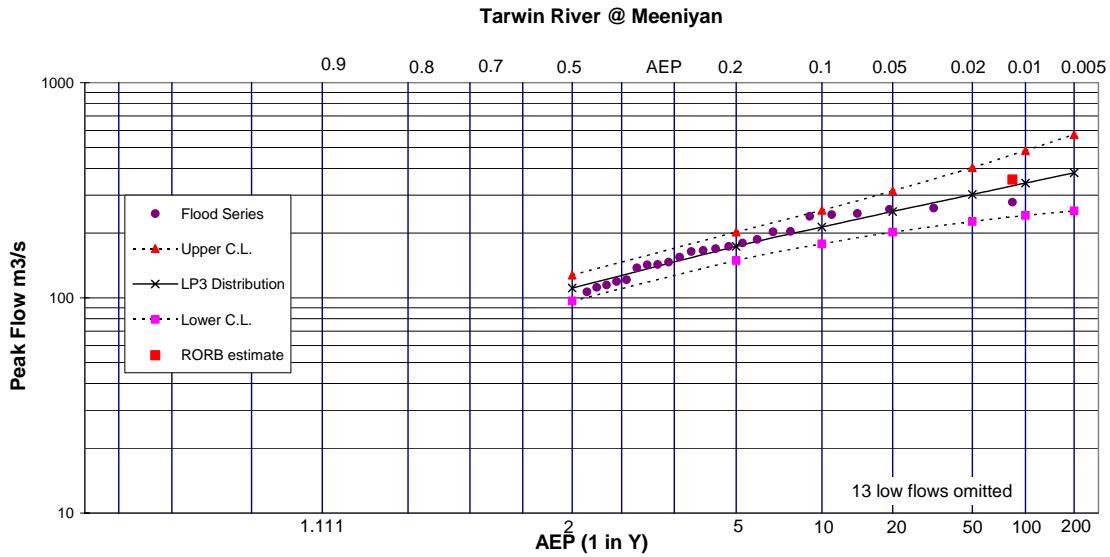
Figure 4-6 Verification of design parameters for Tarwin River at Meeniyan

The rainfall loss parameters were adjusted until similar peak flows from the RORB model and FFA were obtained for the 100 year ARI event. The rainfall loss parameter values, initial loss 30 mm and a continuing loss of 3.0 mm/hr, resulted in a 100 year peak flow of 354m³/s, which was considered to provide good agreement between the RORB model and FFA peak flows for the 100 year ARI event. These rainfall loss parameters were adopted for use in design flood hydrograph estimation. The verification plot for the Tarwin River at Meeniyah is shown in Figure 4-6.

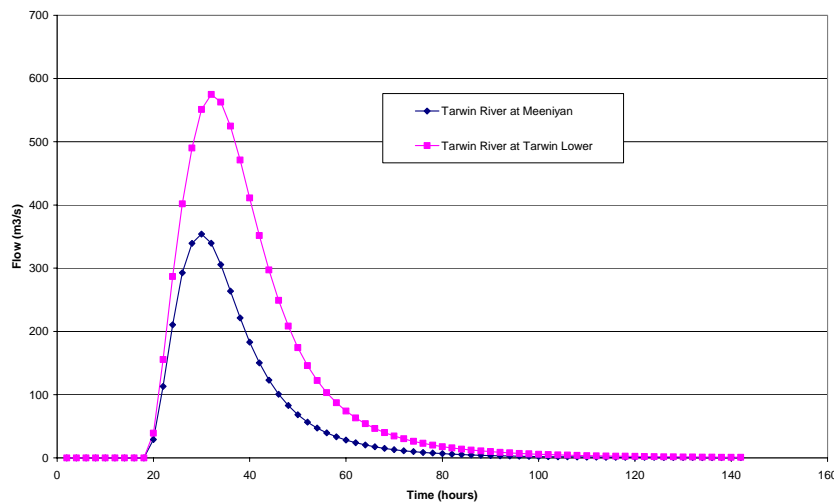
Figure 4-7 RORB 100 Year Design Hydrograph – Tarwin River at Meeniyan and Tarwin Lower

A design flood hydrograph was determined for the 100 year ARI event over a range of storm durations. This range of storm durations was required to ensure the critical storm durations were determined throughout the study area. Peak storm duration was found to be 36 hours, with a peak flow of 574m³/s at Tarwin Lower. Figure 4-7 below shows the 100 year flood hydrograph at Meeniyan and Tarwin Lower.

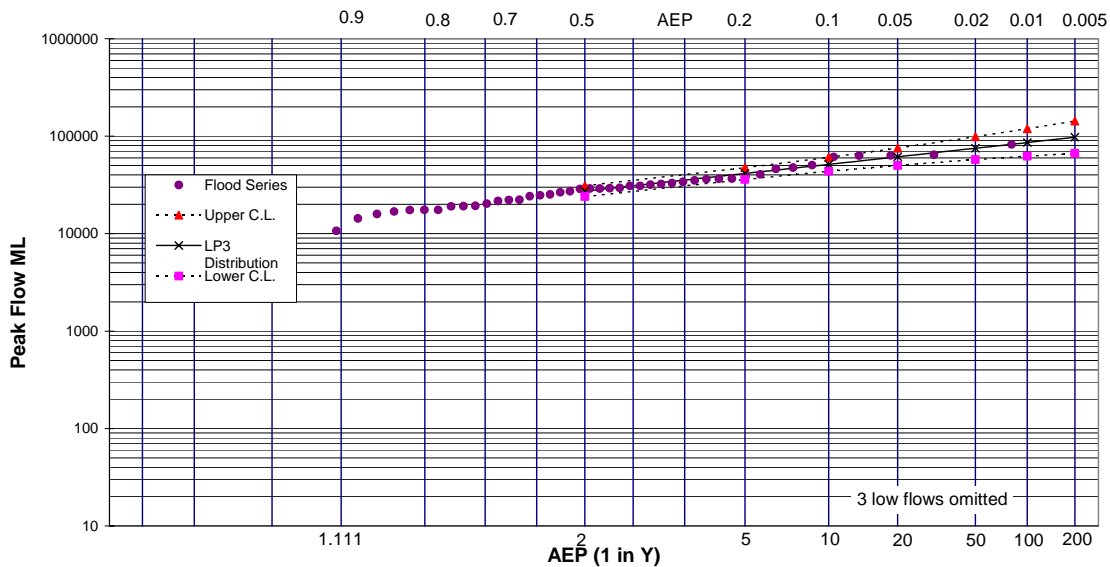
Figure 4-8 Flood frequency analysis - Tarwin River at Meeniyan – Peak 5DV (annual series)

In addition to annual peak flow flood frequency analysis, annual peak 5 day volume (5DV) frequency analysis was also undertaken as an additional check on the design events generated. For the annual peak 5DV series, a LP3 distribution was fitted by the method of moments (ARR, 1999). Figure 4-8 shows the peak 5DV flood frequency analysis for the Tarwin River at Meeniyan.

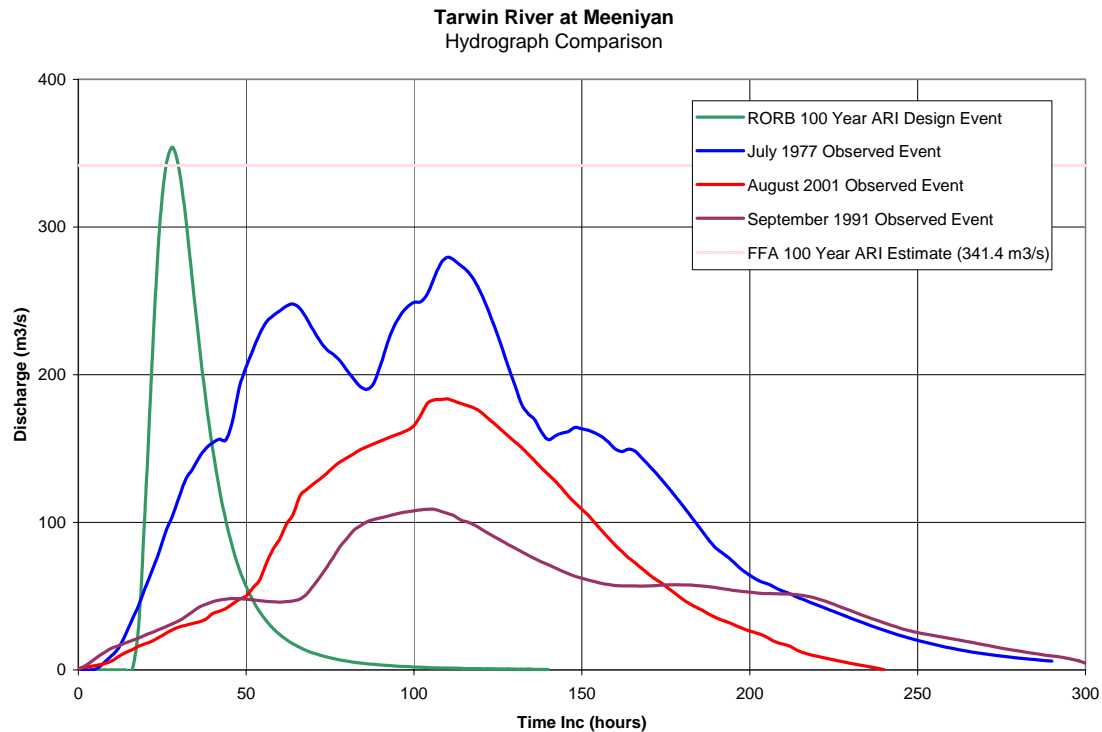
Figure 4-9 Hydrograph Comparison – Tarwin River at Meeniyian Gauge

As discussed in Section 4.1, flood volume is considered to be an important flood characteristic influencing flood behaviour. It is clear from Figure 4-9 that the design hydrograph is not consistent with observed hydrographs at Meeniyian. The RORB model is considered to be adequately calibrated against these observed events using observed rainfall intensities and distributions (see Figure 4-2 to Figure 4-4). However, applying the 100 year design rainfall intensity and distribution to the RORB model results in a hydrograph much steeper and shorter than observed data. This design hydrograph clearly has much less volume (the area under the curve) than observed hydrographs.

This disparity between observed flood hydrographs and design hydrographs is not uncommon. The design methodology uses idealised temporal distribution of rainfall (called temporal patterns or rainfall hyetographs) based on data from areas with similar characteristics and are applicable in “zones” throughout Australia. The Tarwin River lies in Zone 1, which extends along the coast from Melbourne to northern NSW and also covers Tasmania (see Figure 4-10). Within this zone it is assumed that design temporal rainfall patterns are the same. This assumption is not always valid, and in this case results in an inappropriate design hydrograph at Meeniyian.

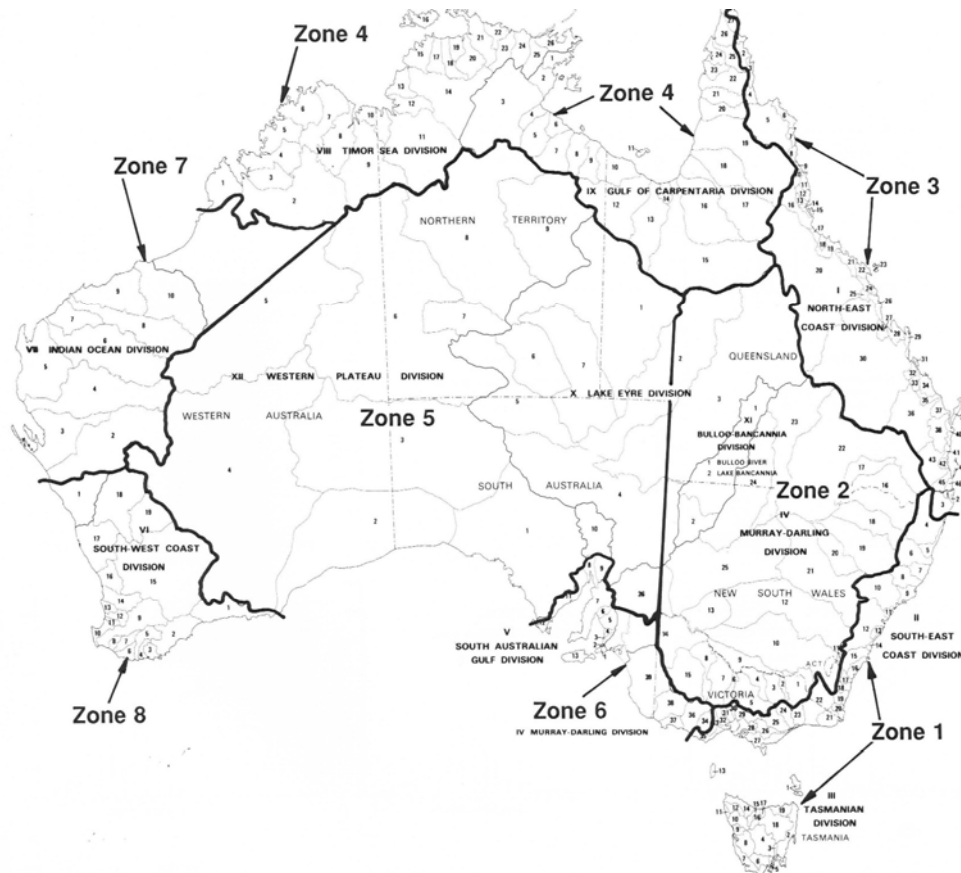
Figure 4-10 Temporal Pattern Zones throughout Australia (ARR 1987)

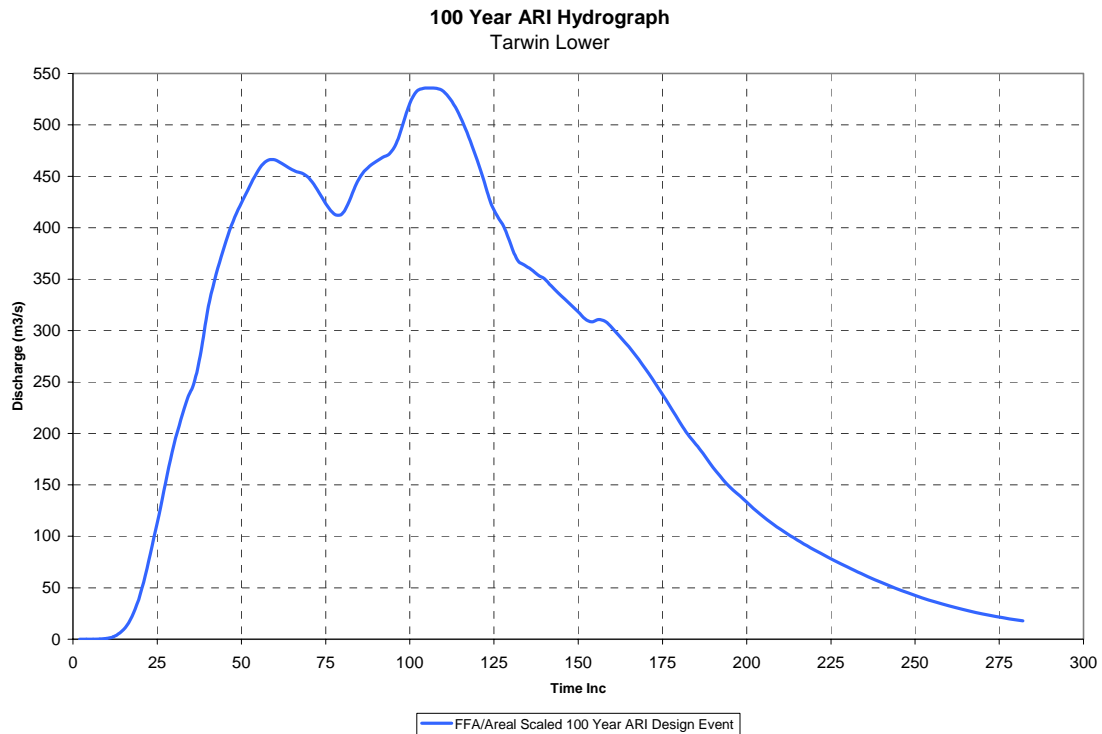
Figure 4-12 Tarwin River at Tarwin Lower – 100 year ARI Hydrograph

Figure 4-12 depicts the adopted 100 year ARI design flood event utilised in the hydraulic analysis based on the scaled historical hydrograph approach. The adopted 100 year ARI peak flow is 535 m³/s.

The adopted hydrograph is considered to represent a realistic design flood hydrograph, consistent with the design peak flood flow, 5 day flood volumes and characteristic of observed flood behaviour within the catchment.

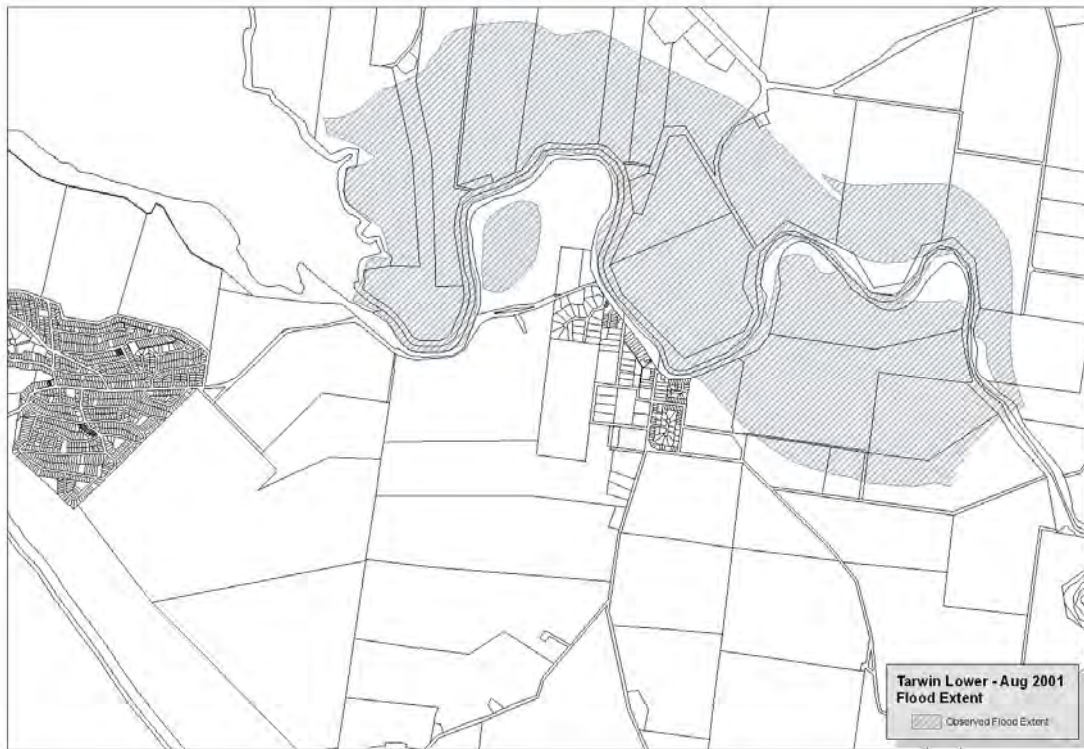
Figure 5-2 August 2001 Observed Flood Extent

In August 2001, a moderate flood occurred in the Tarwin River. The West Gippsland CMA undertook an aerial survey of the event to document flooding throughout the catchment. Video was recorded and from this an estimate of the 2001 flood extent for Tarwin Lower was derived, illustrated in Figure 5-2 below.

The August 2001 flood extent has been interpreted from the WG CMA video. Accurate interpretation of the flood extent is difficult, due to the following issues:

- We understand that the video was recorded at a time several hours after the peak of the flood, and the flood extents observed may not exactly match the peak flood extent
- The video is shot some distance from Tarwin Lower, and the low angle and distance make accurate determination of flood extent difficult
- In some areas, extensive vegetation prohibits identification of an area as flooded or dry, as observation beyond the vegetative cover is not practical.
- No observations of measured flood level for this event have been made available to the study team

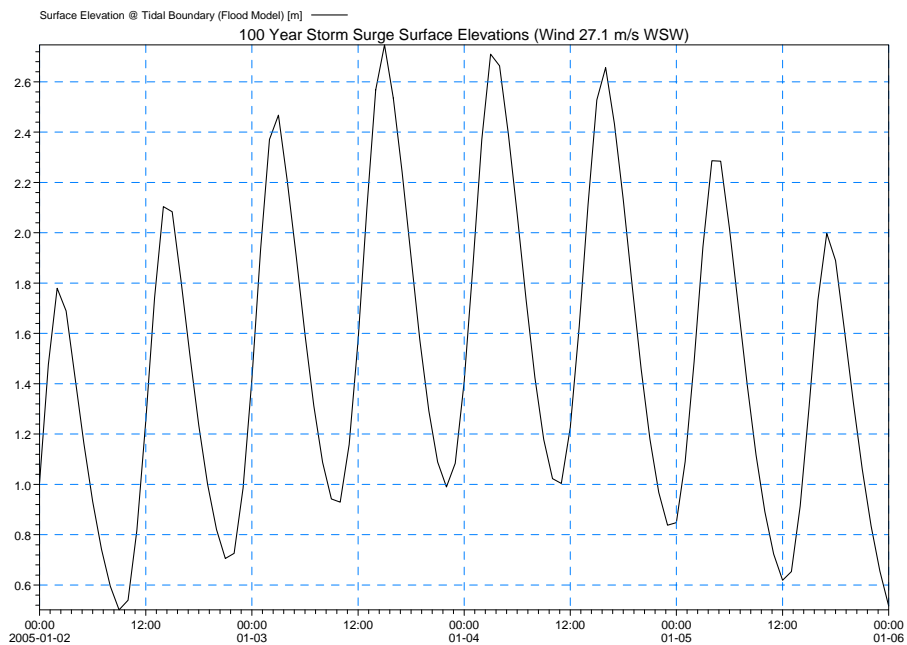
Figure 6-2 Design 100 Year Storm Surge

Together these result in peak water levels near the mouth of the Tarwin River of 2.75m AHD as illustrated in Figure 6-2.

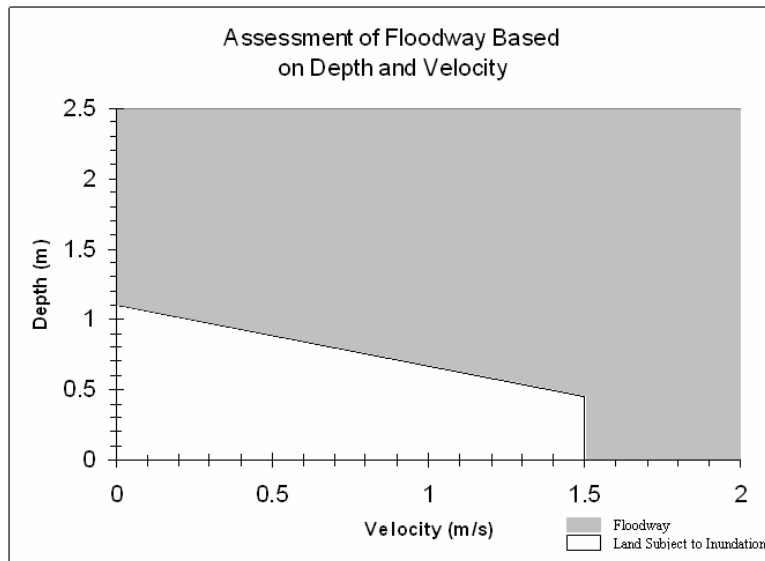
Figure 7-3 – Depth-Velocity Flood Hazard Floodway Assessment

- Estimate the corresponding average velocities and depths and use the chart depicted in Figure 7-3 to assist assessment of the flood hazard.
- If there are any levee spillways estimate the area immediately downstream where obstructions should be minimised to ensure the spillway is effective

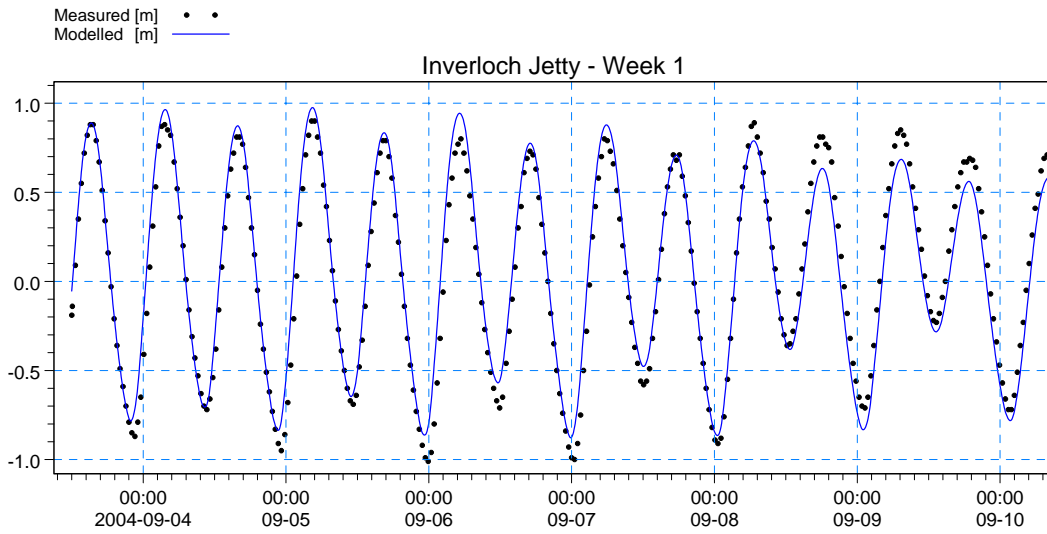
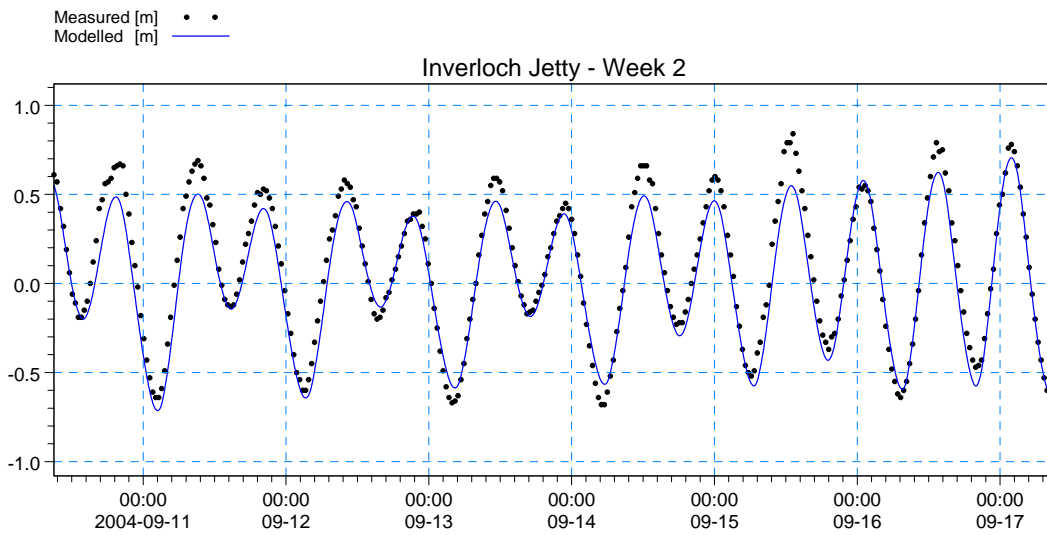
Figure B-1a

Tidal Calibration – Inverloch Jetty

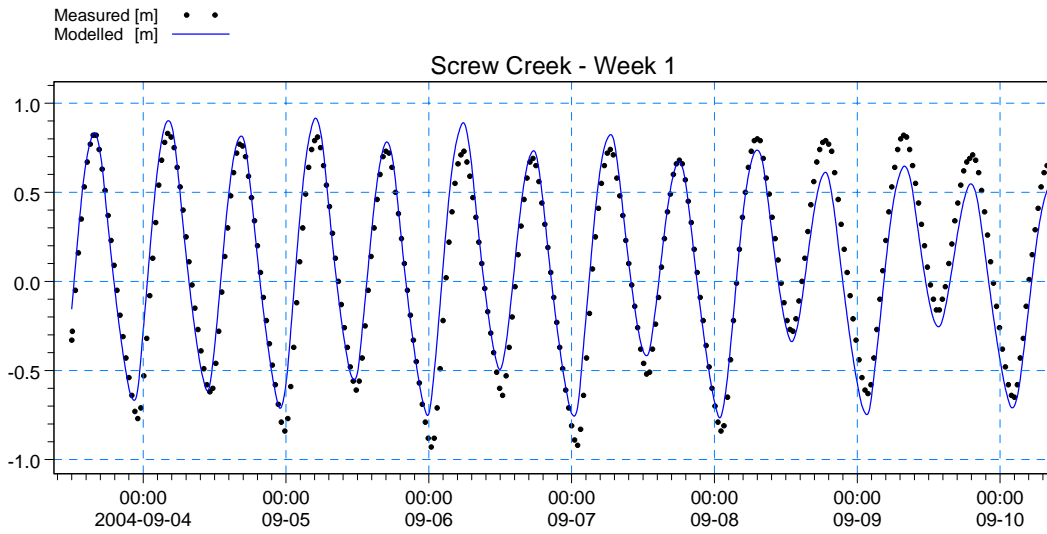
Figure B-2a

Tidal Calibration – Screw Creek

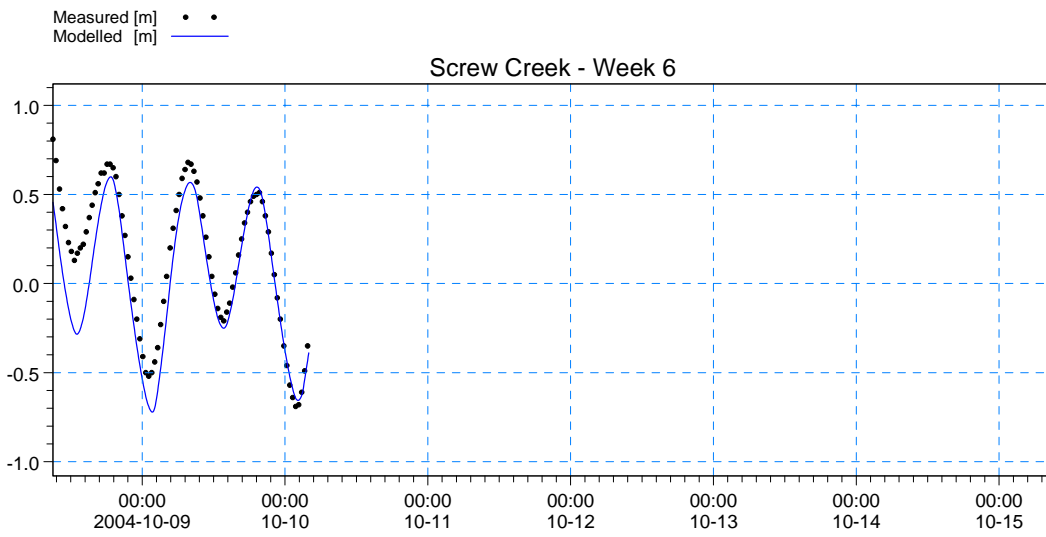
Figure B-2b

Tidal Calibration – Screw Creek
