GIPPSLAND PORTS

**PORT WELSHPOOL LONG JETTY –  
CONDITION ASSESSMENT VALIDATION  
ASSESSMENT REPORT**

F0001-AA004066-AAR-03

15 JULY 2011

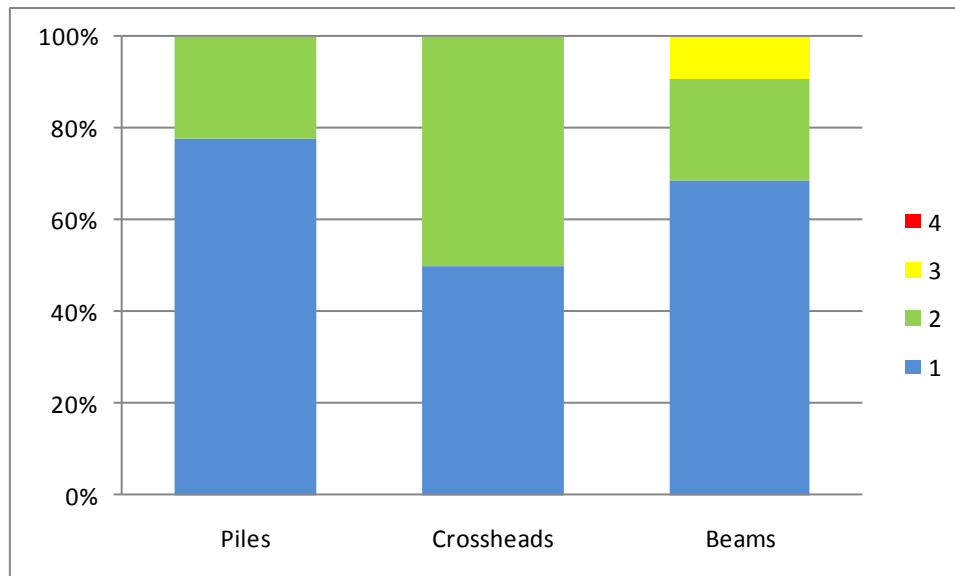
**Figure 3.4.1:** Inspection Area 1 Condition Rating Summary by Element

The type of deterioration resulting in loss of strength in the **beams** (Conditions State 3) is **rot**. Rot has been instigated from moisture entering the beams through splitting over the crossheads. Splitting is a result of the corrosion and expansion of bolts connecting the beams to the crossheads.

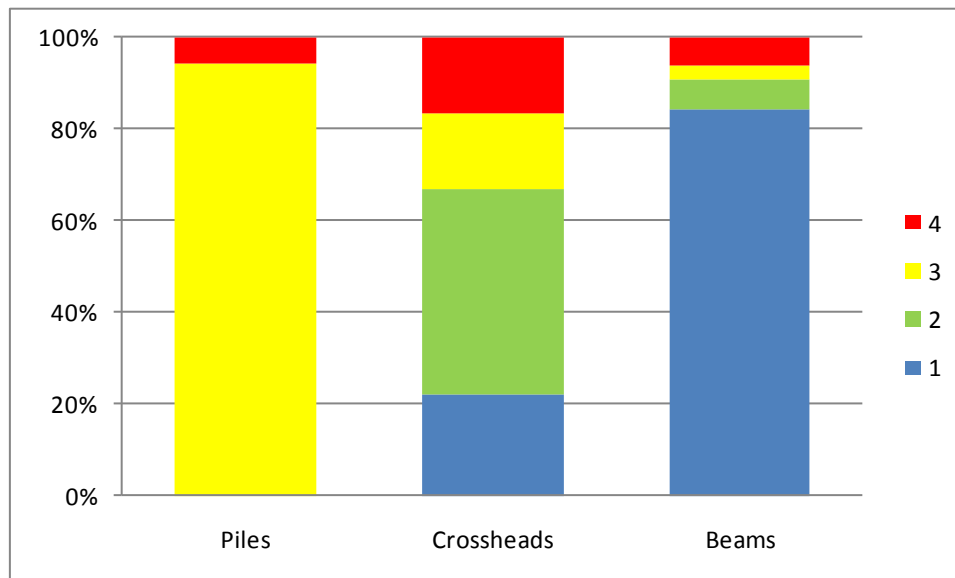
**Table 3.4.2:** Inspection Area 2 Condition Rating Summary by Element

The rating of the majority of **piles** as Condition State 3 has been based on:

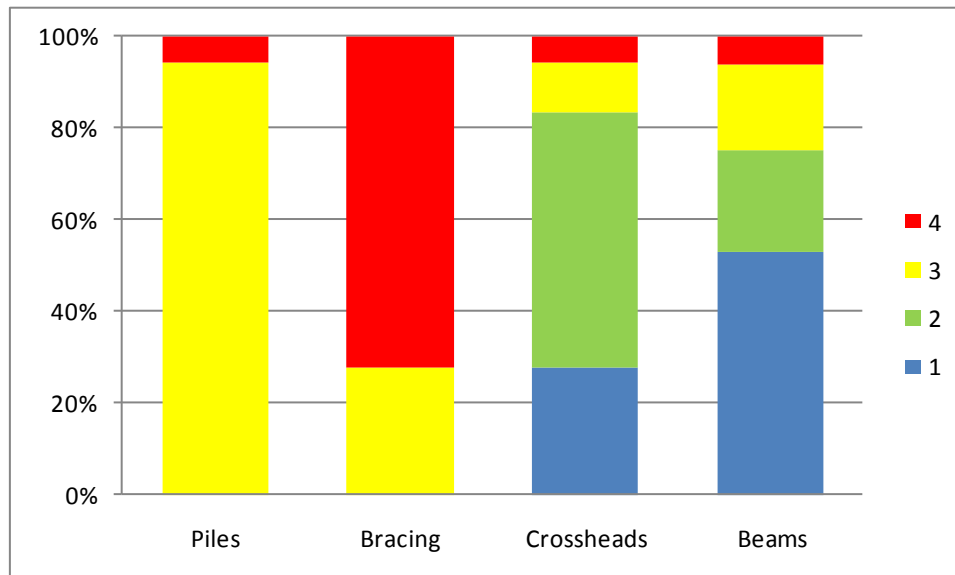
**Figure 3.4.3:** Inspection Area 3 Condition Rating Summary by Element

The rating of the majority of **piles** as Condition State 3 has been based on:

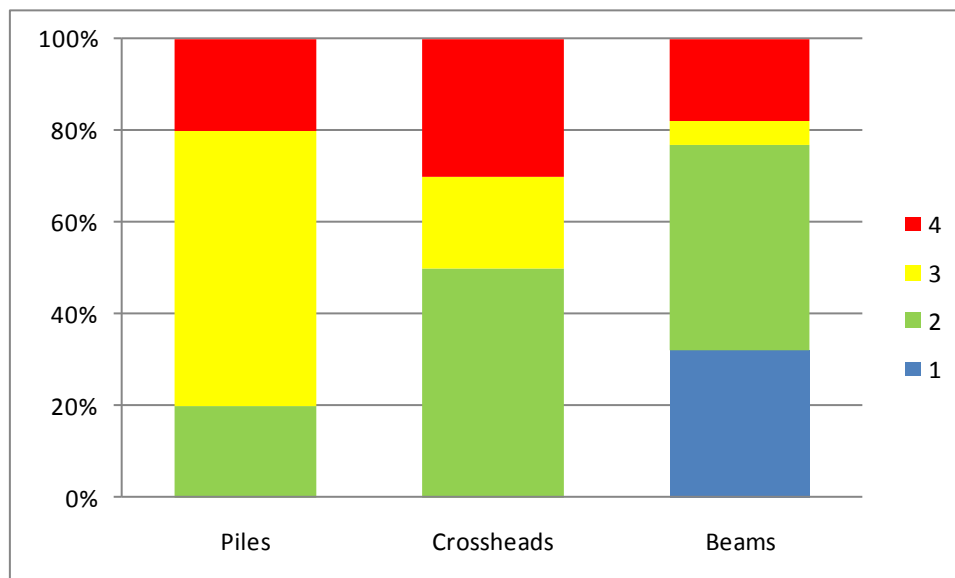
**Figure 3.4.4:** Inspection Area 4 Condition Rating Summary by Element

The rating of **piles** as Condition States 3 & 4 has been based on the reduction in cross section of unrepaired piles from **marine borer attack** and wave/current erosion. Piles classed as condition state 4 have severely reduced or failed cross sections in the inter-tidal zone. All piles have suffered Teredo worm and Limnoria attack. Piles in condition states 2 & 3 had a remaining effective diameter of between 170mm and 250mm.

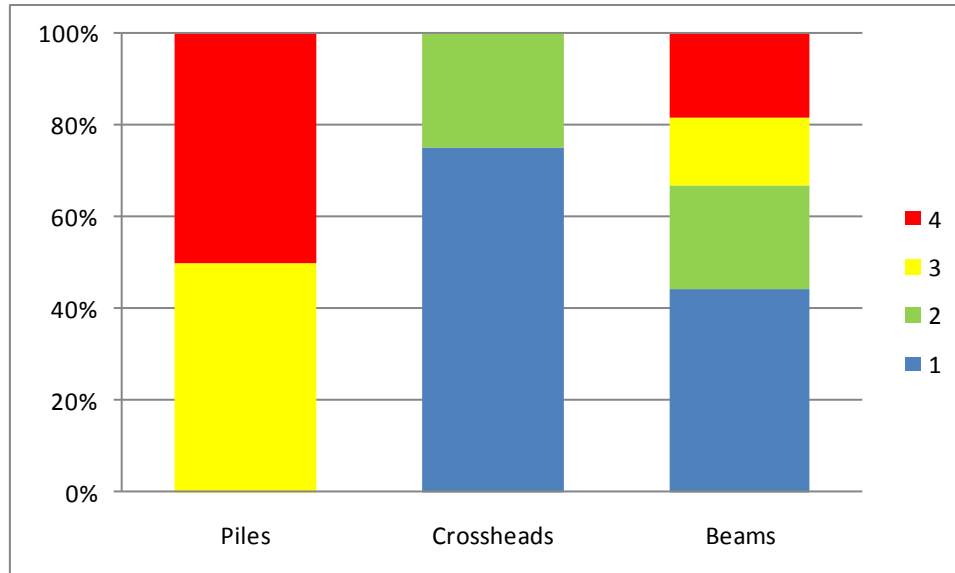
**Figure 3.4.5:** Inspection Area 5 Condition Rating Summary by Element

The rating of **piles** as Condition States 3 & 4 has been based on the reduction in cross section of unrepaired piles from marine borer attack and wave/current erosion. Piles classed as condition state 4 have severely reduced or failed cross sections in the inter-tidal zone. All Piles have suffered heavy Teredo worm and Limnoria attack. The piles which had not failed or are close to failure (Condition State 4) had a remaining effective diameter between 140mm and 210mm.

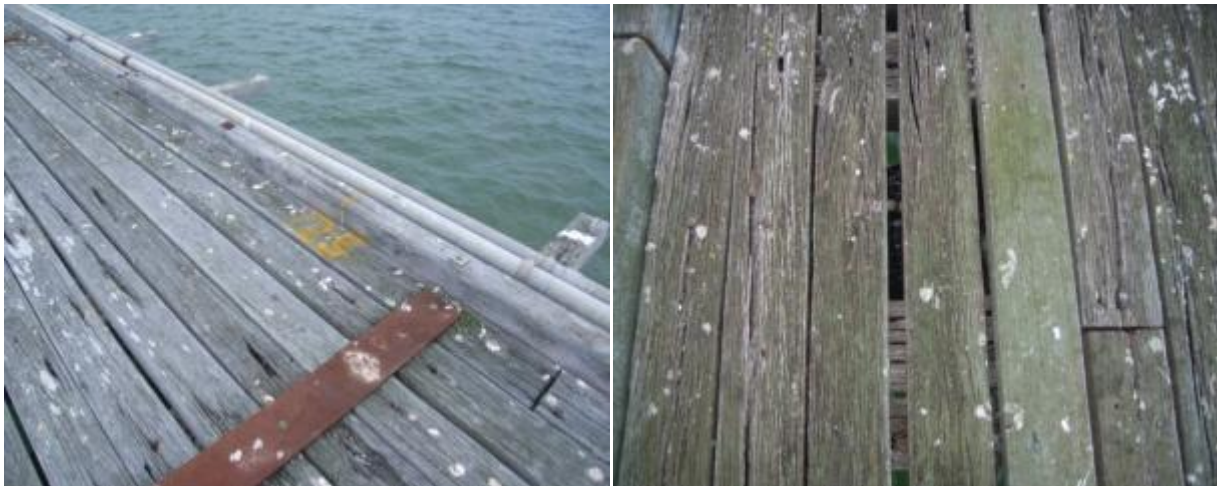
**Figures F7-8:** Current state of Jetty Structure

In addition to vertical tolerances between deck planks, the width of the horizontal gap between adjacent deck planks must be considered. The gap should be minimised to avoid posing a trip hazard through causing imbalance or a healed shoe to pass between deck planks. Spacing, natural variation and warping of deck planks at the Long Jetty have resulted in gaps of up to 75mm between planks. It is recommended that gaps between adjacent planks be a maximum of +13mm wide.

It is also recommended that all capping plates over transverse joints be removed or rebated as they are not flush with the decking surface and present a trip hazard.

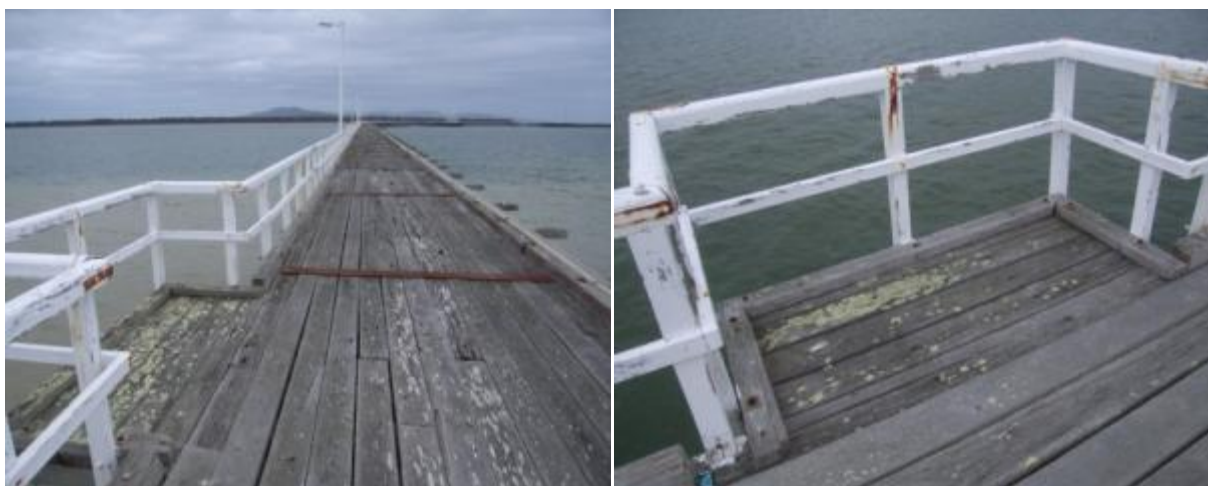
**Figures F9-10:** Small passing bays on the Jetty Structure

The current configuration of the Port Welshpool Long Jetty allows for the provision of seats where small passing bays are part of the Jetty’s superstructure. These passing bays are currently spaced at intervals of approximately 60m. It is recommended that a seat be installed at every second passing bay along the jetty’s length.

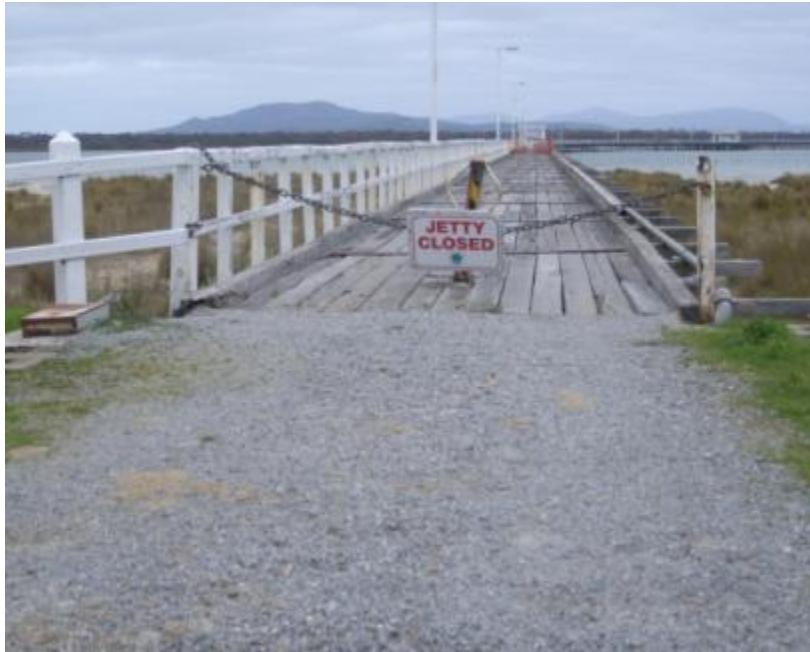
At the time of inspection there was no provision for disabled access to the jetty. It is understood that Gippsland Ports is only responsible for the Jetty structure and that the gravel path and road surrounding the jetty is managed by others. Gippsland Ports should be aware that access to their site by disabled members of the public is not currently compliant with Australian Standards and may limit its use by these members of the community.

**Figure F11:** Access to the start of the Jetty

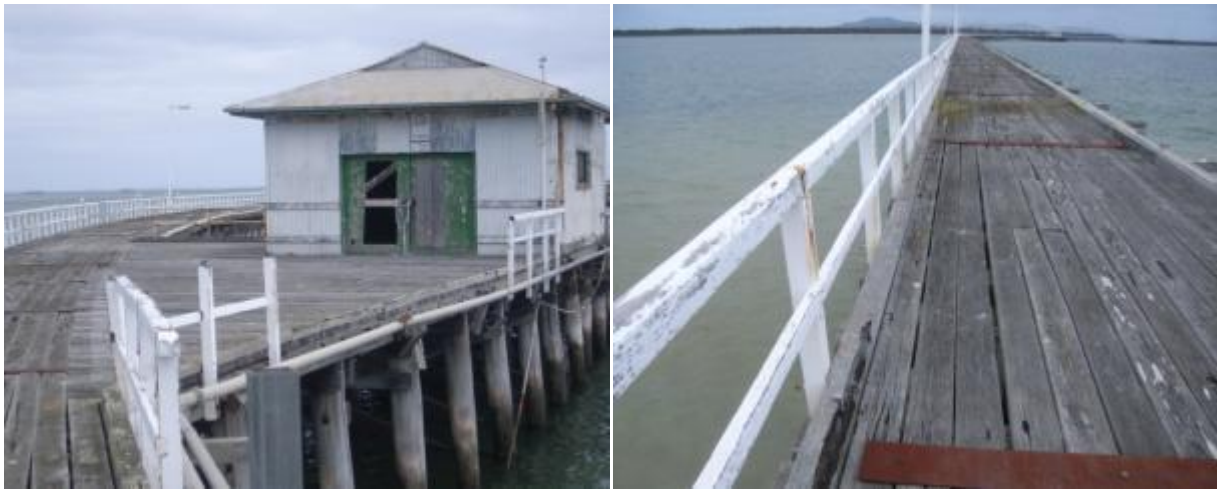
Port Welshpool Long Jetty features handrails along one side for most of its length. AS 4997: Guidelines for the Design of Maritime Structures states that *“Where access to the water or vessels is not required and where a person falling from the structure is likely to fall more than 1.5m to strike a hard surface or the seabed, a guardrail (handrail) should be provided in accordance with AS1657”*. It is recommended that handrails be provided to both sides of the jetty along its entire length where there is currently no fall prevention (this requirement will change if the jetty will be used for berthing when re-opened). It is recommended that Gippsland Ports investigate the requirements under the relevant Australian standards for handrails before implementing this requirement (i.e. AS1657). The structural adequacy of the existing handrails should also be checked before the structure is re-opened.

**Figures F12-13:** Timber handrails

- Rebuild the jetty where it is currently discontinuous to achieve the intended structural form.
- Extensive replacement of missing deck planks.
- Deck planks to be back sawn where required to achieve a vertical tolerance no greater than  $\pm 10\text{mm}$ .
- Replace deck planks to ensure gaps between adjacent planks are no greater than 13mm.
- Remove or rebate capping plates.
- Liaise with the relevant authority on current access limitations prior to jetty entry.
- Install ladders at 60m intervals along the jetties length.
- Replace existing handrails where required.
- Provide compliant handrails to both sides of the jetty, along its entire length.
