PORT WELSHPOOL LONG  
JETTY – CONDITION  
ASSESSMENT VALIDATION

## GIPPSLAND PORTS

## ASSESSMENT REPORT

**Report No** F0001-AA004066-AAR-02

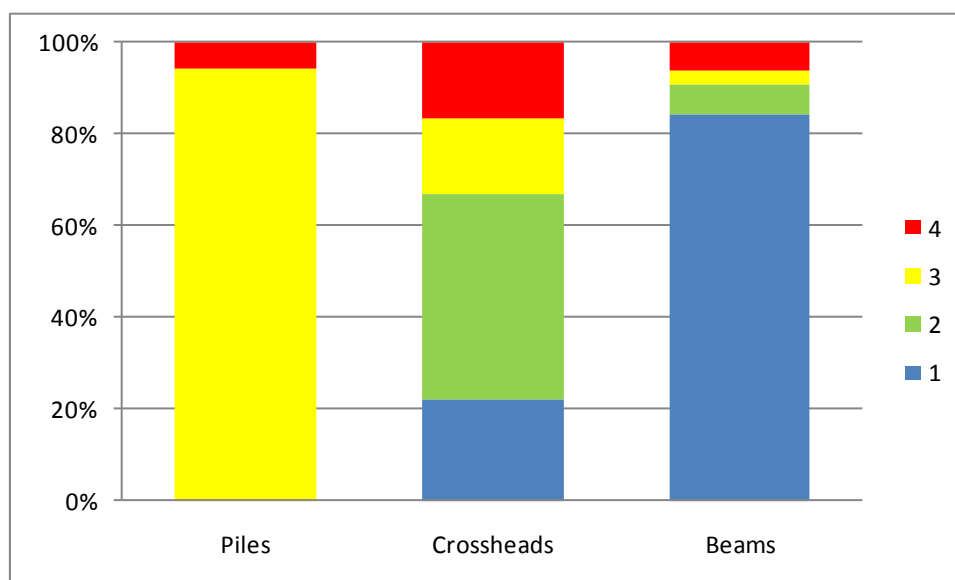
**Table 3.4.2:** Inspection Area 2 Condition Rating Summary by Element

The rating of the majority of **piles** as Condition State 3 has been based on:

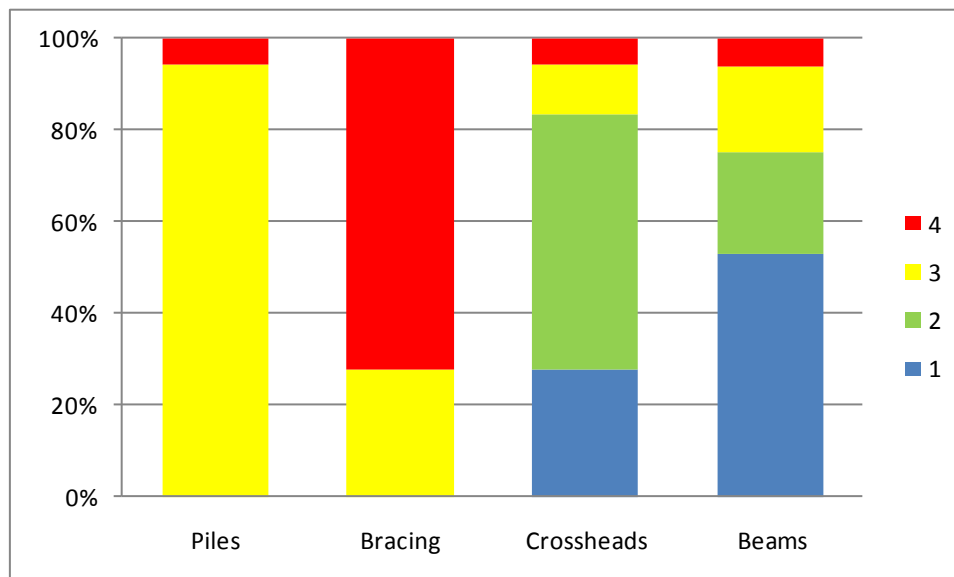
Figure 3.4.3: Inspection Area 3 Condition Rating Summary by Element

The rating of the majority of **piles** as Condition State 3 has been based on:

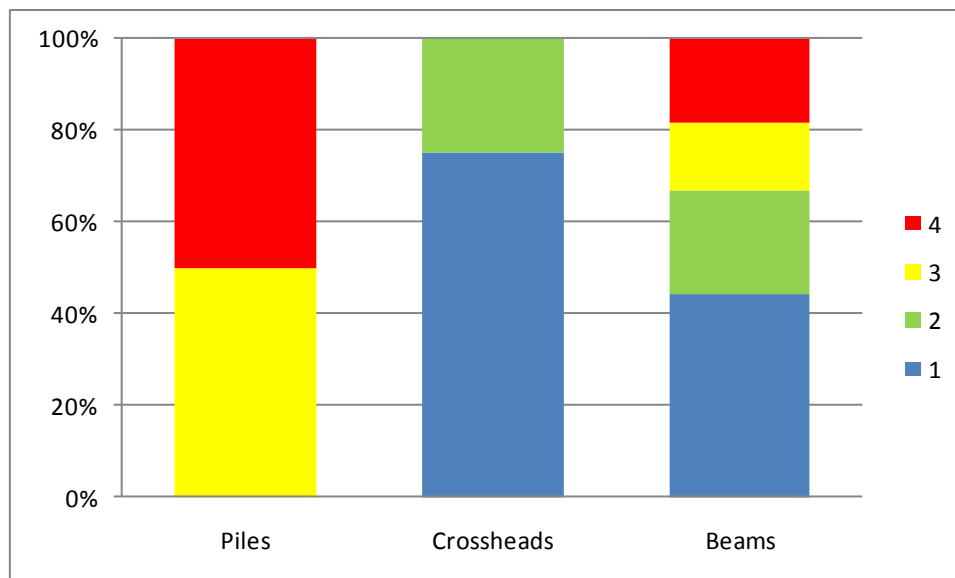
**Figure 3.4.5:** Inspection Area 5 Condition Rating Summary by Element

The rating of **piles** as Condition States 3 & 4 has been based on the reduction in cross section of unrepaired piles from marine borer attack and wave/current erosion. Piles classed as condition state 4 have severely reduced or failed cross sections in the inter-tidal zone. All Piles have suffered heavy Teredo worm and Limnoria attack. The piles which had not failed or are close to failure (Condition State 4) had a remaining effective diameter between 140mm and 210mm.

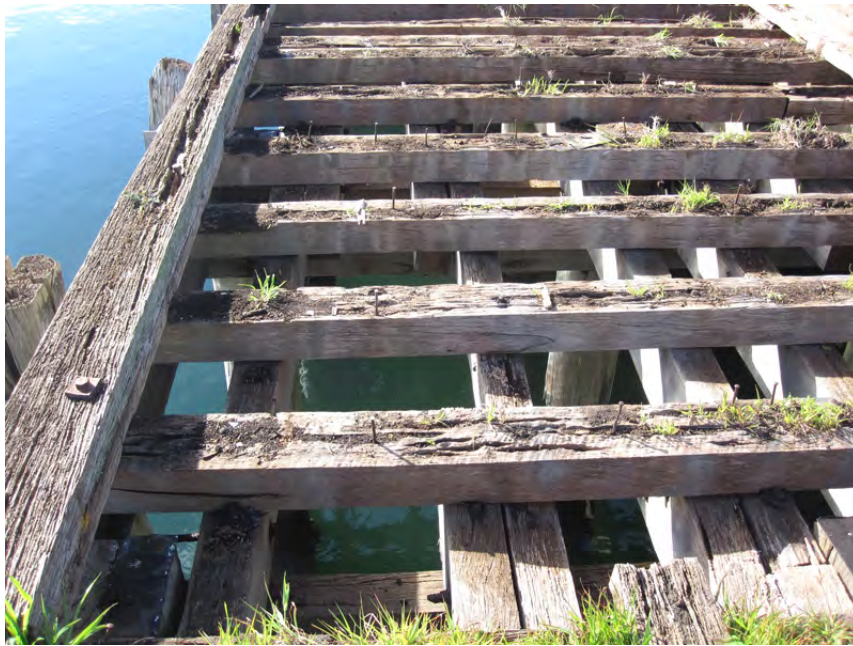
Decking joists (not inspected, generally in poor condition) on longitudinal beams, which rest upon crossheads (Figure 26). Different to other locations where crossheads rest upon the longitudinal beams.

**Figure 26: Area 5, decking joists resting on longitudinal beams resting on crossheads.**

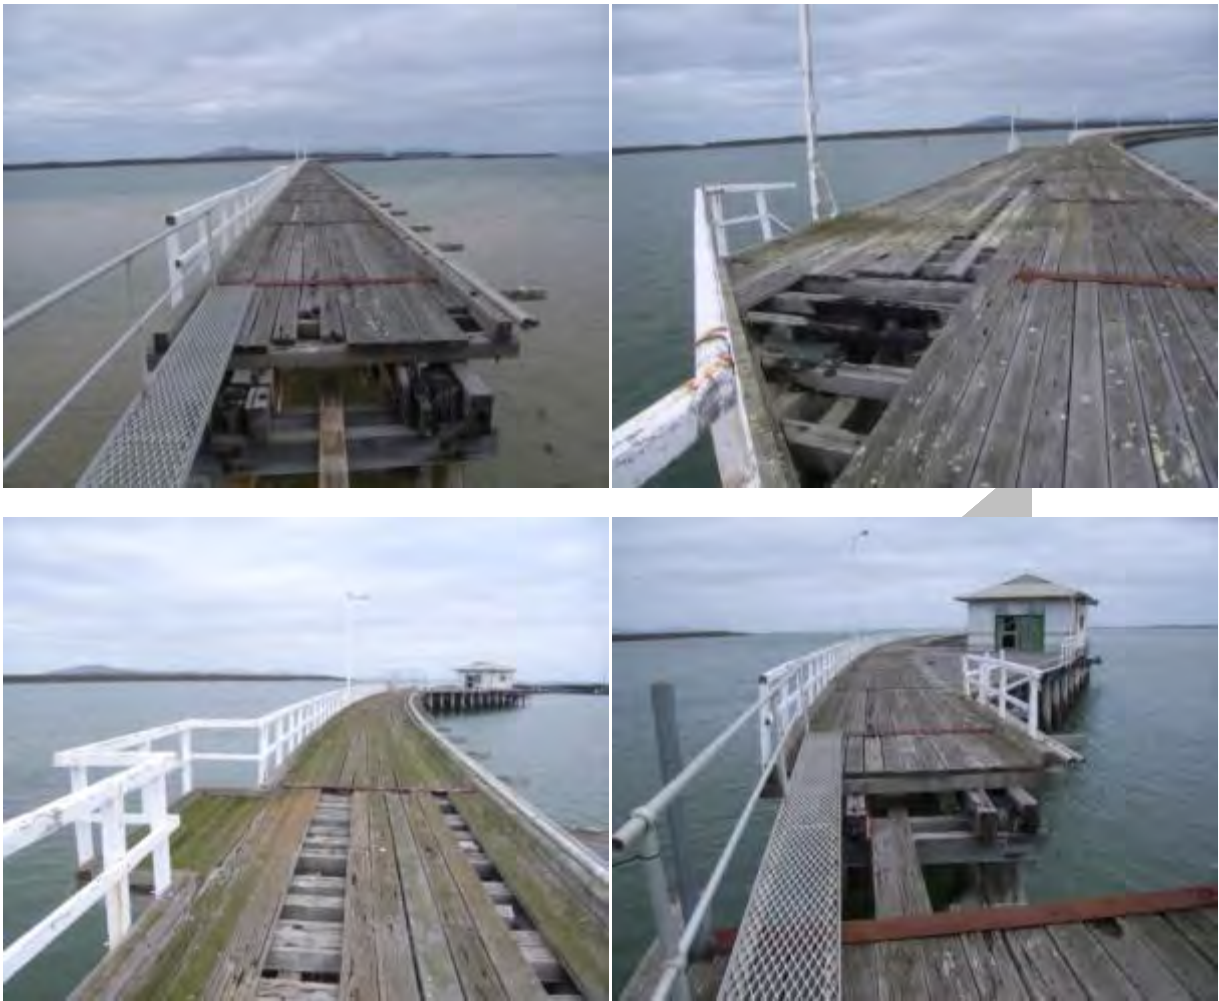
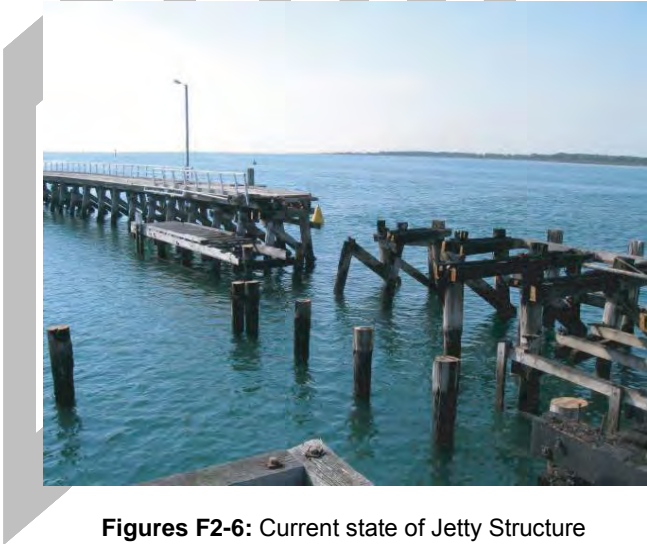
**Figures F2-6:** Current state of Jetty Structure

- Reconstruction of the jetty in sections where it has burnt out or been purposefully removed.
- Extensive replacement of the jetty superstructure, especially the heavily deteriorated deck planks.

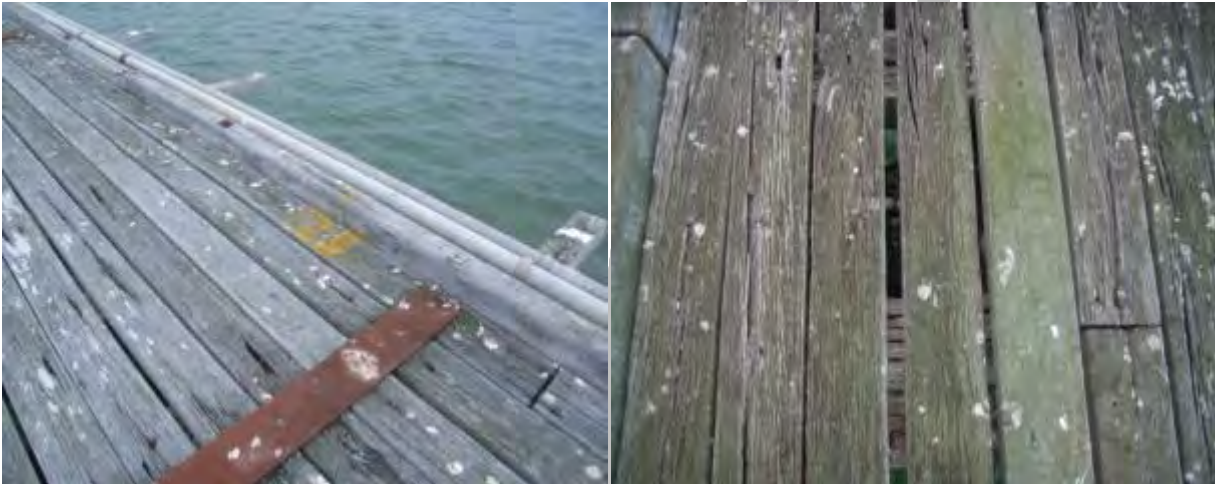
In addition to vertical tolerances between deck planks, the width of the horizontal gap between adjacent deck planks must be considered. The gap should be minimised to avoid posing a trip hazard through causing imbalance or a healed shoe to pass between deck planks. Spacing, natural variation and warping of deck planks at the Long Jetty have resulted in gaps of up to 75mm between planks. It is recommended that gaps between adjacent planks be a maximum of +13mm wide.

**Figures F7-8:** Current state of Jetty Structure

It is also recommended that all capping plates over transverse joints be removed or rebated as they are not flush with the decking surface and present a trip hazard.

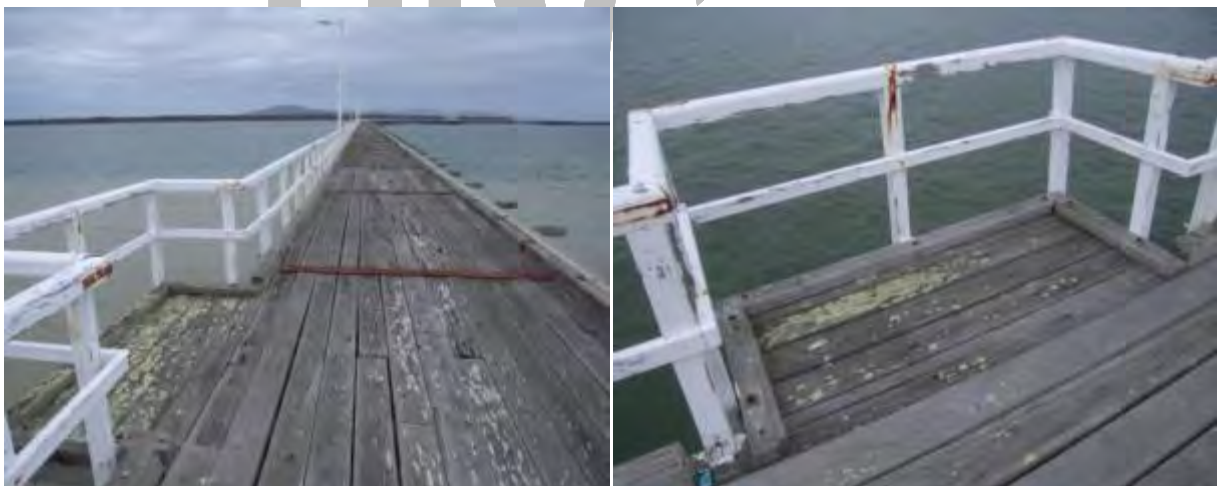
**Figures F9-10:** Small passing bays on the Jetty Structure

The current configuration of the Port Welshpool Long Jetty allows for the provision of seats where small passing bays are part of the Jetty’s superstructure. These passing bays are currently spaced at intervals of approximately 60m. It is recommended that a seat be installed at every second passing bay along the jetty’s length.

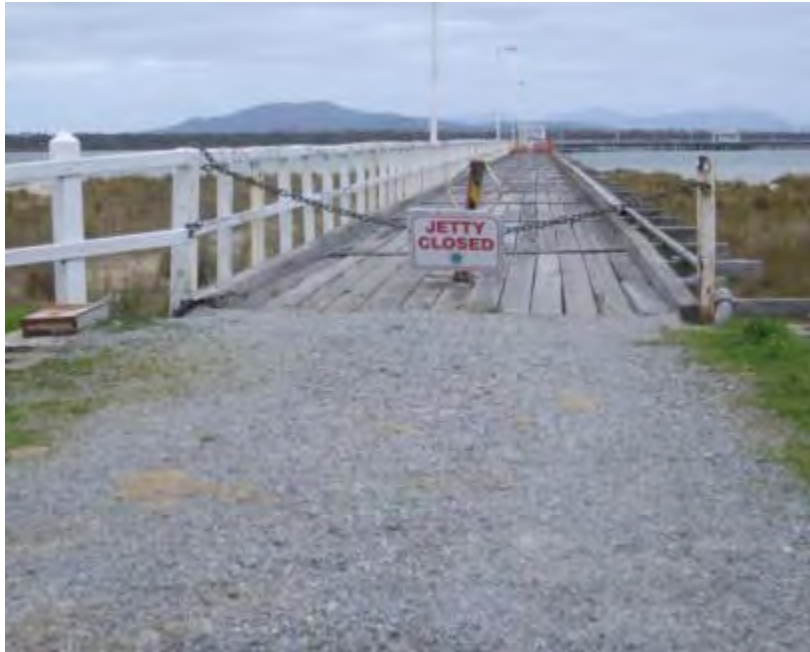
At the time of inspection there was no provision for disabled access to the jetty. It is understood that Gippsland Ports is only responsible for the Jetty structure and that the gravel path and road surrounding the jetty is managed by others. Gippsland Ports should be aware that access to their site by disabled members of the public is not currently compliant with Australian Standards and may limit its use by these members of the community.

**Figure F11:** Access to the start of the Jetty

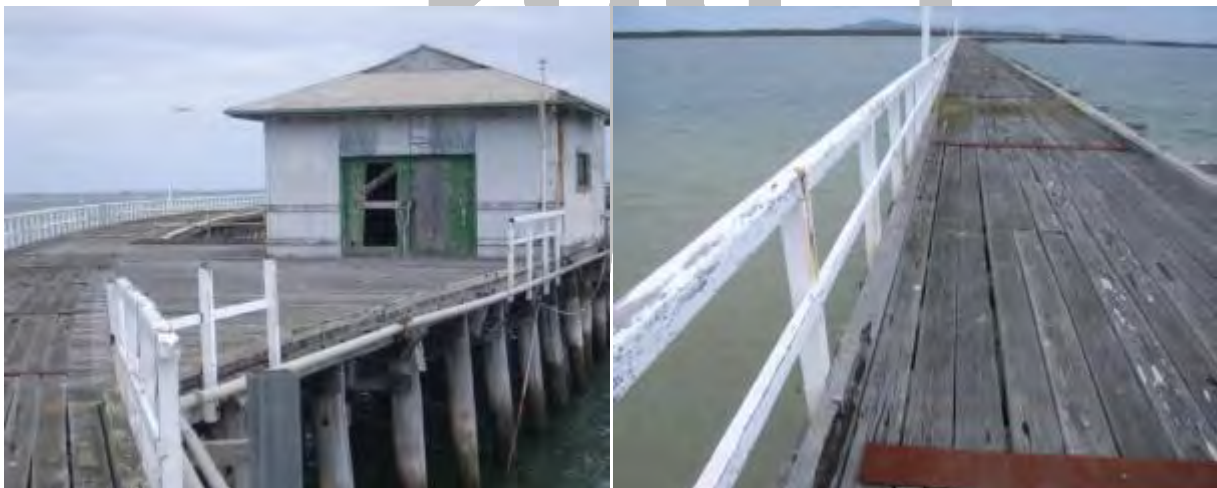
Port Welshpool Long Jetty features handrails along one side for most of its length. AS 4997: Guidelines for the Design of Maritime Structures states that *“Where access to the water or vessels is not required and where a person falling from the structure is likely to fall more than 1.5m to strike a hard surface or the seabed, a guardrail (handrail) should be provided in accordance with AS1657”*. It is recommended that handrails be provided to both sides of the jetty along its entire length where there is currently no fall prevention (this requirement will change if the jetty will be used for berthing when re-opened). It is recommended that Gippsland Ports investigate the requirements under the relevant Australian standards for handrails before implementing this requirement (i.e. AS1657). The structural adequacy of the existing handrails should also be checked before the structure is re-opened.

**Figures F12-13:** Timber handrails
