Shipping Pier Inspection – Port Welshpool

GIPPSLAND PORTS

KINA DIVING PTY LTD

2,3,4,5 August 2011

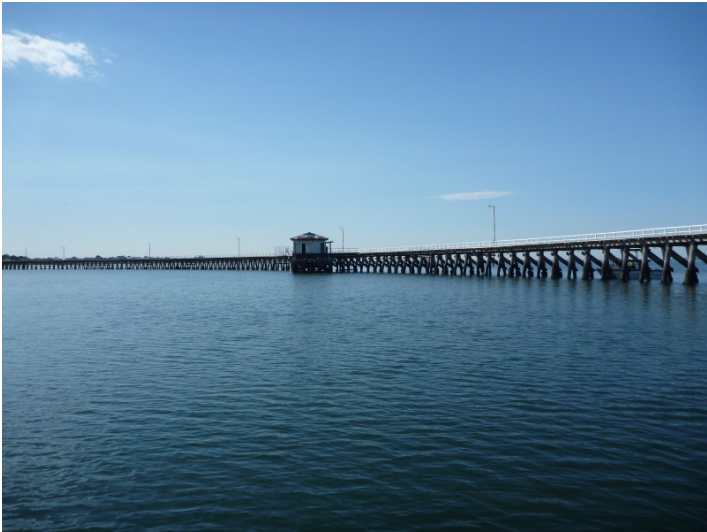
Trestle Area

Piles Inspected: Bent 142- 251

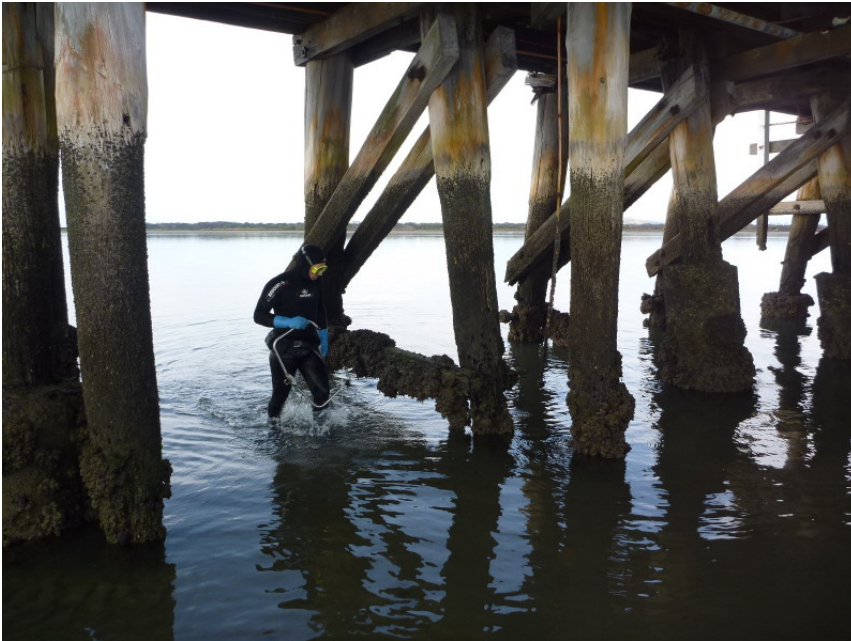
The dive team carried out a full video inspection of all the trestle section starting from Bent 142 out to Bent 251 which is where the fire damaged section begins. Due to exceptionally low tides, bents 201-210 were inspected visually in the dry and no video footage taken due to the difficulty of operating the U/W inspection system above water.

Diver inspecting Bents 201-210 at dead low tide.
