Slope Stability Assessment

**No. 99, Bena Road, Korumburra,
Victoria, 3950**

175232-PRJ75208-GEO-REP 01

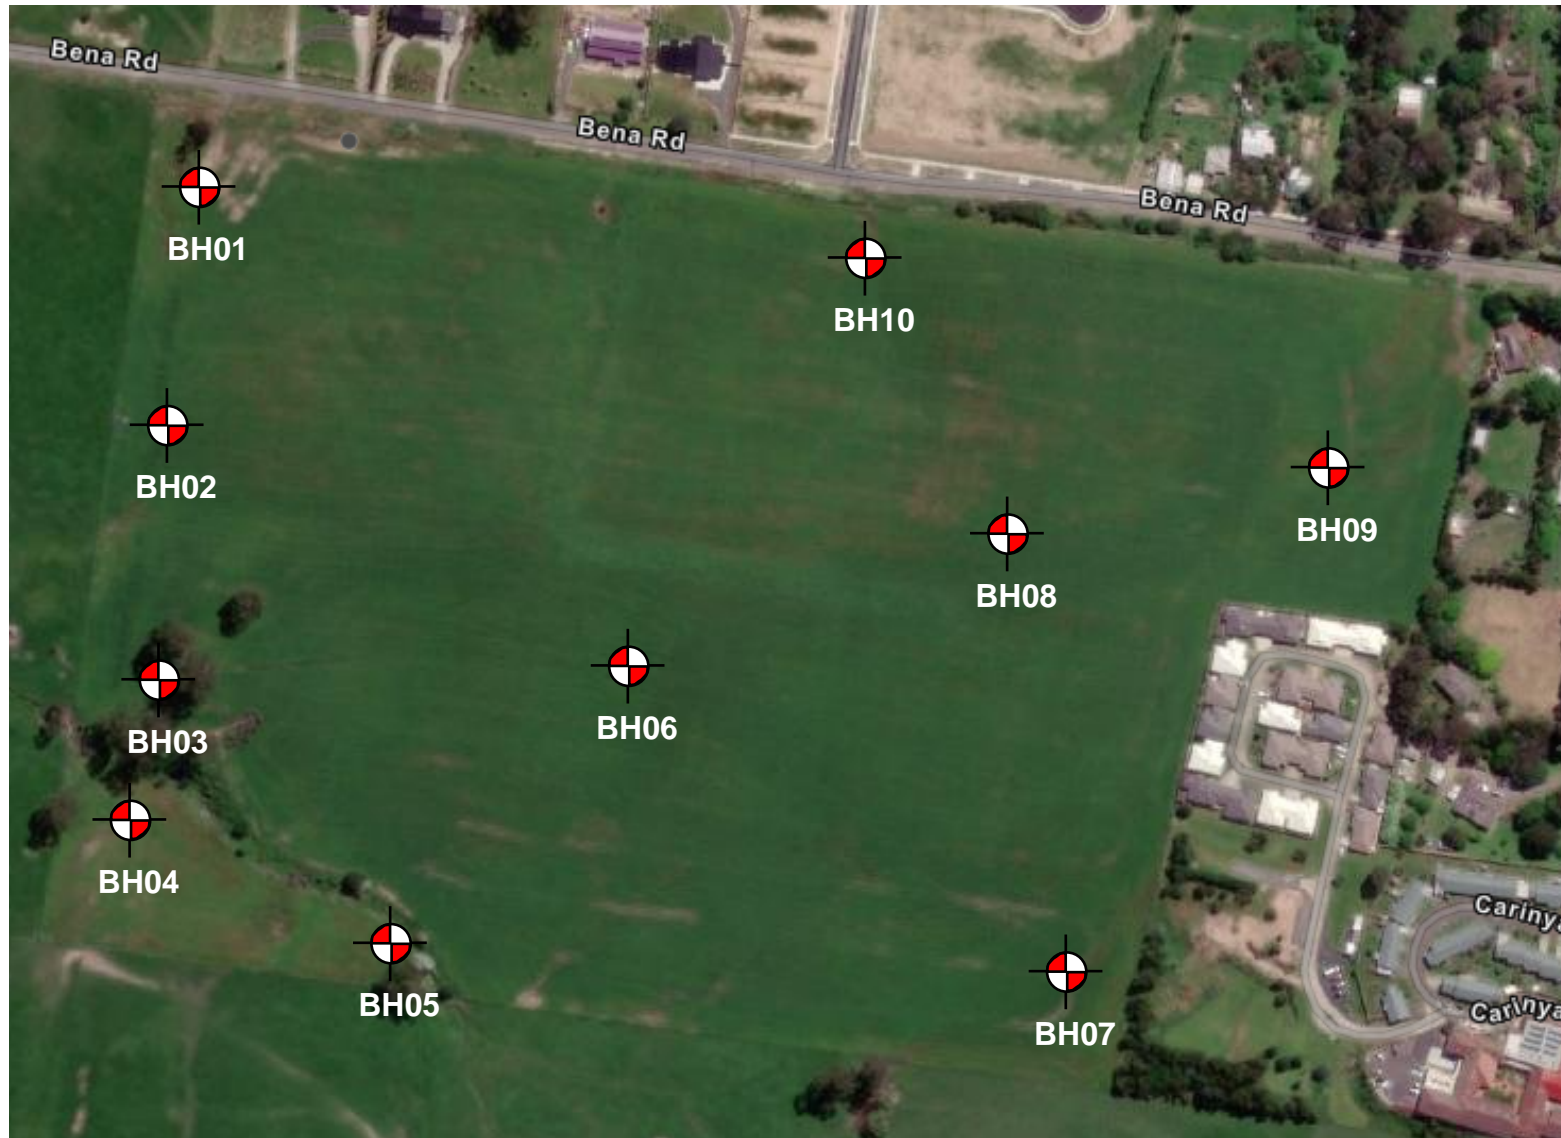
Site Plan and Borehole Logs
